**Salina Airport Authority**  
3237 Arnold Avenue  
Salina, KS 67401

## Report 1 - Structural Condition Assessment

### Hangers P1-P4, P13

**JANUARY 27, 2022**

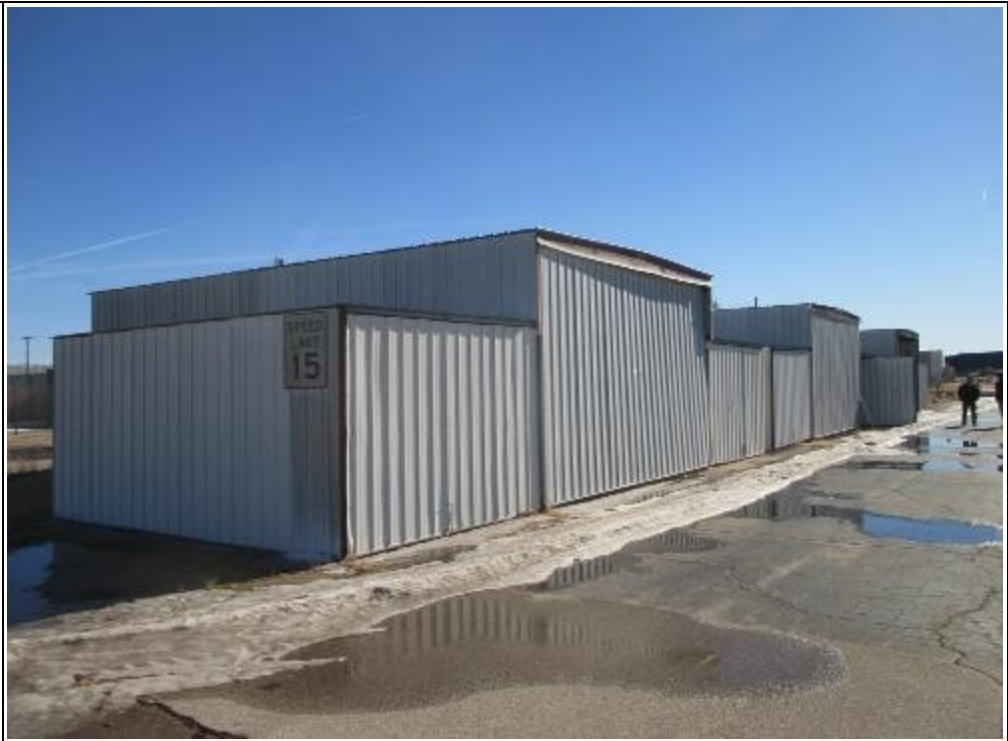
**Photograph: 1**

View of the front elevation of the Hangars 1 thru 3 from the north-west.

The "P" Hangars had similar configurations and construction.

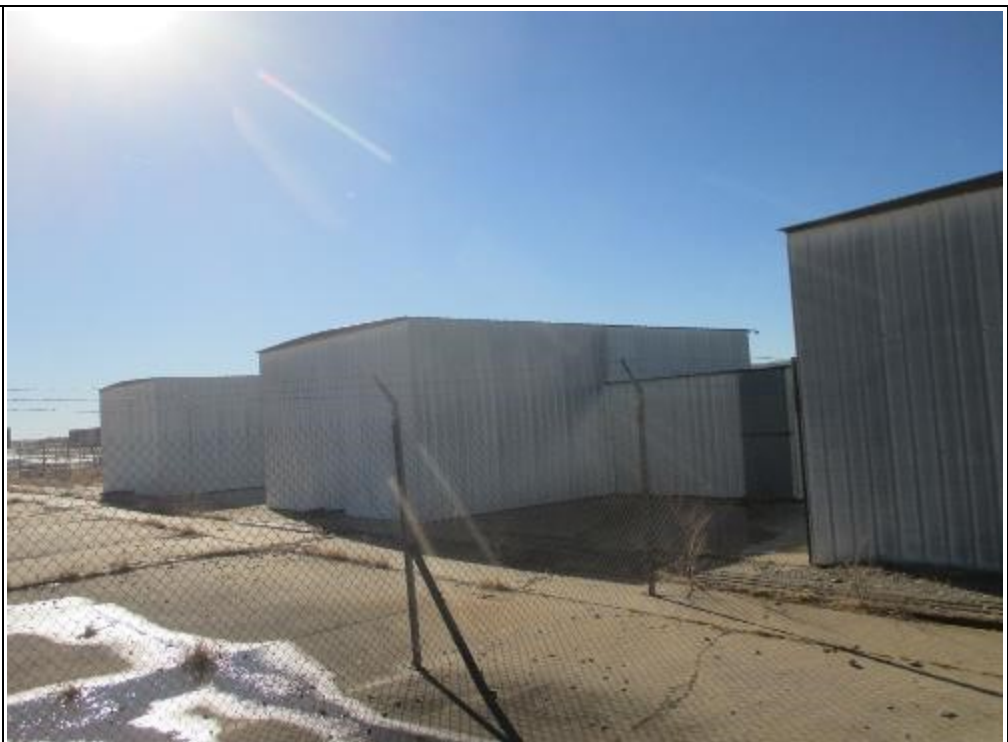
**Photograph: 2**

View of the rear elevations of the Hangars from the east.

The "P" Hangars had similar configurations and construction.

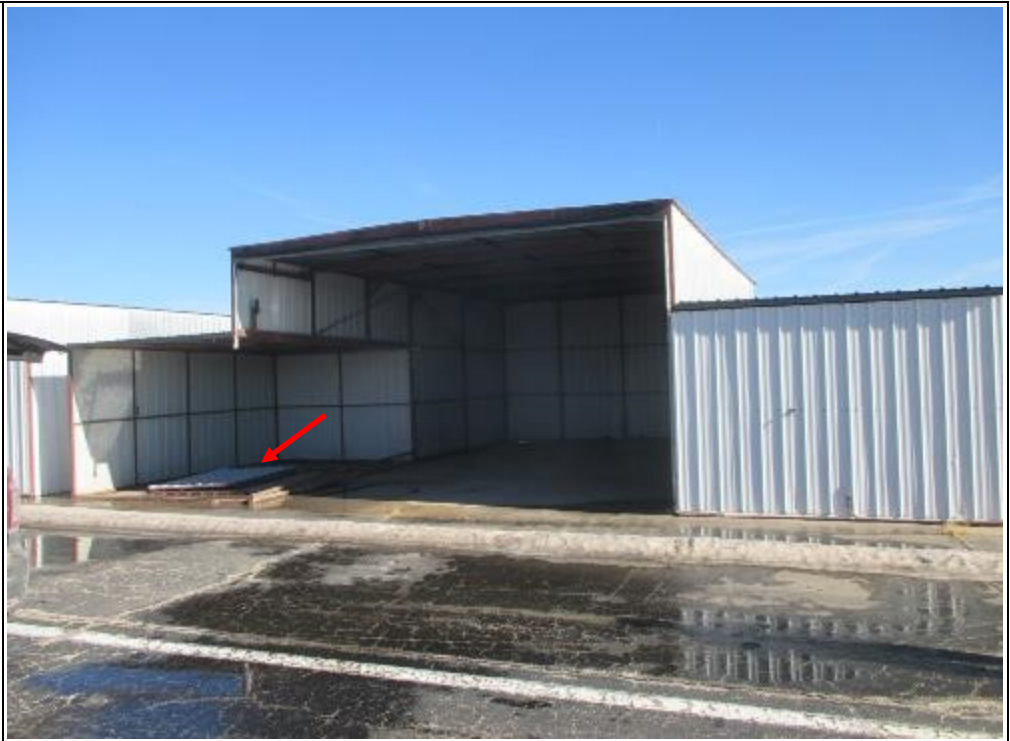
### Photograph: 3

The hangar exterior did not have missing roof or wall panels. The left bay roof had two roof panels with dents to their flutes, and the metal panels were displaced downward. The left bifold door was folded and detached and was laying on the concrete slab on the left bay floor. The right bifold door operated and did not apparently bind. The center overhead door was missing. The ends of the trim above the overhead door were bent. The overhead door tracks on both sides were bent. The overhead door hardware and spring assemblies were detached, and several pieces of the assemblies were laying on the center bay hangar floor. The track bolt for the sliding door was not bent, and the ends of the bolt were marred. The bottom frame member for the left bay was bent and fractured. The top of the member at the bend was fractured, and the fracture surfaces had surface corrosion from apparent corrosion. The gap above the right bifold door and the frame appeared to be uniform and was approximately one inch (see Photos 3 thru 11).

View of the front elevation of Hangar P1.

The overhead door was missing, and the left bi-fold door was on the hangar floor (red arrow).

1. Replace the overhead and left bifold doors including their springs, hardware, and track assemblies.
2. Replace the upper track and hardware for the right bifold door.

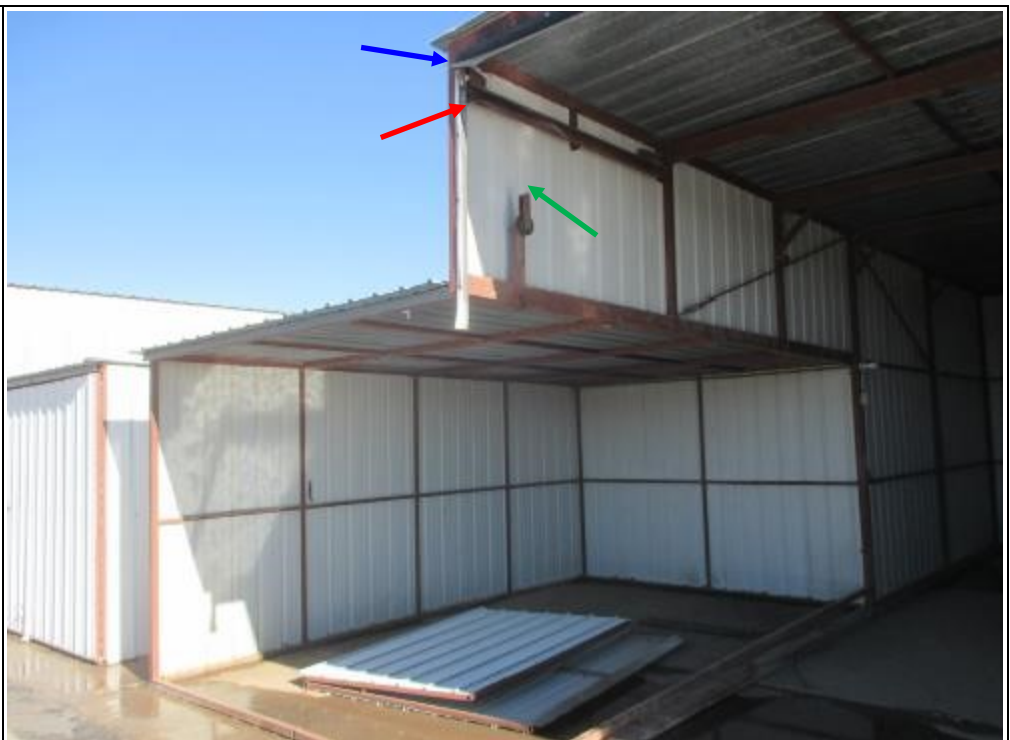
### Photograph: 4

Closeup of the bent door track (red arrow) and missing hardware (green arrow) on the left side of the overhead door for Hangar P1.

Note the bent trim above the top of the overhead door opening (blue arrow).

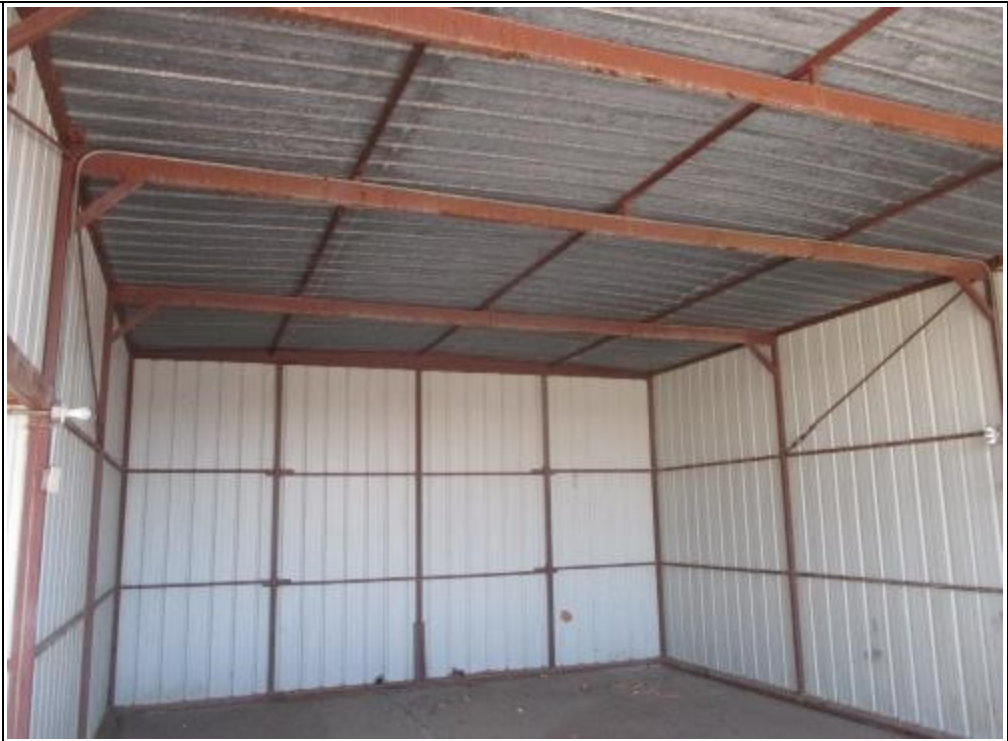
**Photograph: 5**

Interior view of the center bay for Hangar P1.

Hangar P2 was similar.

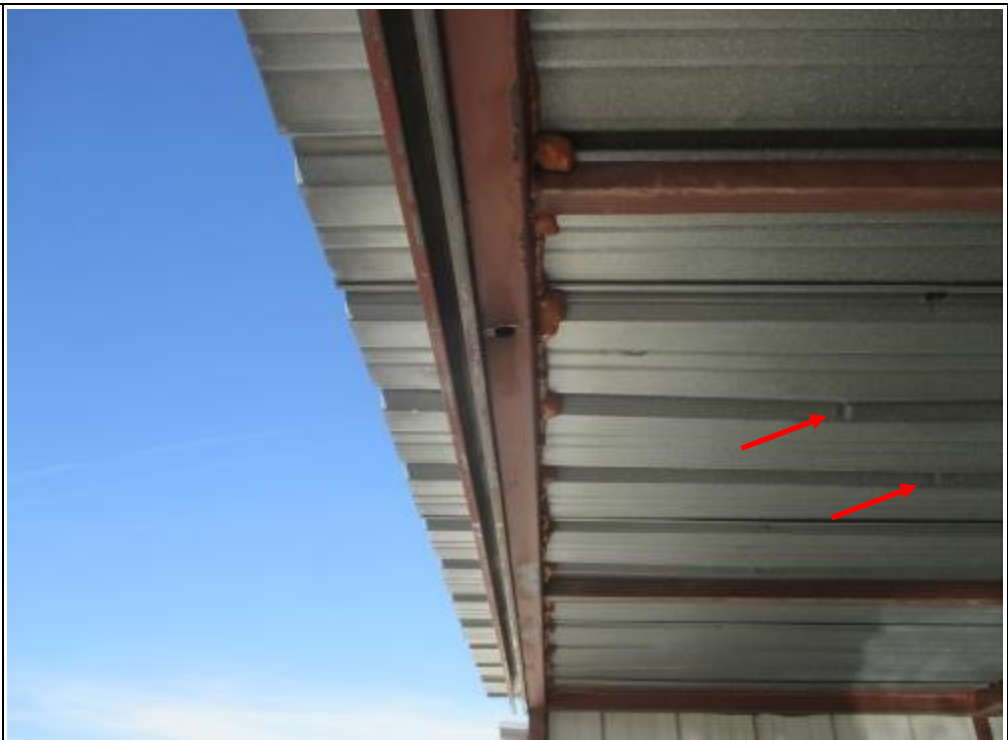
**Photograph: 6**

View of the upper track assembly for the left bifold door for Hangar P1.

Two roof panels had two flutes that were bent downward (red arrows).

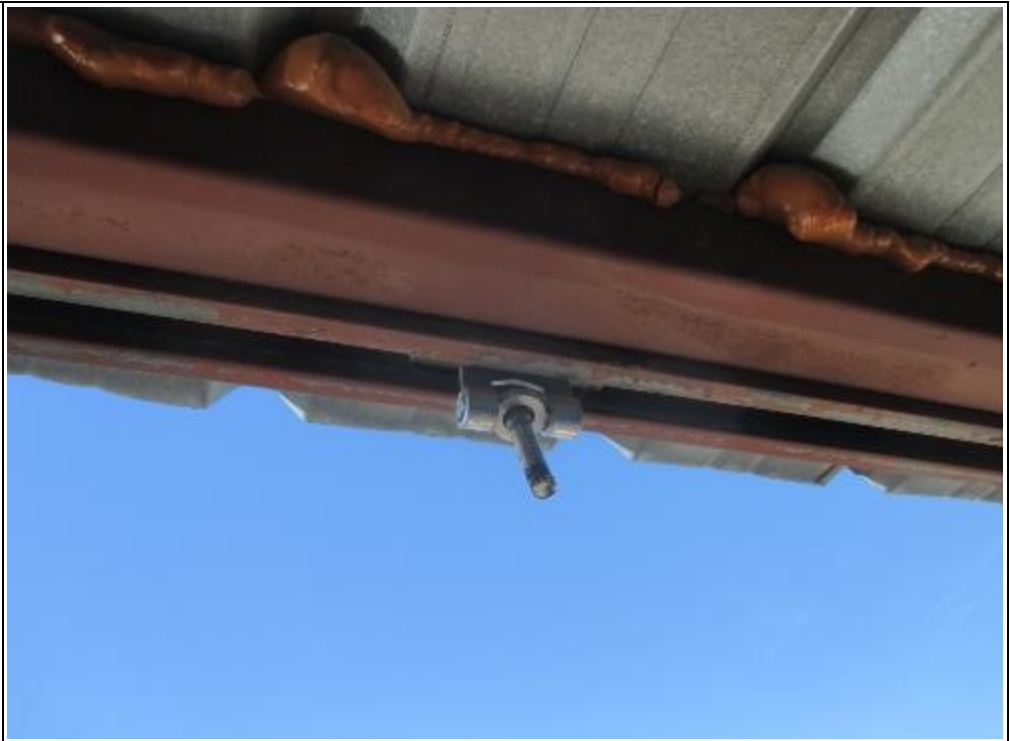
**Photograph: 7**

View of the track bolt for the left bifold door for Hangar P1.

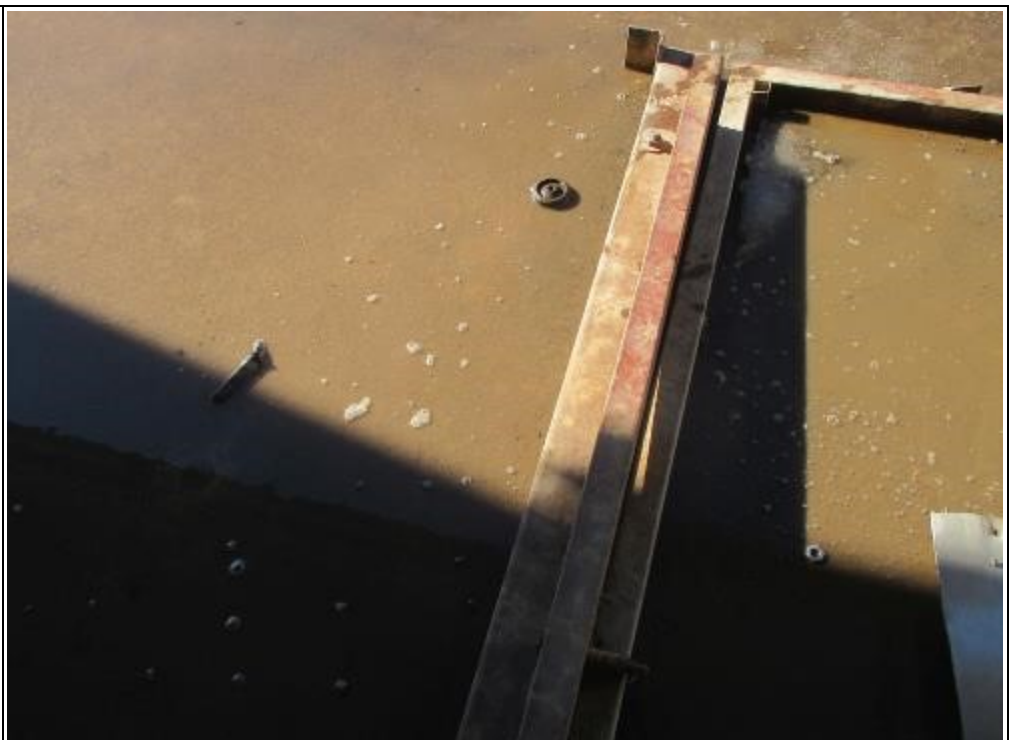
**Photograph: 8**

View of apparent overhead door hardware on the hangar floor for Hangar P1.

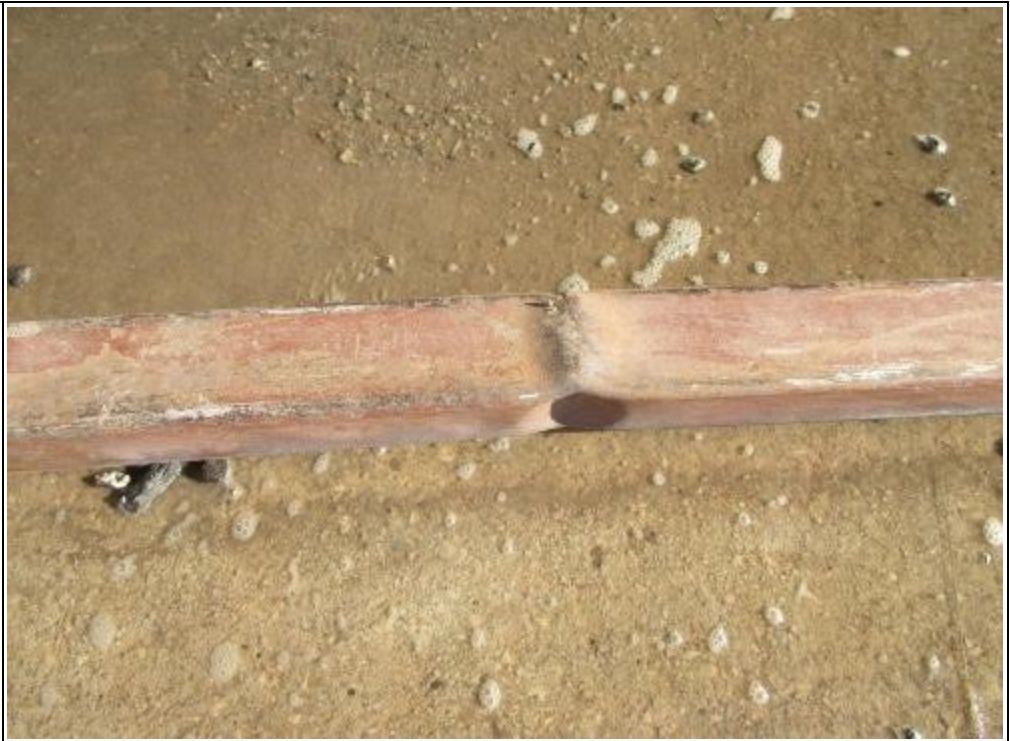
**Photograph: 9**

View of a bent floor frame member for Hangar P1.

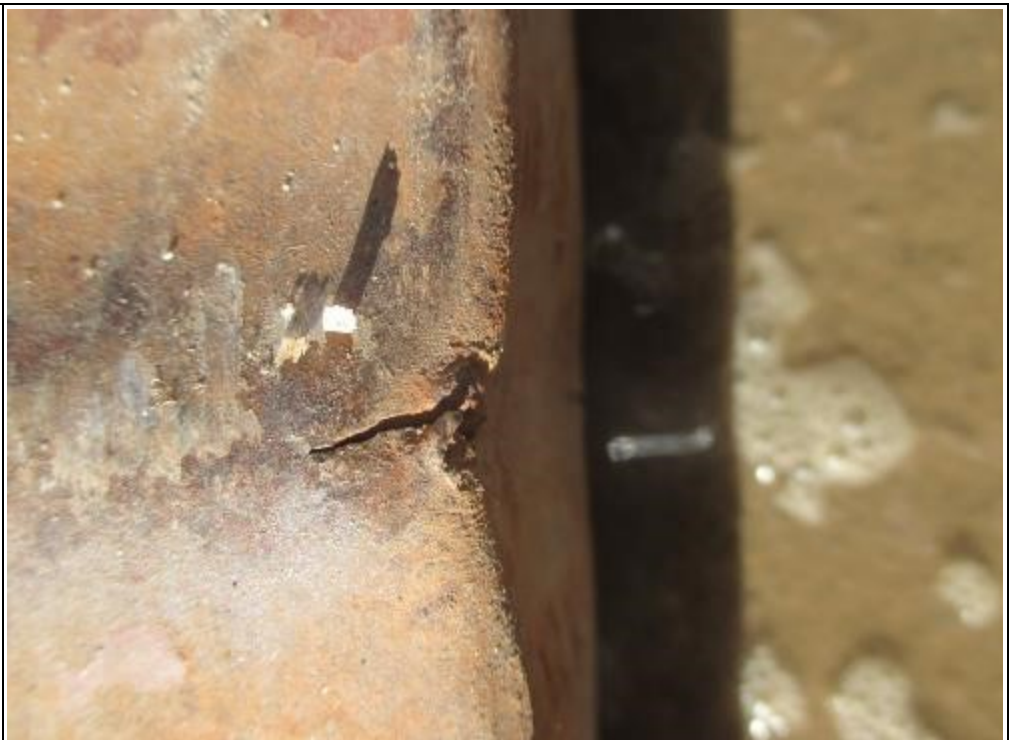
**Photograph: 10**

Closeup of the bent floor frame member for Hangar P1.

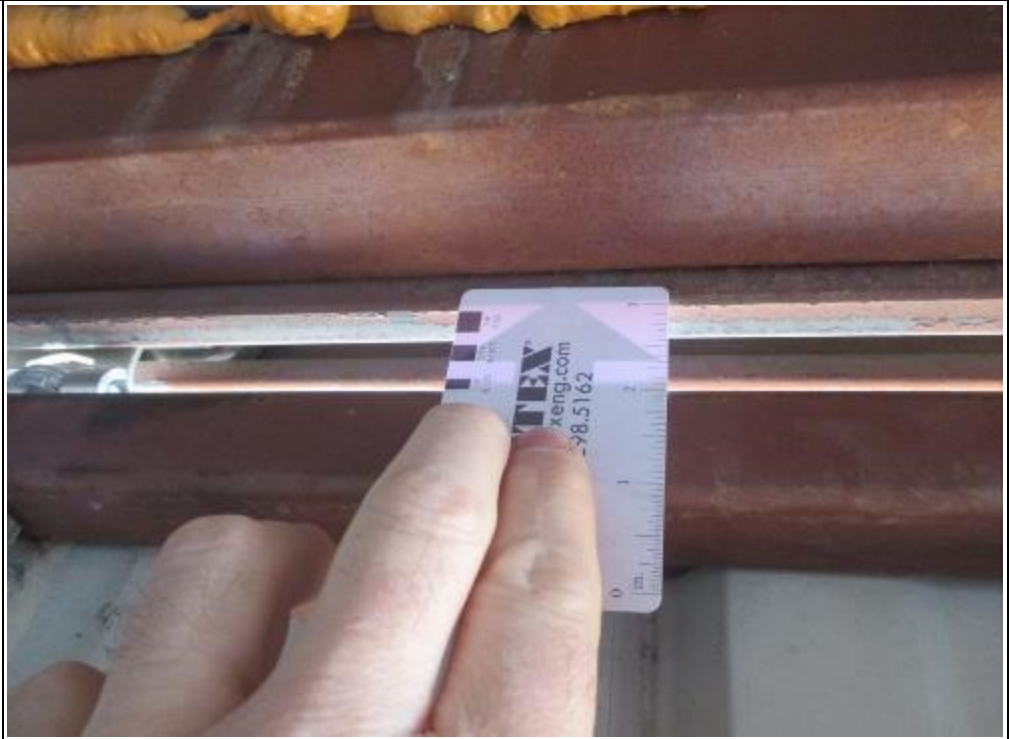
**Photograph: 11**

View of the gap between the right bifold door and upper track for Hangar P1.

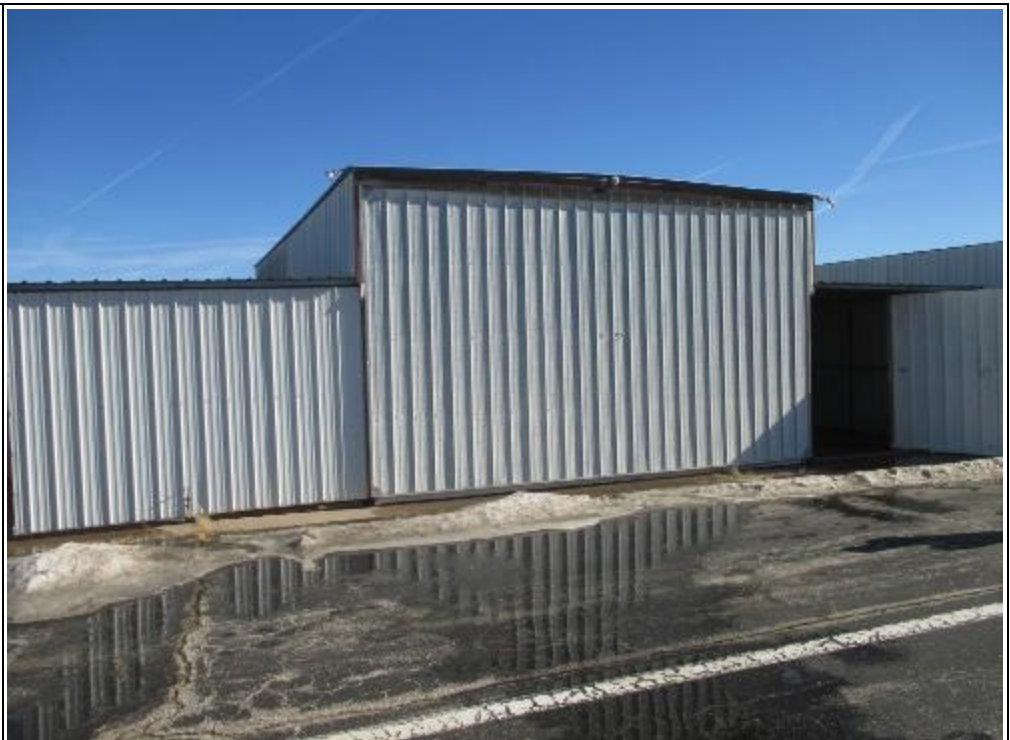
**Photograph: 12**

The hangar doors for Hangar P2 were in place and were not apparently bent or deformed. The hangar bifold doors operated. The overhead door was vertical but did not operate. The upper rollers and door tracks on both sides of the overhead door were bent. The metal cover plate for the left bifold door was bent. The bent surfaces for the cover plate had a dulled appearance. The track bolt for the left bifold door was bent (see Photos 12 thru 15).

View of the front elevation for Hangar P2.

1. Replace the hardware and spring assemblies for the overhead door.
2. Replace the upper track and hardware for both bifold doors.

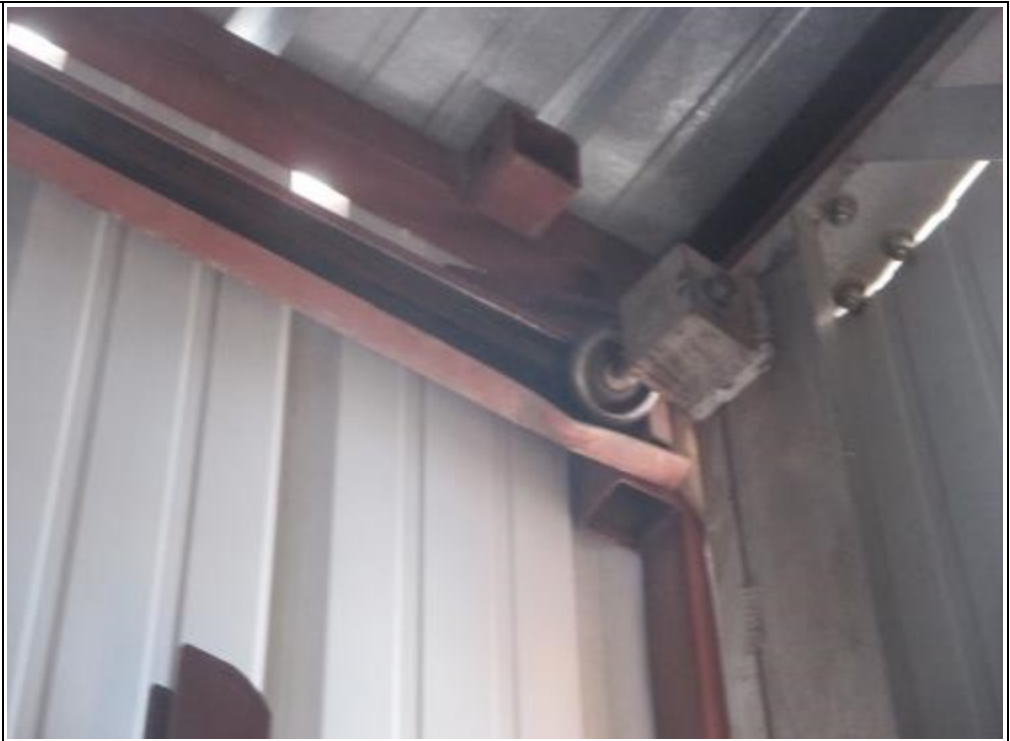
**Photograph: 13**

View of the bent upper right track and roller assembly for the over-head door for Hangar P2.

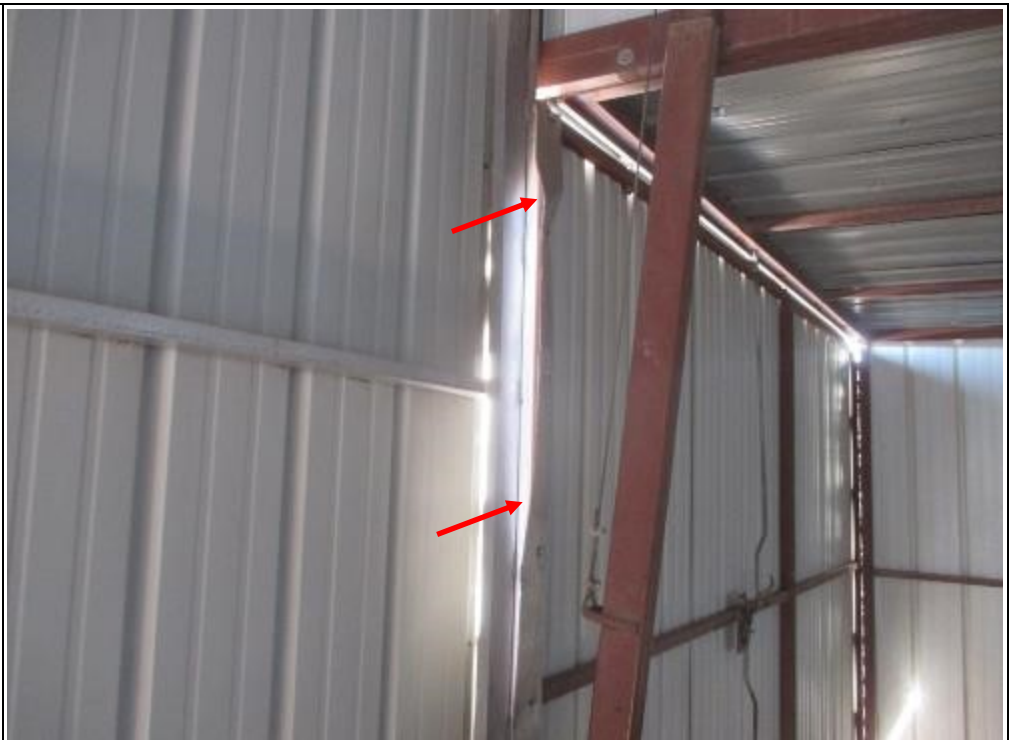
**Photograph: 14**

View of the bent cover plate (red arrow) for the left bifold door for Hangar P2.

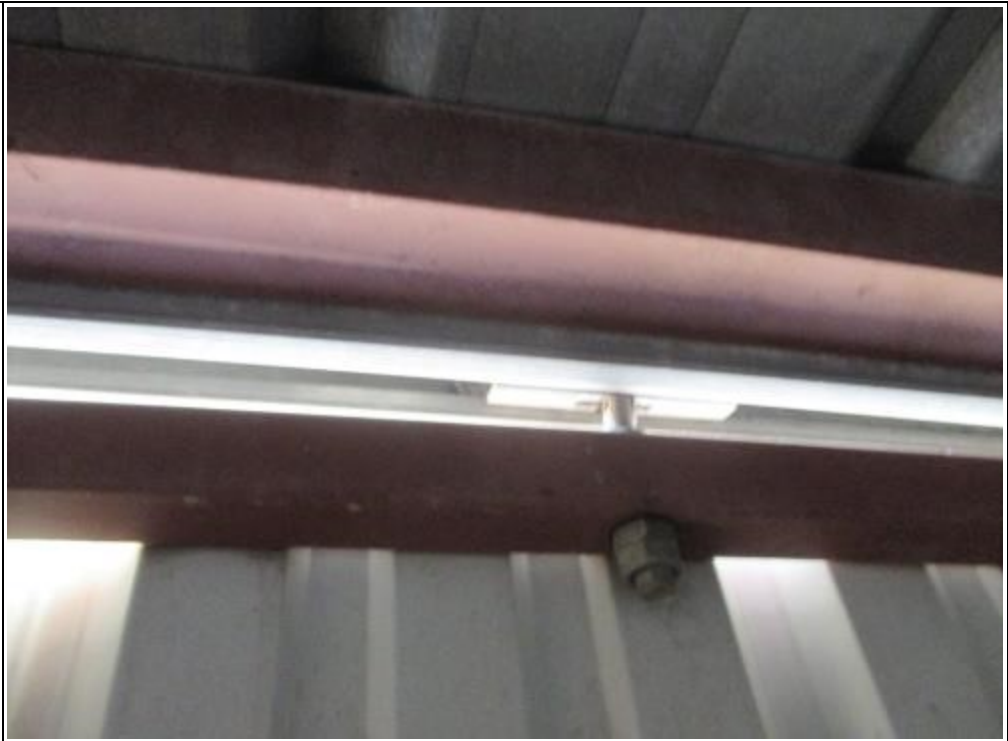
**Photograph: 15**

View of a bent track bolt for the left bifold door for Hangar P2.

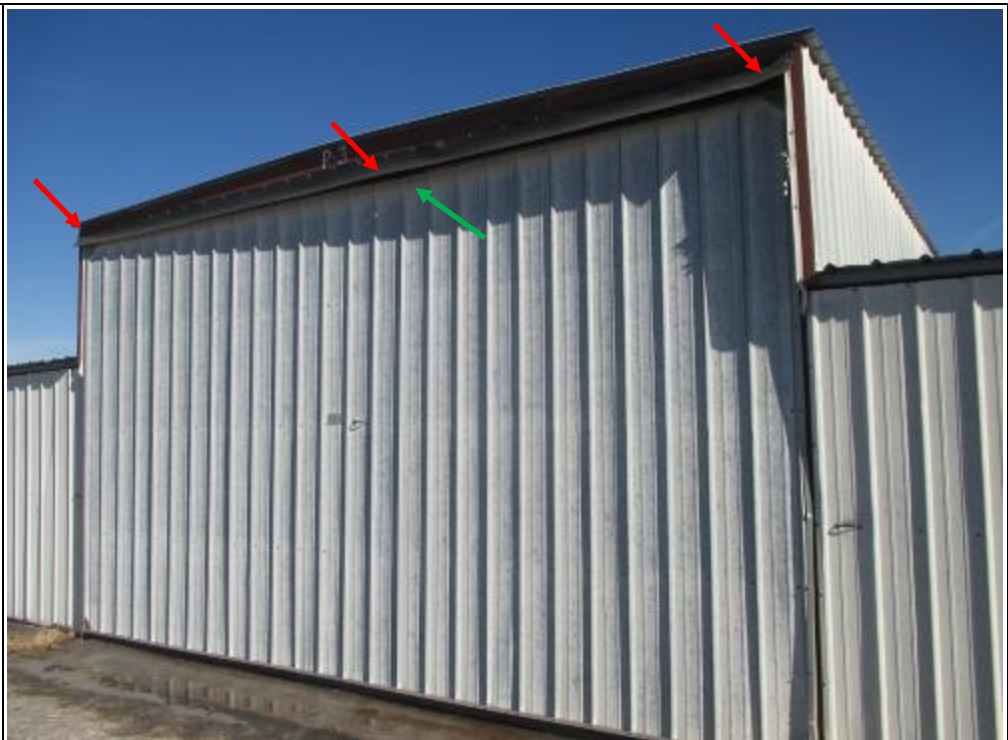
**Photograph: 16**

VERTEX inspected Hangar P3 from the exterior since the hangar was locked and was not accessible. The north wall of the center bay had a wall panel had a linear dent and was fractured along the dent. The area left of the fracture had vertical discolored streaks. The fractured edges were rounded and dulled in appearance. The upper corners of the overhead doors were displaced inward. The top center of the overhead door appeared to be bent inward. The trim above the overhead door was bent in the middle and at its ends (see Photos 16 thru 18).

View of the front elevation for Hangar P3.

The upper trim above the overhead door was bent (red arrows).

The middle top of the overhead door had gap and appeared to be bent inward (green arrow).

1. Replace the upper cross member of the overhead door.
2. Replace the overhead door upper rollers and tracks.

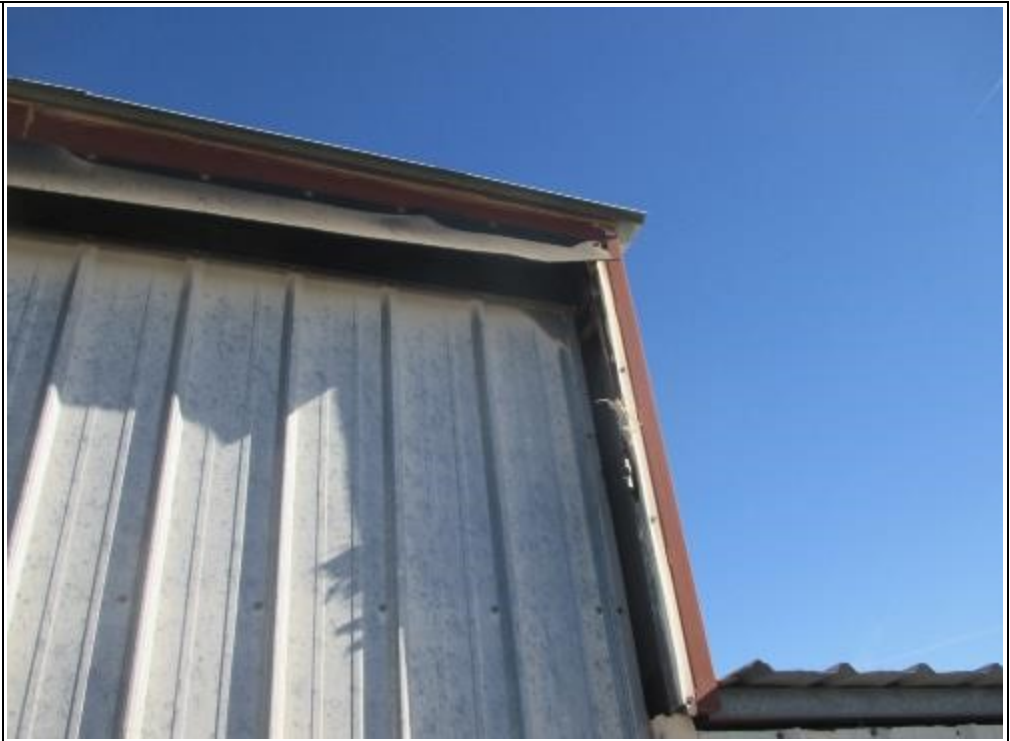
**Photograph: 17**

The upper right corner of the Hangar P3 overhead door was displaced towards the hangar interior.

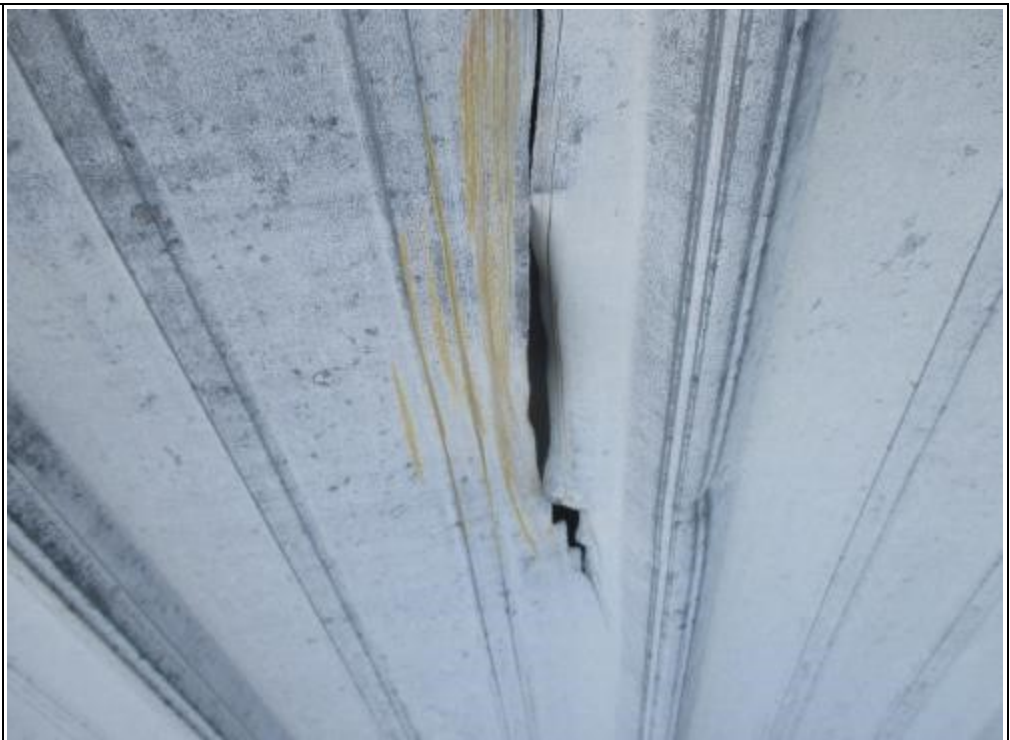
**Photograph: 18**

View a dented panel on the north side of the center bay for Hangar P3.

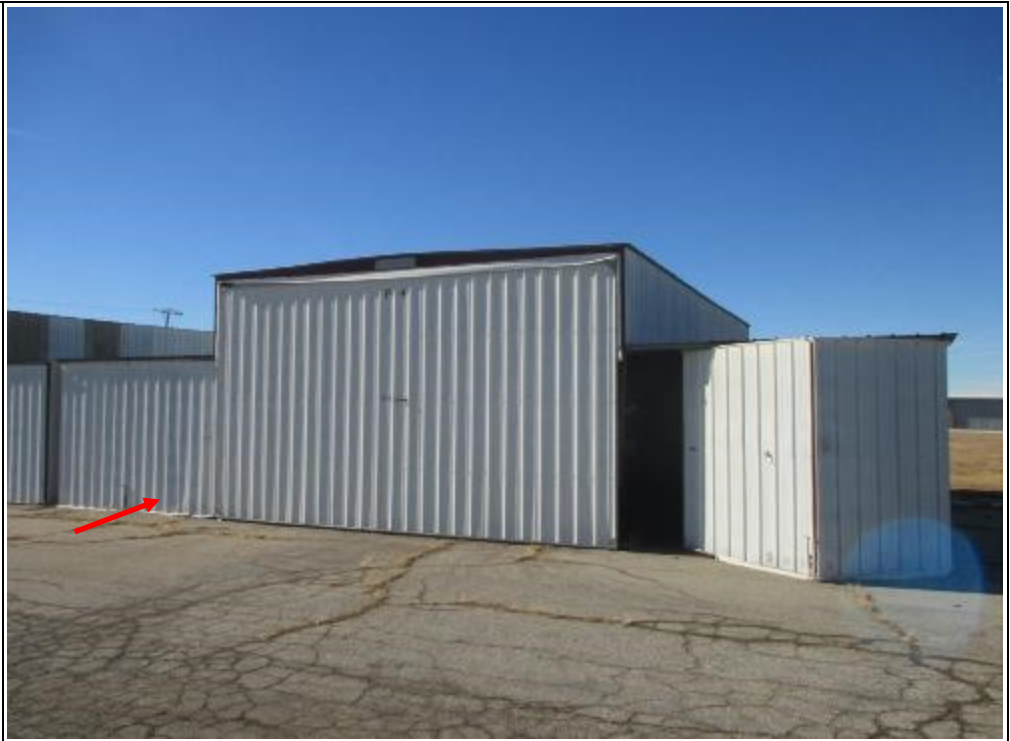
**Photograph: 19**

The hangar exterior was not missing wall or roof panels. The left bifold door had a wall panel dented inward toward the building interior. The west walls of the center bay and left bays had wall panels dented inward toward the building interior. The center bay had three dented panels, and the left bay had one bent panel. The indentions were linear and were dulled in appearance. The ends of the trim above the overhead door were bent. The center bay roof had two roof panels that were bent. One of the bent roof panels was lifted upward, and there was a visible gap at the adjacent panel joint. The other bent roof panel was bent at its flute and was visibly displaced downward (see Photos 19 thru 21).

View of the front (east) elevation of Hangar P4.

The metal panel on the left bifold door was bent (red arrow).

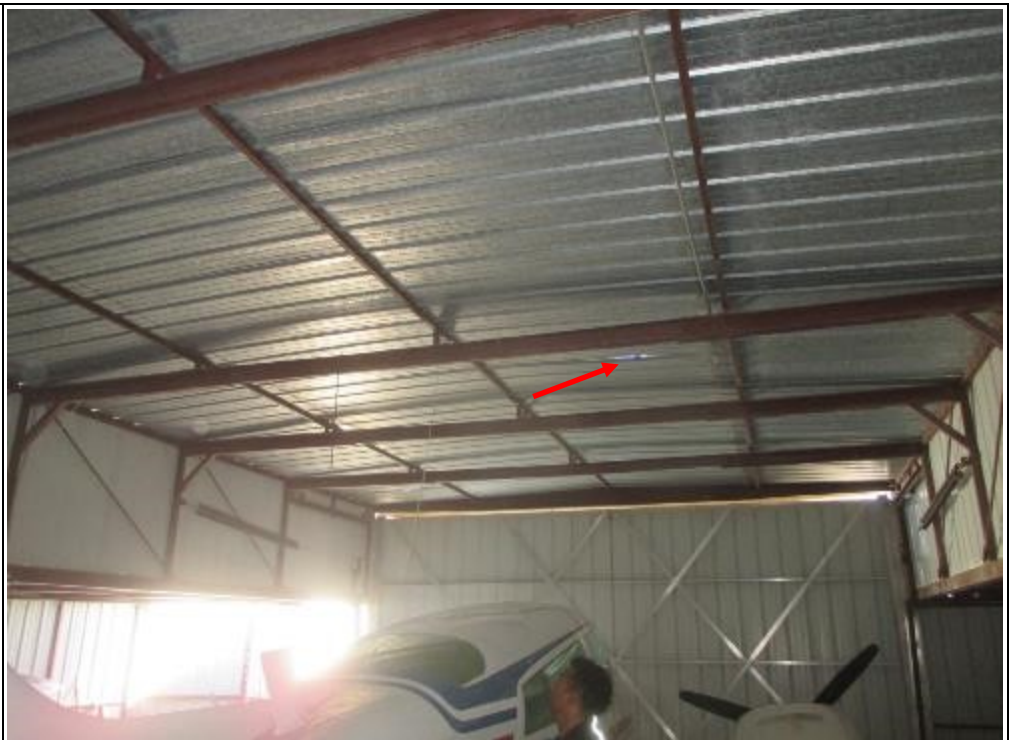
**Photograph: 20**

View of the interior of Hangar P4.

The metal roof panels were bent at two places.

Note the gap in the metal roof panels at one location (red arrow).

9. Replace the upper rollers, tracks, and spring assemblies for the overhead door.
10. Remove and reinstall the overhead and both bifold doors.
11. Replace the exterior wall panel for the left bifold door.
12. Replace two center bay roof panels.

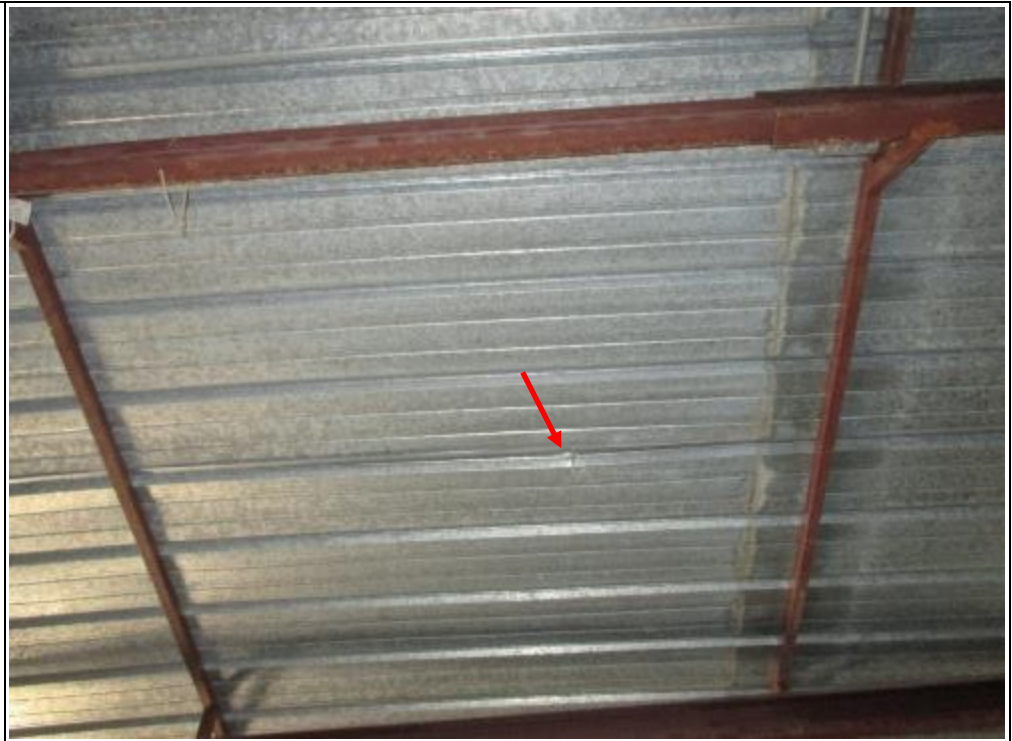
**Photograph: 21**

View of an additional metal roof panel that was bent downward (red arrow).

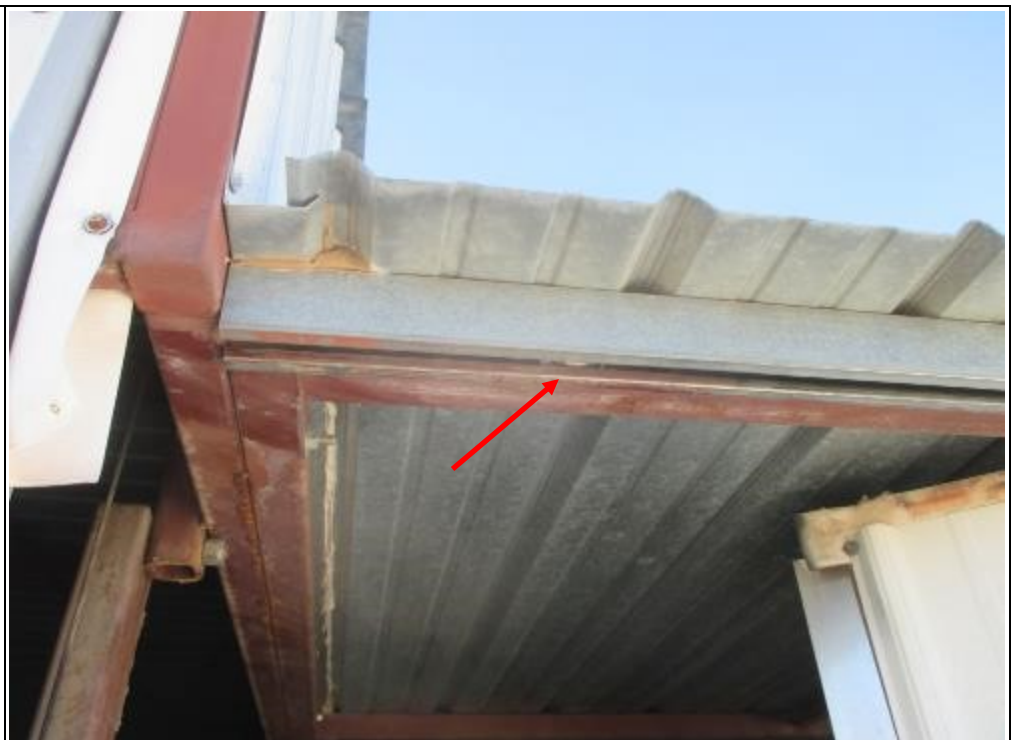
**Photograph: 22**

The overhead door did not operate. The left bifold door did not operate, and the right bifold door required substantial force by hand to operate. The top left side of the right bifold door was missing its track bolt. The gap above the right bifold door was not uniform and was less than one inch. The top of the left bifold door sloped to the center bay at 0.3 of a degree. The gap above the left bifold door appeared to be uniform at approximately one-inch wide. The north wall of the right bay was out of plumb by 1.2 degrees. The north-south roof member for the right bay sloped at 0.7 of a degree toward the exterior wall. The east-west roof purlins for the left and for the right bays were 0.3 of a degree or less from a degree from level (see Photos 22 thru 24).

View of the track above the left side of the bifold door for Hangar P4.

1. Brace, shore and support the upper roofs supported by the upper left and right center bay sidewall frames.
2. Remove the side bay roof assembly (purple shaded area in Figure 1).
3. Remove, replace, and weld the 1.75-inch square tube member of the roof assembly that supports the tracks for the bifold doors (blue arrow in Figure 1).
4. Remove and reinstall the center bay upper sidewall wall panels.
5. Jack and level the upper center bay sidewall frames that support the lower and upper roofs (green arrow in Figure 1).
6. Remove, replace, and weld the 2-inch square tubes roof strut that supports the lower side bay roofs (red arrow in Figure 1).
7. Remove and replace the diagonal rod brace (orange arrow in Figure 1).
8. Replace the upper tracks and hardware for both bifold doors.

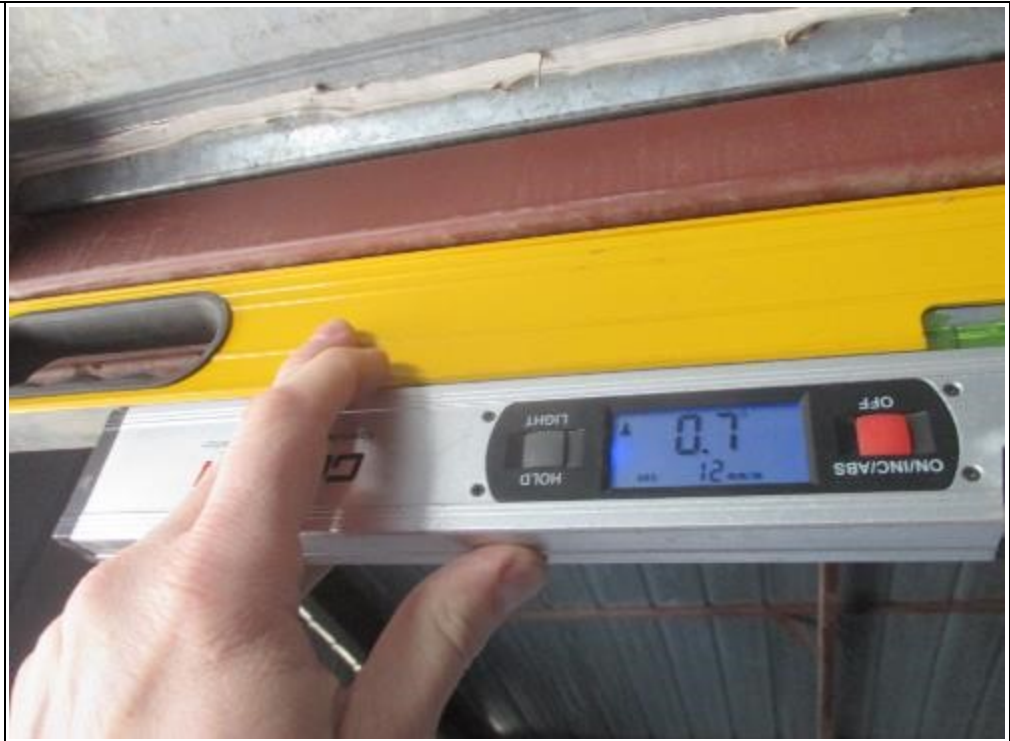
**Photograph: 23**

View of level reading taken for a frame member for Hangar P4.

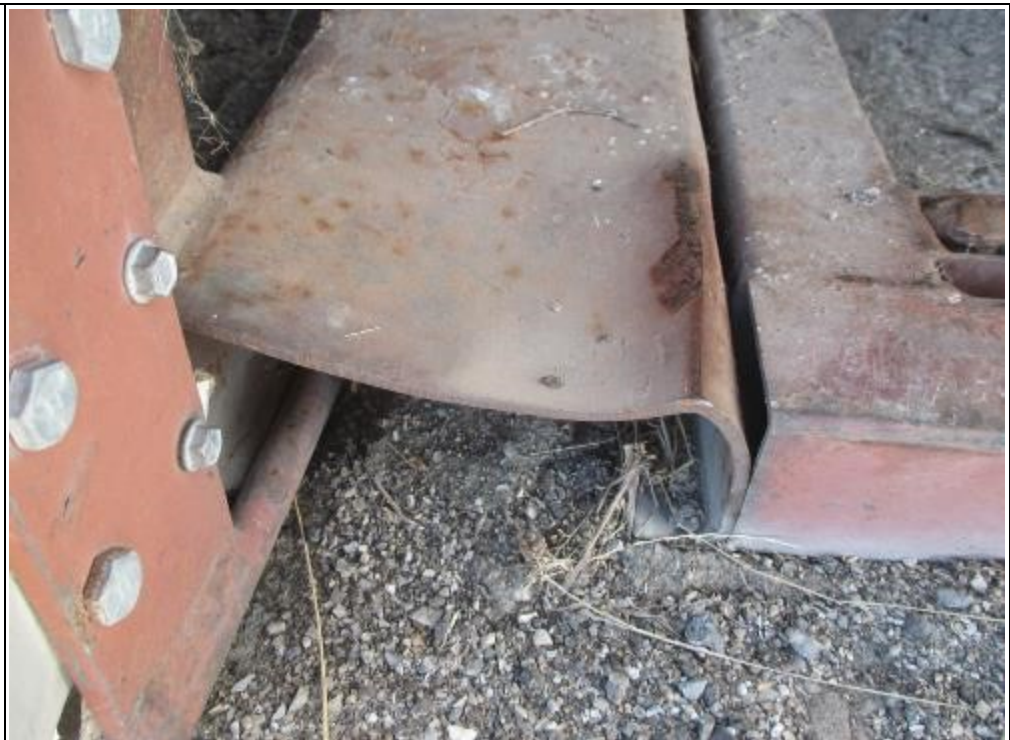
**Photograph: 24**

View of the end of the bottom frame for the right side of the center bay.

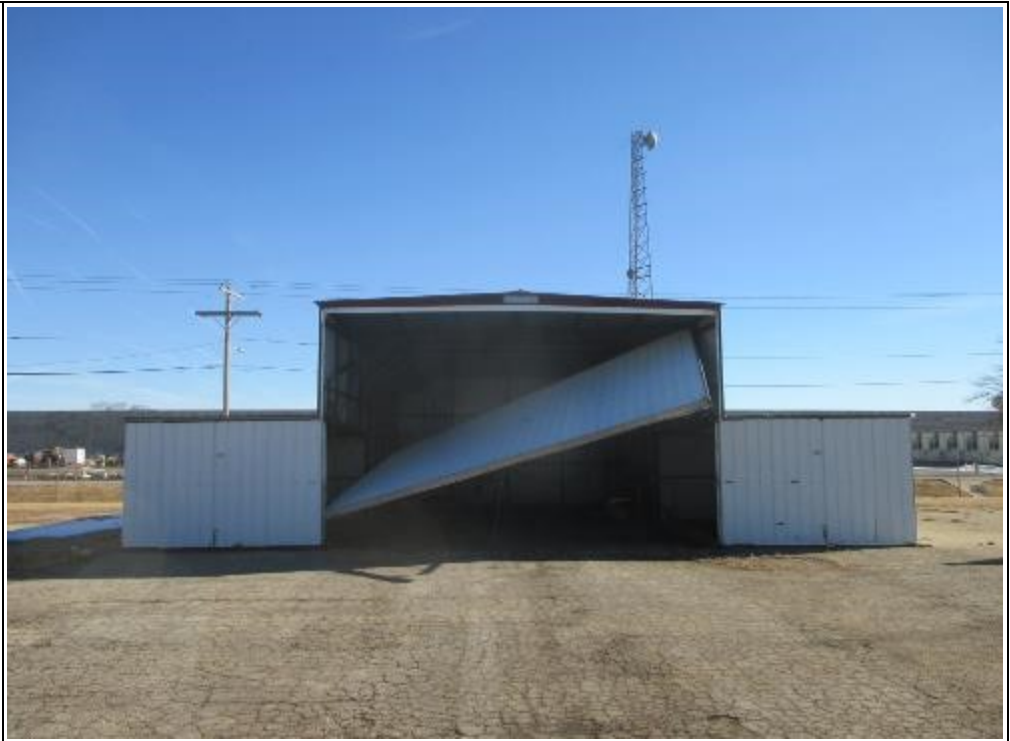
**Photograph: 25**

The overhead door was detached and displaced inward towards the hangar interior and was resting in a diagonal position. The right side of the door was supported by the center bay upper wall. The roof of the right bay sloped towards the center bay. The lower left corner of the overhead door was resting against the left bifold door and had pushed the right side of the left door outward. The upper right door track and roller were bent. The bolts that attached the overhead door hardware were bent. The left side of the overhead door was bent, and the strapping on the back of the door was bent and warped (see Photos 25 thru 31).

View of the front elevation for Hangar P13.

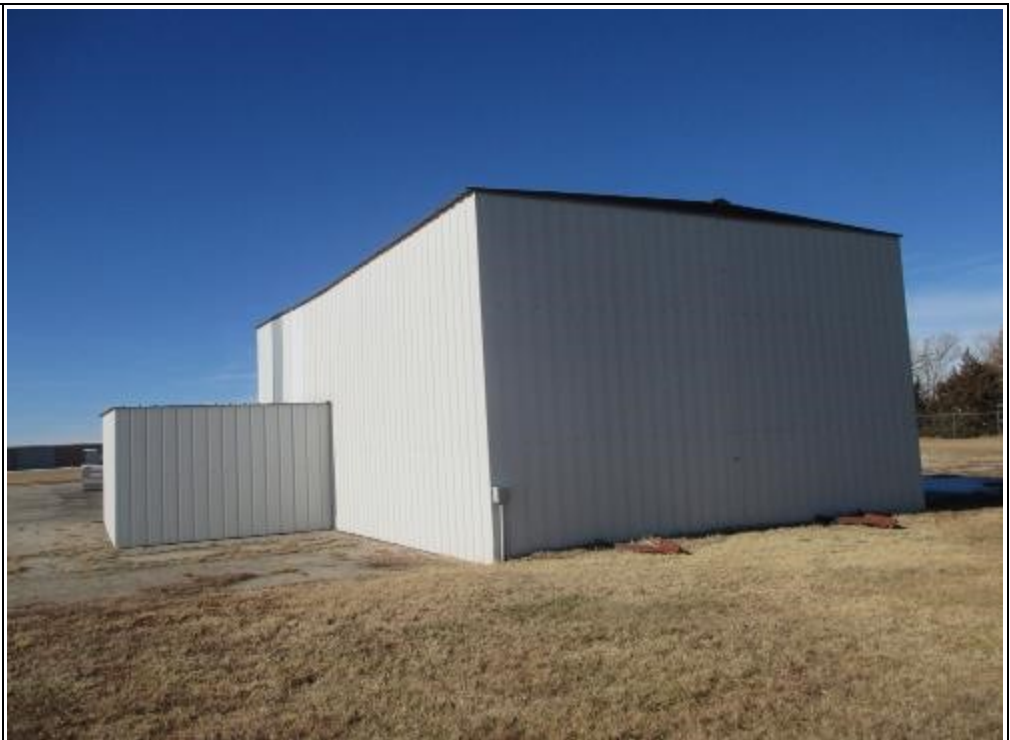
**Photograph: 26**

View of the rear elevation for Hangar P13.

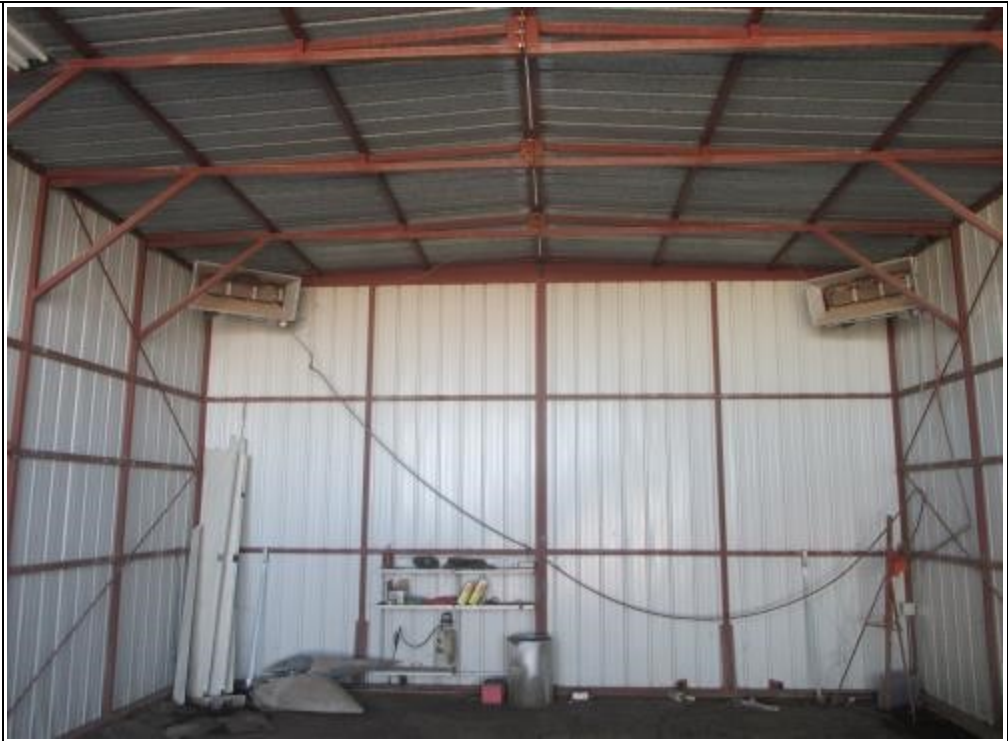
**Photograph: 27**

Interior view of Hangar P13.

Note that the roof frame members for Hangar P13 utilized a multiple steel tube members.
