**Salina Airport Authority**  
3237 Arnold Avenue  
Salina, KS 67401

## Report 1 - Structural Condition Assessment

### Hangers P1-P4, P13

**JANUARY 27, 2022**

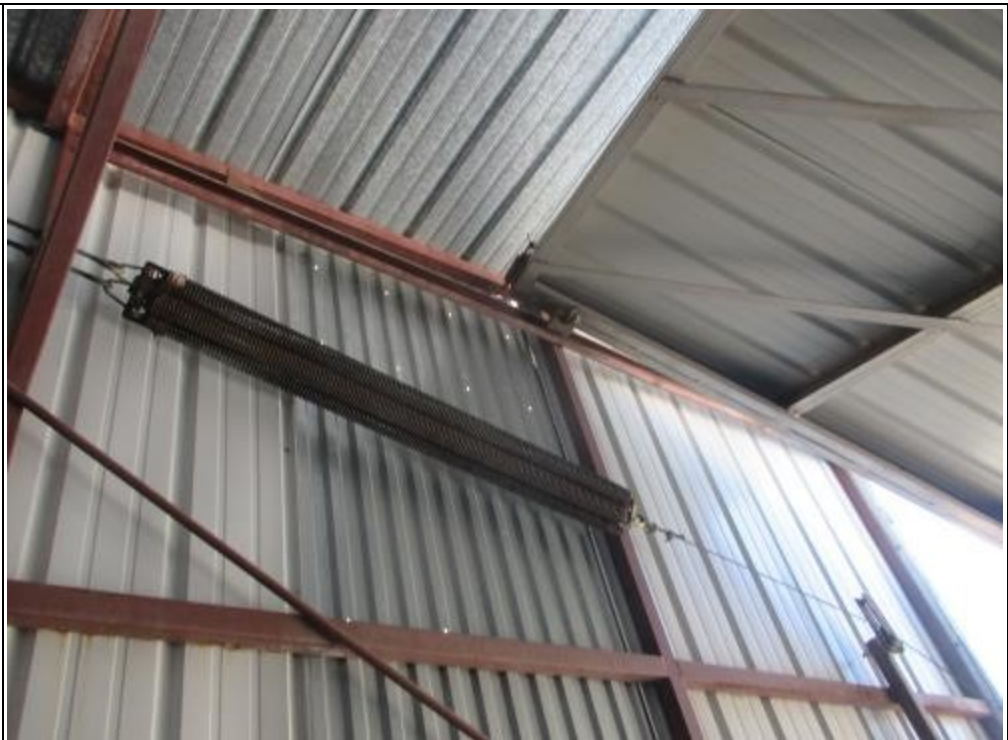
**Photograph: 28**

View of the door track and hardware for the right side of the overhead door for Hangar P13.

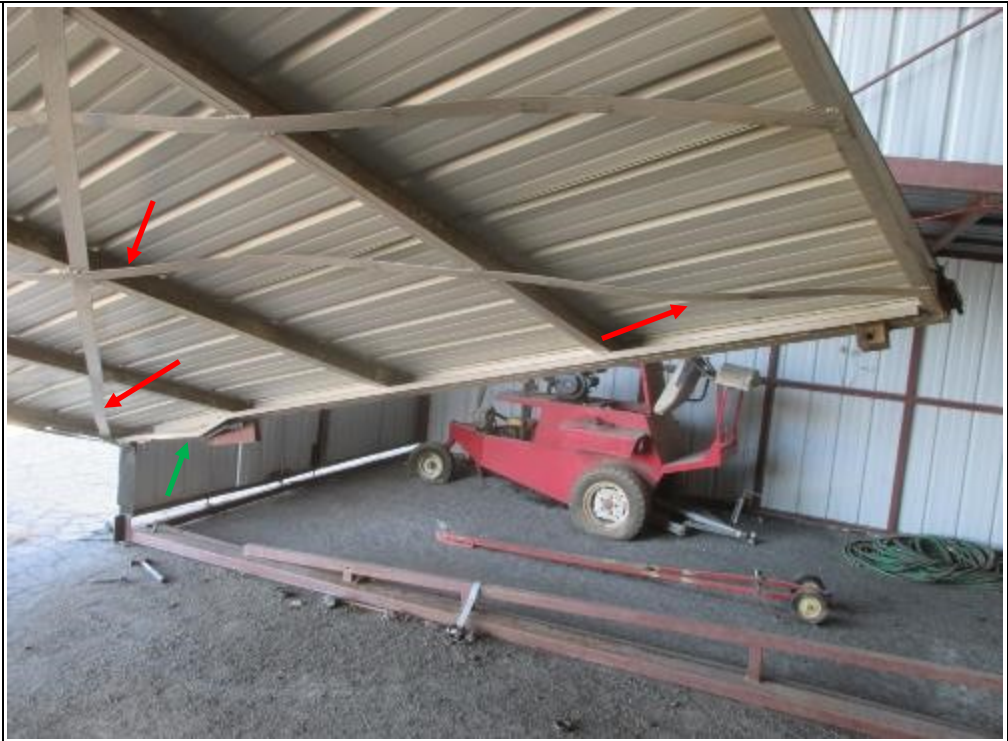
**Photograph: 29**

View of the left side of the overhead door for Hangar P13.

The door strapping was warped (red arrows), and the bottom left corner of the door was bent (green arrow).

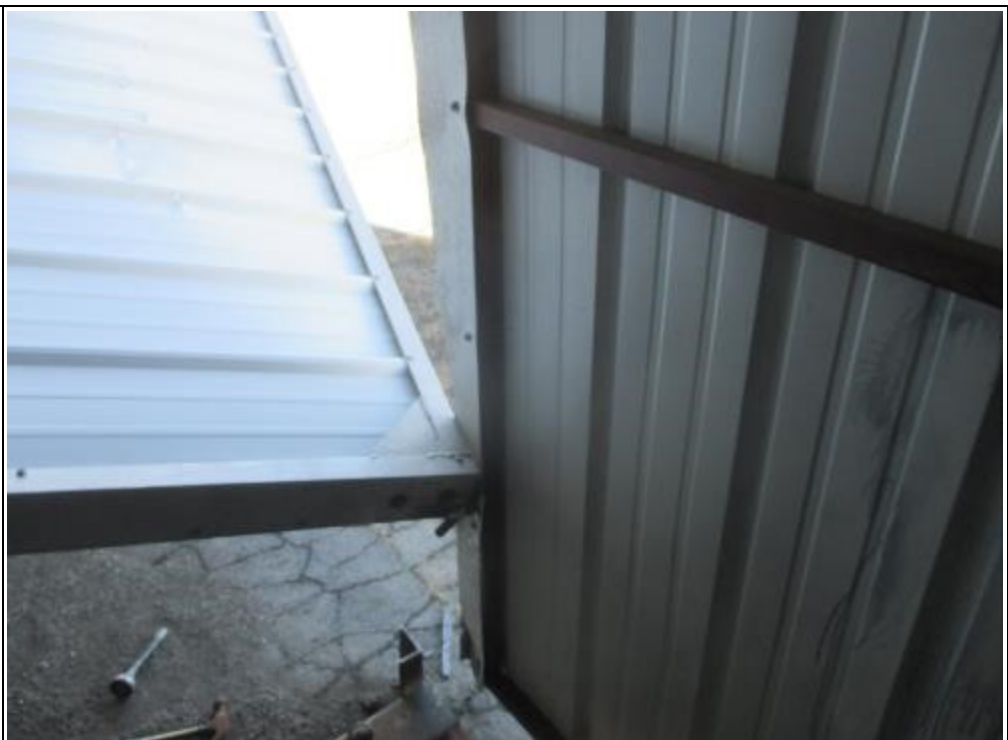
**Photograph: 30**

View of the left side of the overhead door resting on the right edge of the left bifold door for Hangar P13.

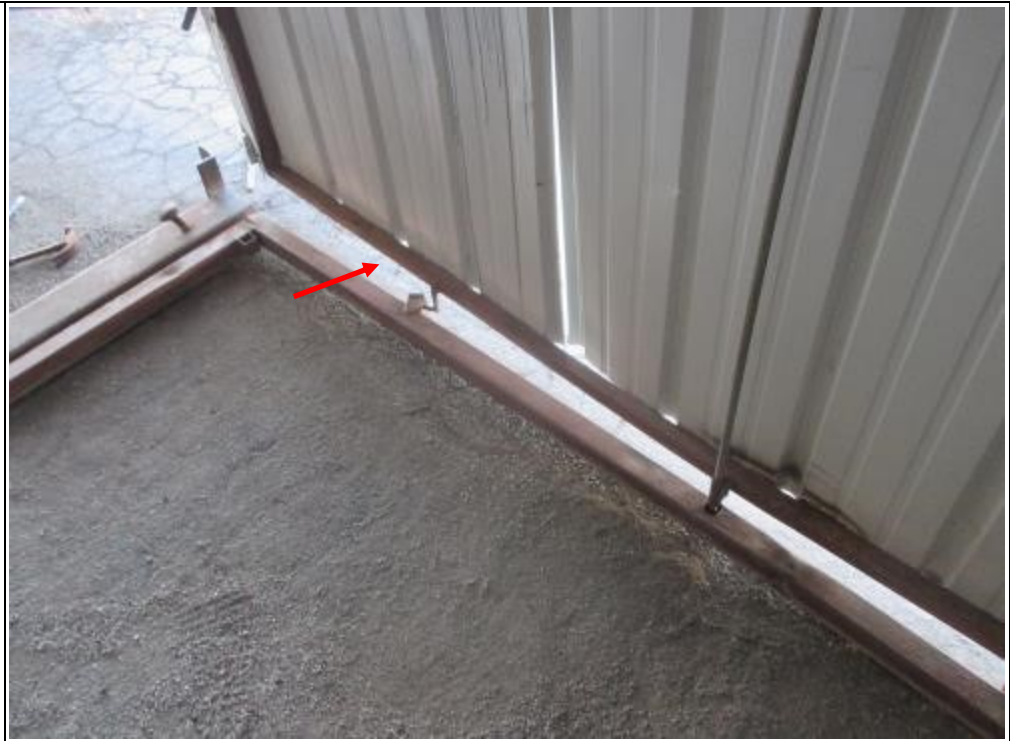
**Photograph: 31**

View of the bottom member for the left bi-fold door for Hangar P13

The bottom member of the bifold door was bent (red arrow).

1. Complete bullets 1 thru 7 and Figure 1 for Hangar 4 above.
2. Remove and reinstall the right bifold door.
3. Remove the left bifold door and replace the following:
  - a. Approximately (6.5) feet of horizontal 1" square tube.
  - b. Approximately (7) feet of vertical 2" square tube.
  - c. Approximately (7) feet of the aluminum cover plate.
4. Remove the overhead door and replace the following doors components:
  - a. Approximately (14 .25) feet of aluminum 3"x1" angle.
  - b. Approximately (14.25) feet of aluminum 4" deep channel with 0.5" flanges.
  - c. Approximately (125) feet of aluminum strapping on the back of the door.
5. Remove the right center bay bottom frame assembly and replace the following:
  - a. Approximately (37) feet of 5" deep channel with 2" flanges the length of the center bay (red arrow in Figure 2).

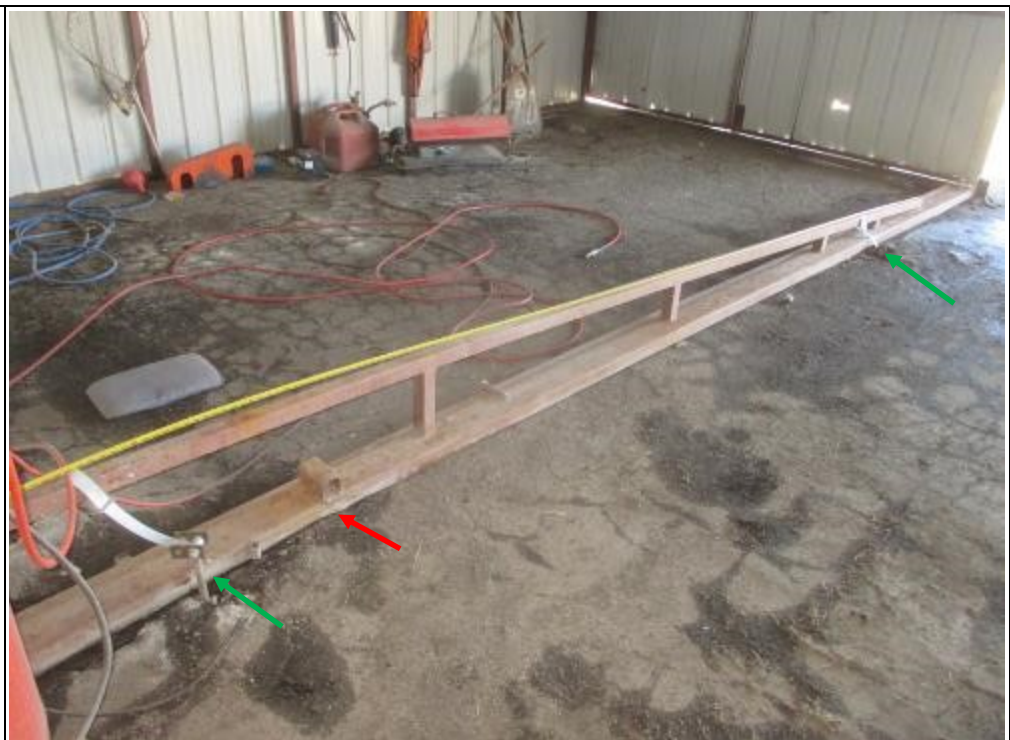
**Photograph: 32**

The channel for the bottom frame assembly on the right side of the center bay was bent upward, and one of the flanges was buckled. The tie-down straps for the bottom frame assembly were loose, and the anchor rods were withdrawn from the pavement. Multiple anchor straps for hangar tie-downs were loose around the hangar perimeter, and the anchor rods for the tie-downs had been partially withdrawn from the pavement. The diagonal rod bracings for the center bay side walls were not apparently bent (see Photos 32 thru 34).

View of the bottom frame assembly on the right side of the center bay for Hangar P13.

The bottom channel from bent (red arrow), and the anchor rods for the tiedown straps were partially withdrawn from the pavement (green arrows)

- b. Approximately (17.5) feet of sloped 2" square tube on the 5" deep channel (green arrow in Figure 2).
  - c. Approximately (2) feet of vertical 2" square tube for the vertical frame members (blue arrows in Figure 2).
6. Remove and replace approximately (22) tie-down straps including their anchor bolts.

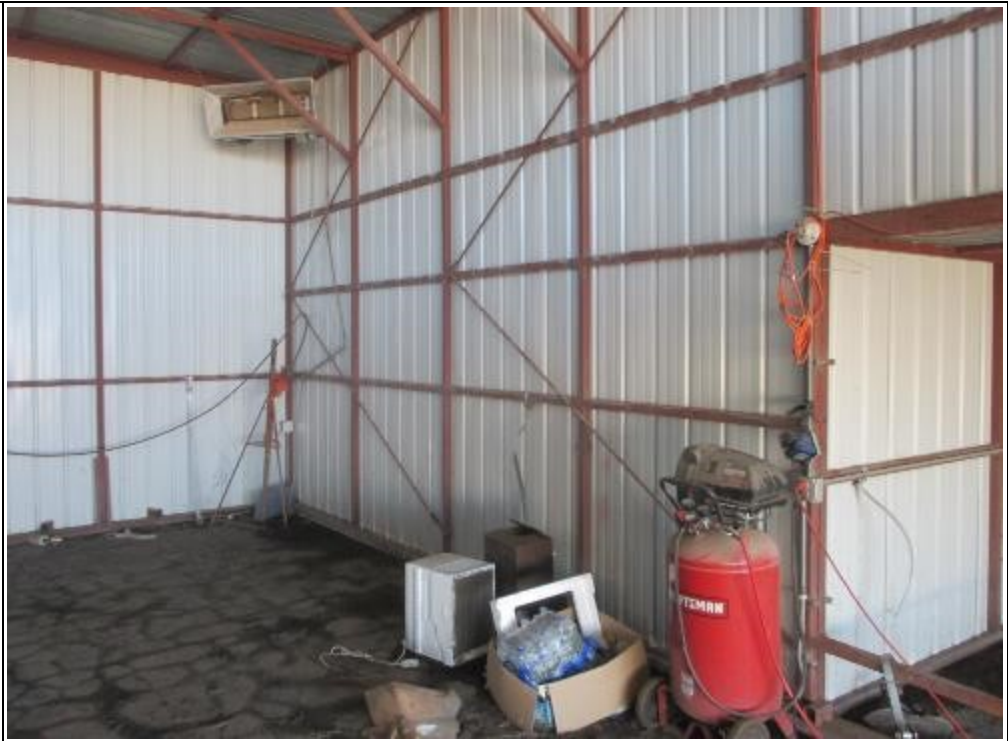
**Photograph: 33**

Interior view of the right wall for the center bay for Hangar P13.

The diagonal bracing was not apparently bent.

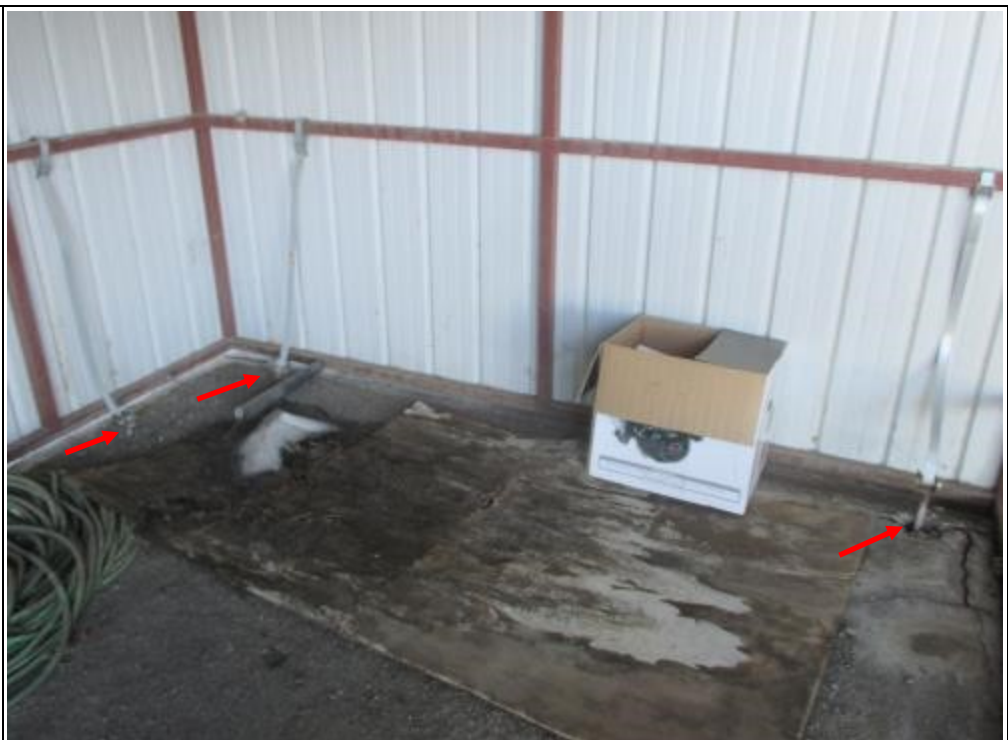
**Photograph: 34**

View of the tie-down anchor straps rear of the center bay for Hangar P13.

Multiple anchor rods for the tie-down straps had been withdrawn from the pavement around the perimeter of the hangar (red arrows).
