**Salina Airport Authority**  
3237 Arnold Avenue  
Salina, KS 67401

## Report 2 – Cause and Origin Report

### Buildings 120, 412, and 959

**FEBRUARY 9, 2022**

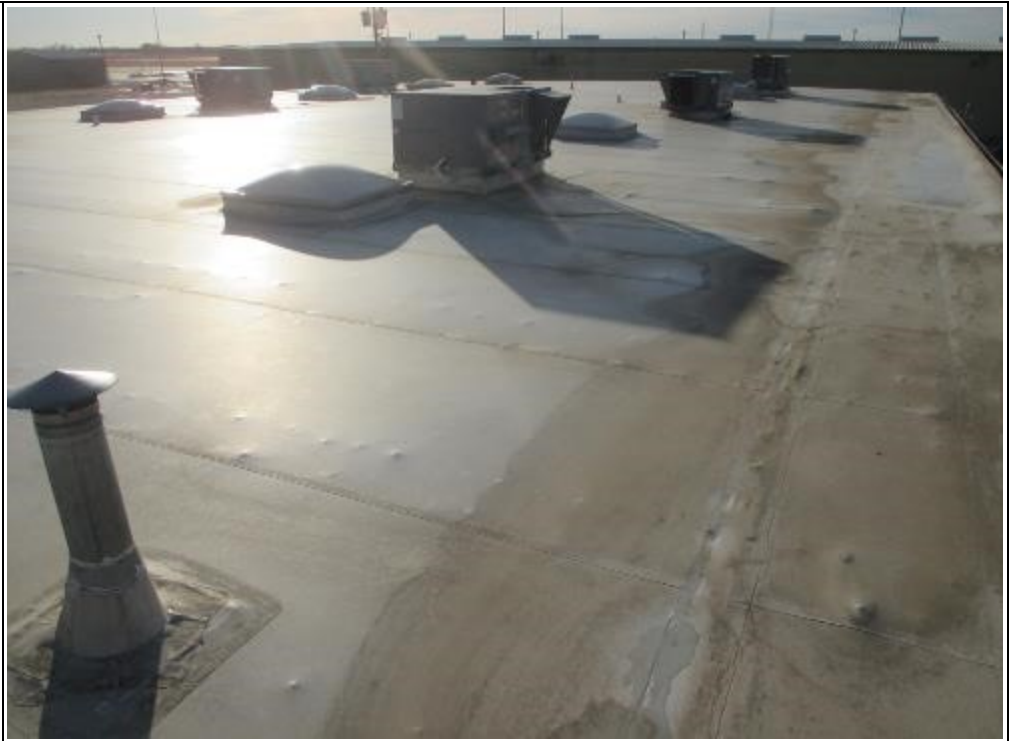
**PHOTOGRAPHIC DOCUMENTATION****Photograph: 11****Description:**

ran in the north-south direction. The lapped seams of the membrane segments had been heat welded. The lapped side seams were approximately 1.5 inches wide (see Photos 11 thru 13).

Building 412: View of the upper roof looking west.

The roof had discolored and stained areas along the north and south ends.

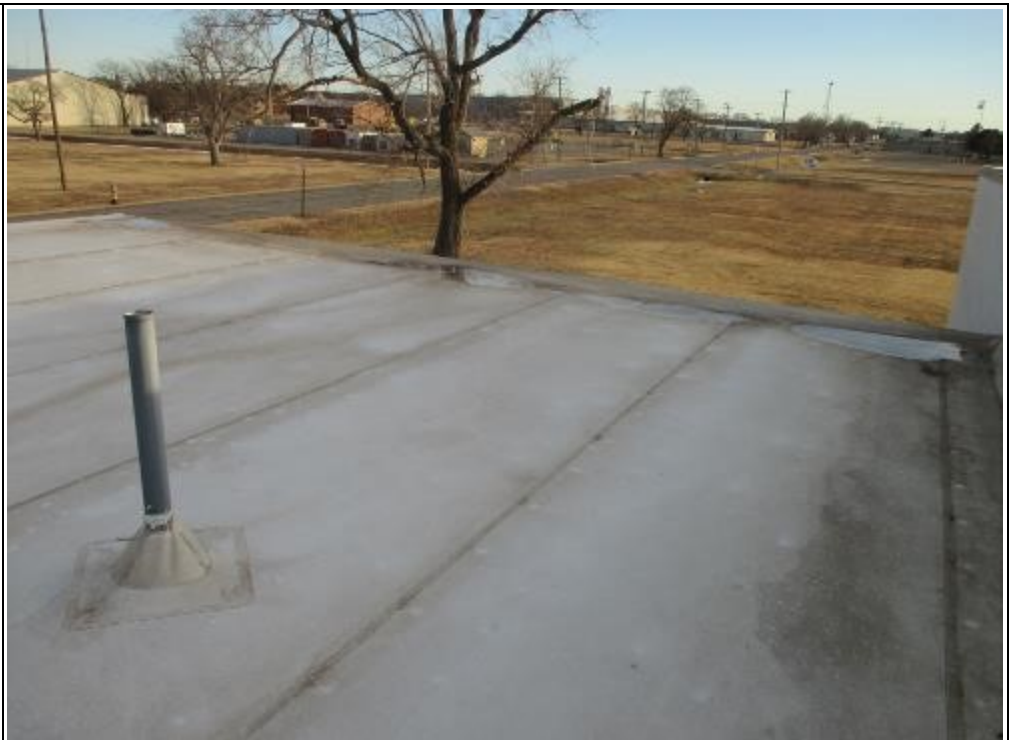
**Photograph: 12****Description:**

Building 412: View of the upper roof looking south.

The roof had discolored and stained areas along the north and south ends.

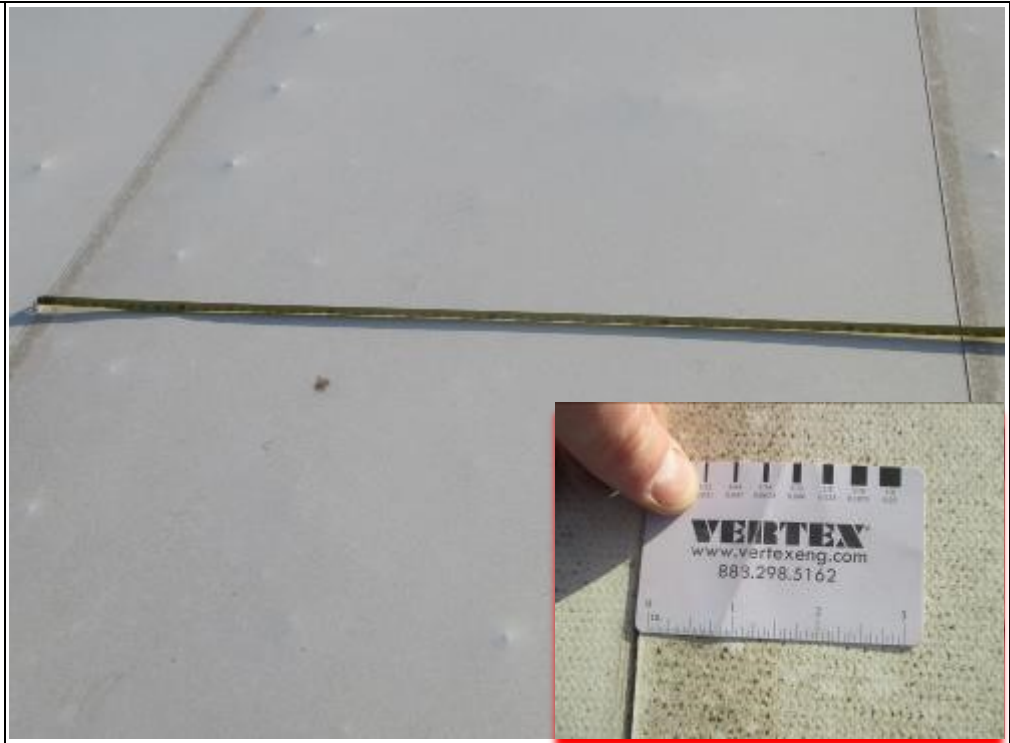
**Photograph: 13****Description:**

Building 412: View of the roof membrane width.

The roof membrane edges were side lapped approximately 1.5 inches (inset photo).

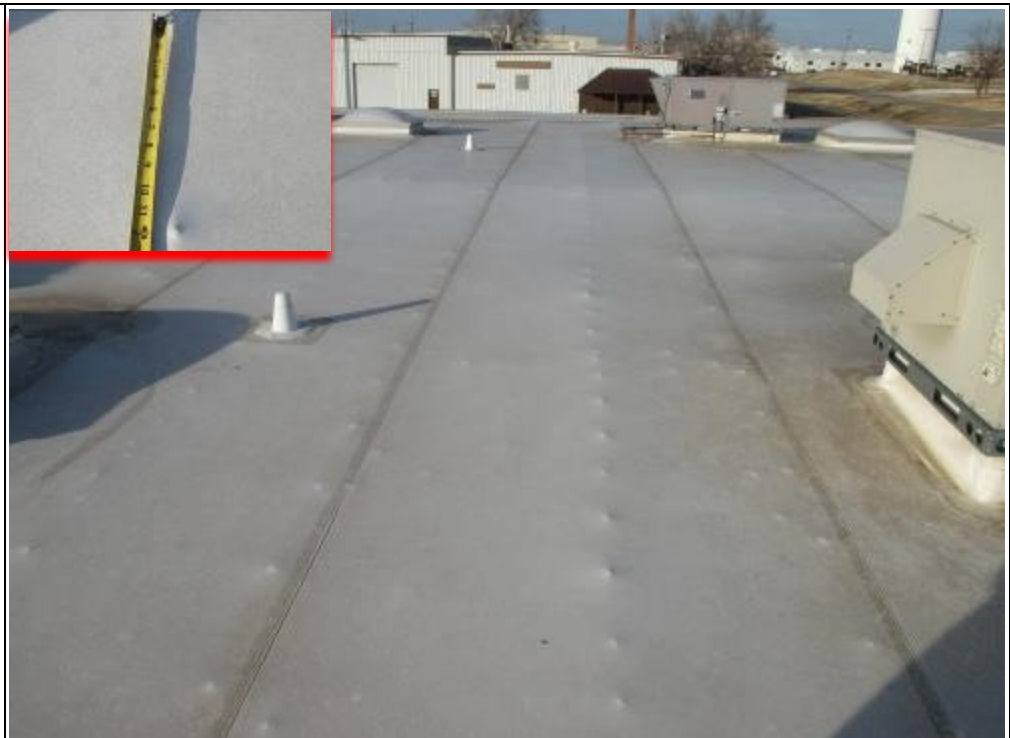
**Photograph: 14****Description:**

The roof membrane had rows of apparently withdrawn fasteners at the lapped seams in the north-south direction that had pushed and stretched the roof membrane upward at each apparent fastener. Additional rows of apparently withdrawn insulation fasteners were seen between the lapped joints, and the spacing of the rows for the apparently withdrawn fasteners was not consistent. The spacing of the apparent fasteners was approximately 12 inches on center in the north-south direction. The roof membrane at the apparently withdrawn fasteners had a bright appearance, and the surrounding area was not discolored or faded. The apparently withdrawn fasteners within the discolored and stained of the areas with sediment stains at the north and south ends of the roof were also bright and not faded. A semi-oval area approximately ten inches wide was bubbled at the east end of the upper roof ridge. The bubbled area was bright in appearance. The east end of the upper roof rake had several additional withdrawn fasteners at the metal termination bar. The threads of the fasteners at the termination bar were discolored from corrosion due to apparent surface rust (see Photos 14 thru 18).

Building 412: View of rows of apparently with-drawn fasteners where the roof membrane was pushed and stretched upward.

The apparent fastener spacing was approximately 12 inches (inset photo).

- Building 412: Remove and replace the lower and upper thermoplastic membrane roofs as required. Replace any damaged or displaced roof insulation.
- Building 959: Remove and replace the upper hangar thermoplastic membrane roof as required. Replace any damaged or displaced roof insulation.
- Runway 17-35: Plumb and adjust the supports for the light boxes of the runway PAPI system. Calibrate the PAPI system by a qualified technician.

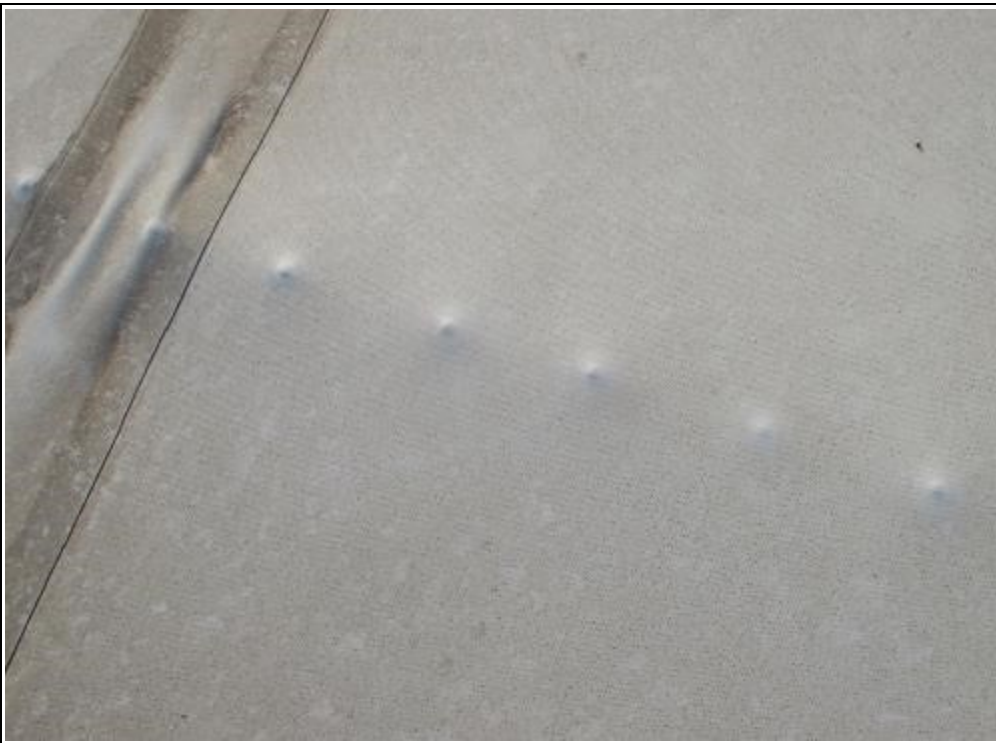
### Photograph: 15

Building 412: Closeup of a row of apparently withdrawn fasteners.

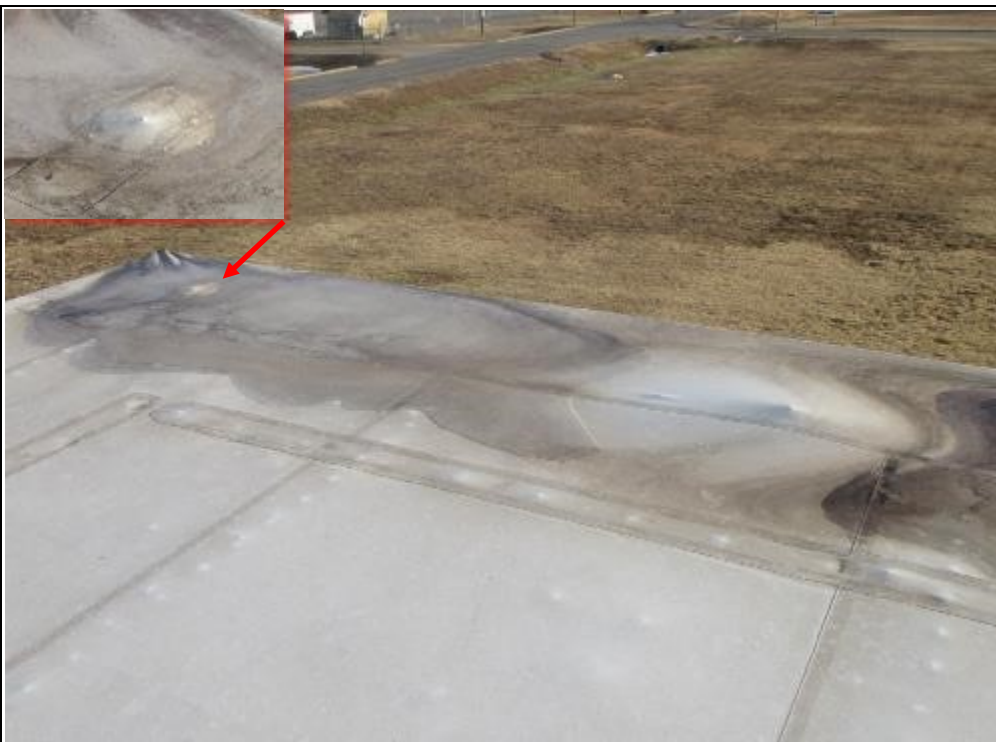
### Photograph: 16

Building 412: View of apparently withdrawn fasteners along the south roof eave. An inset image in the top left corner provides a magnified view of the fasteners, with a red arrow pointing from the main image to the inset.

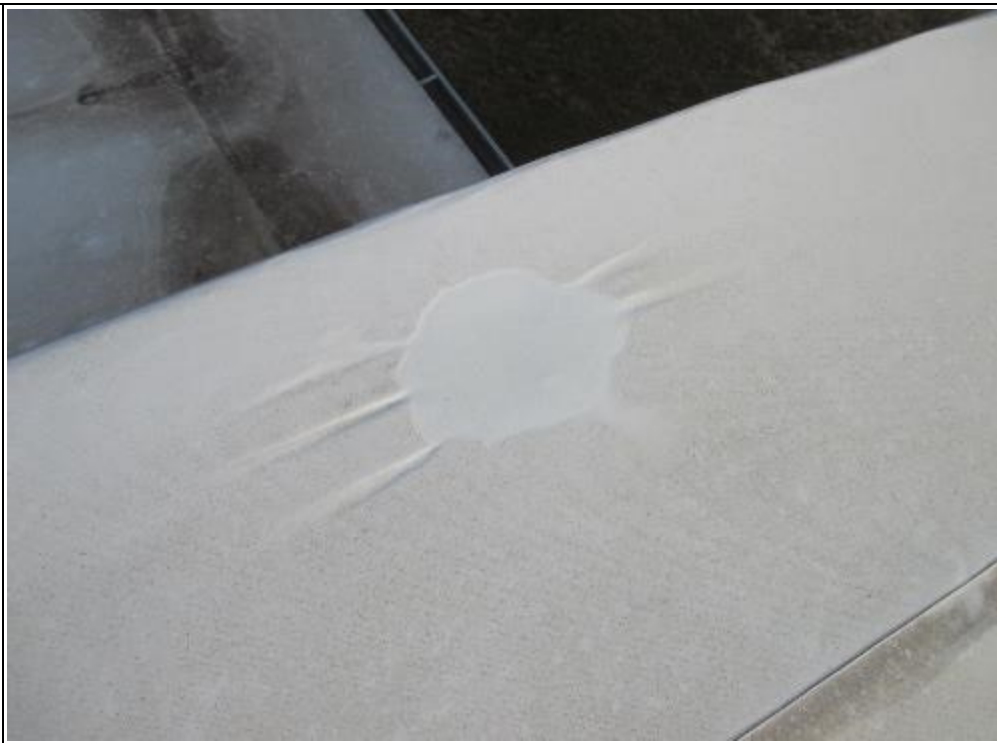
**PHOTOGRAPHIC DOCUMENTATION****Photograph: 17****Description:**

Building 412: View of an apparently stretched area of roof membrane at the roof ridge at the east side of the roof.

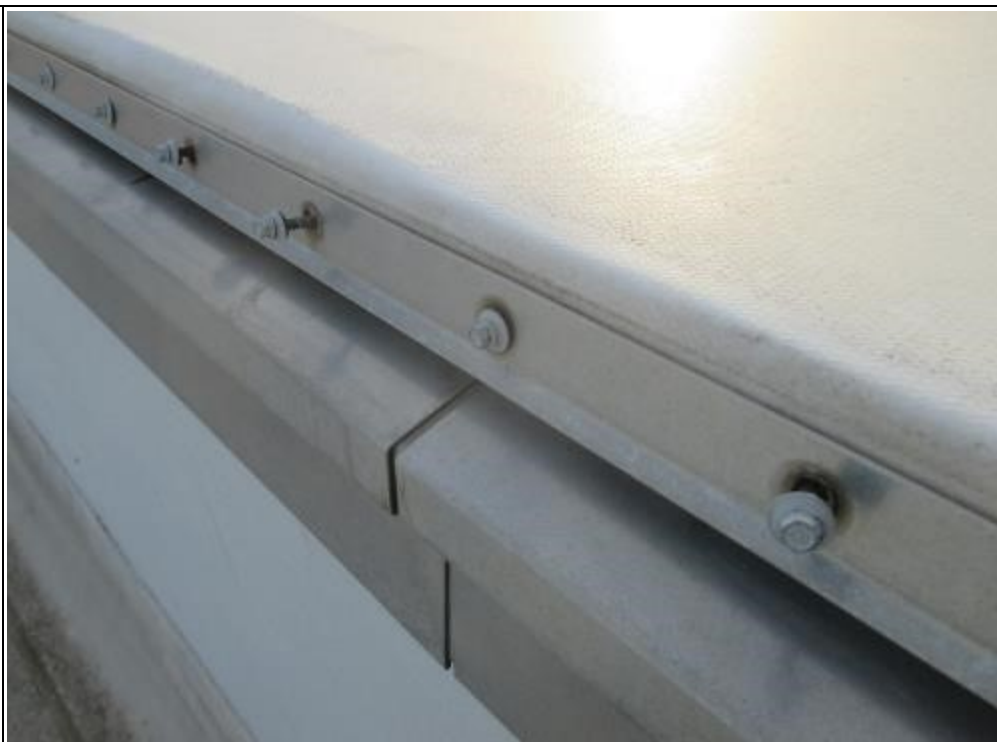
**Photograph: 18****Description:**

Building 412: View of partially withdrawn fasteners on the east roof rake of the upper roof.

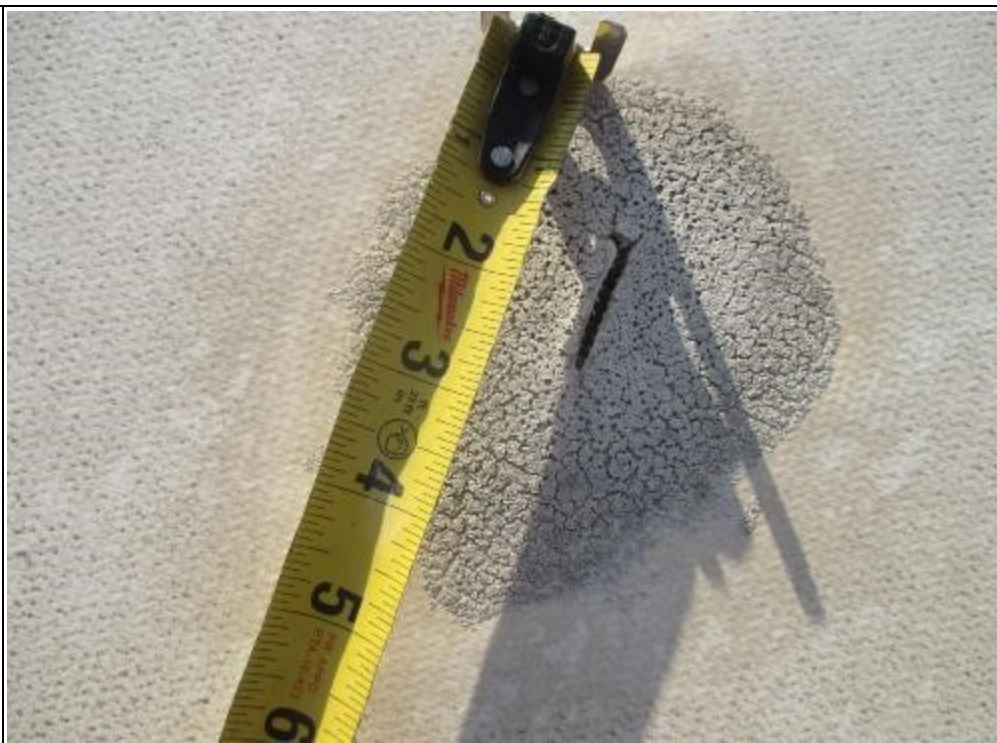
**Photograph: 19****Description:**

The roof had linear tears to the roof membrane at several locations. The roof tears appeared to align with the apparently withdrawn fastener locations and were approximately 1 to 2 inches in length. The torn edges were rounded and worn. The exposed membrane reinforcement at the tears was faded. The areas surrounding the tears appeared to have a surface applied liquid repair material, and the repair material was alligator cracked and faded (see Photos 19 and 20).

Building 412: View of a tear in the roof membrane.

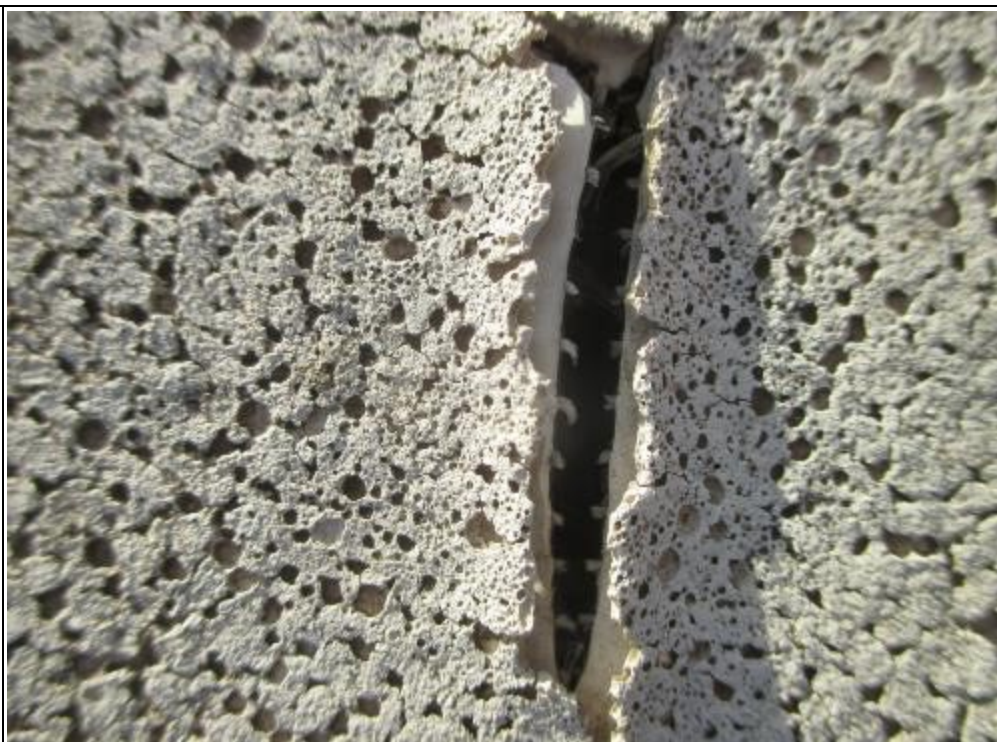
**Photograph: 20****Description:**

Building 412: Closeup of a roof tear in the roof membrane.

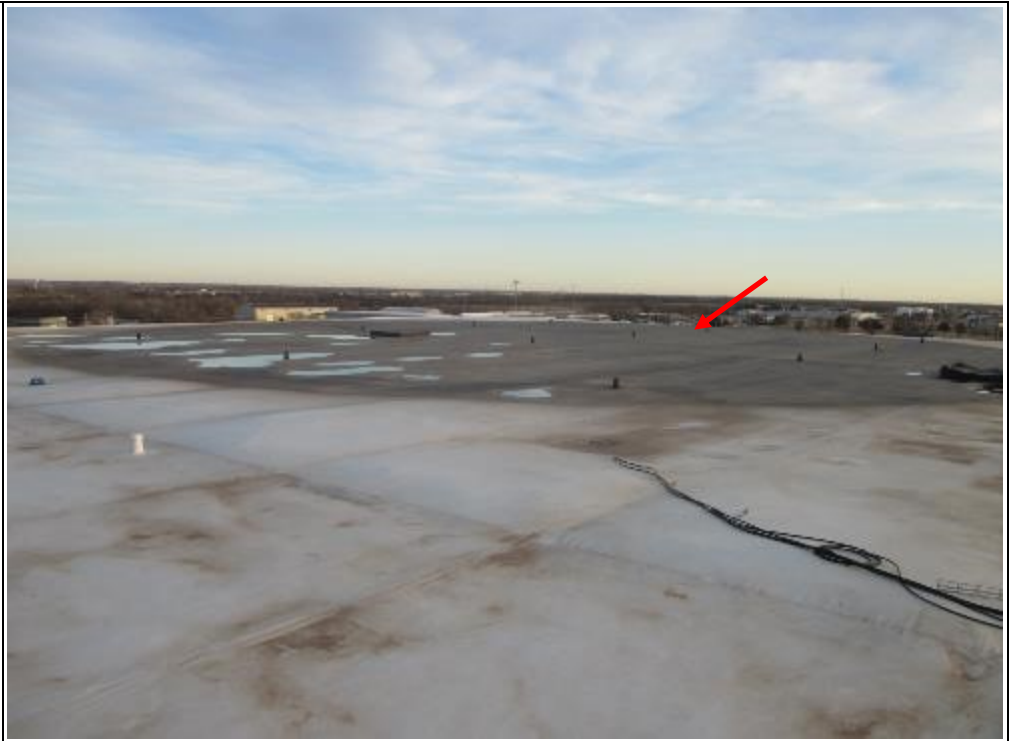
**Photograph: 23****Description:**

were approximately three inches wide (see Photos 21 thru 23).

Building 959: View of the southeast corner of the roof.

The roof had circular area from an apparently black-colored pigment applied to the roof membrane (red arrow).

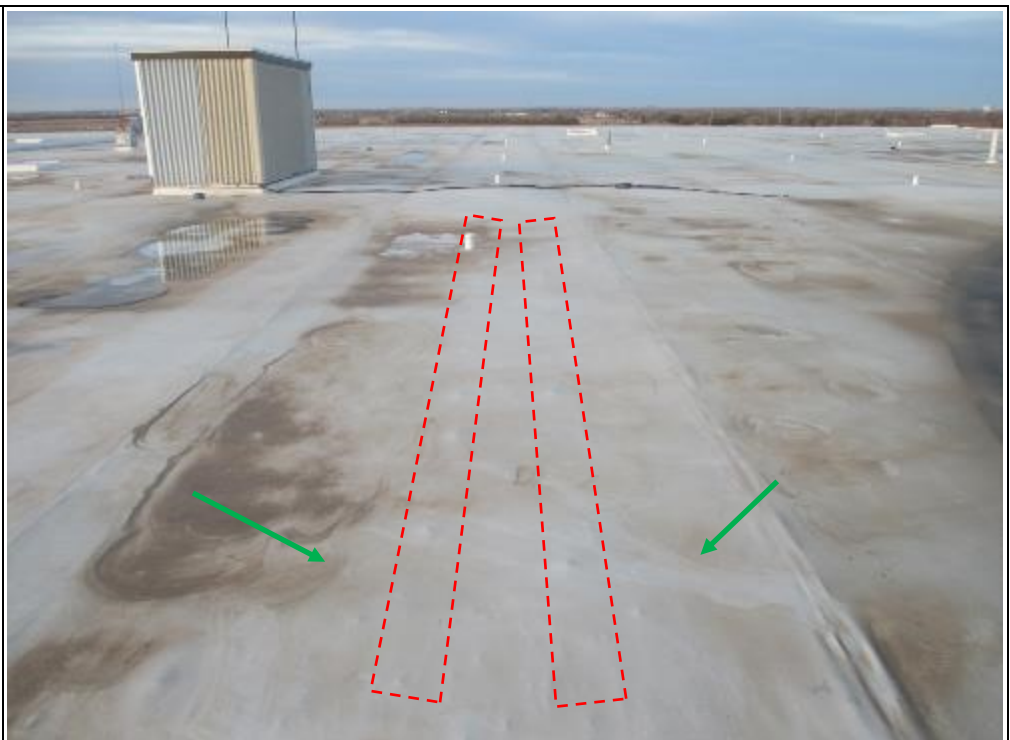
**Photograph: 24****Description:**

Building 959: View of apparent rows of mechanical fasteners in the north-south direction. (red polygons).

Note the apparent mounding of the roof materials below the roof membrane (green arrows).

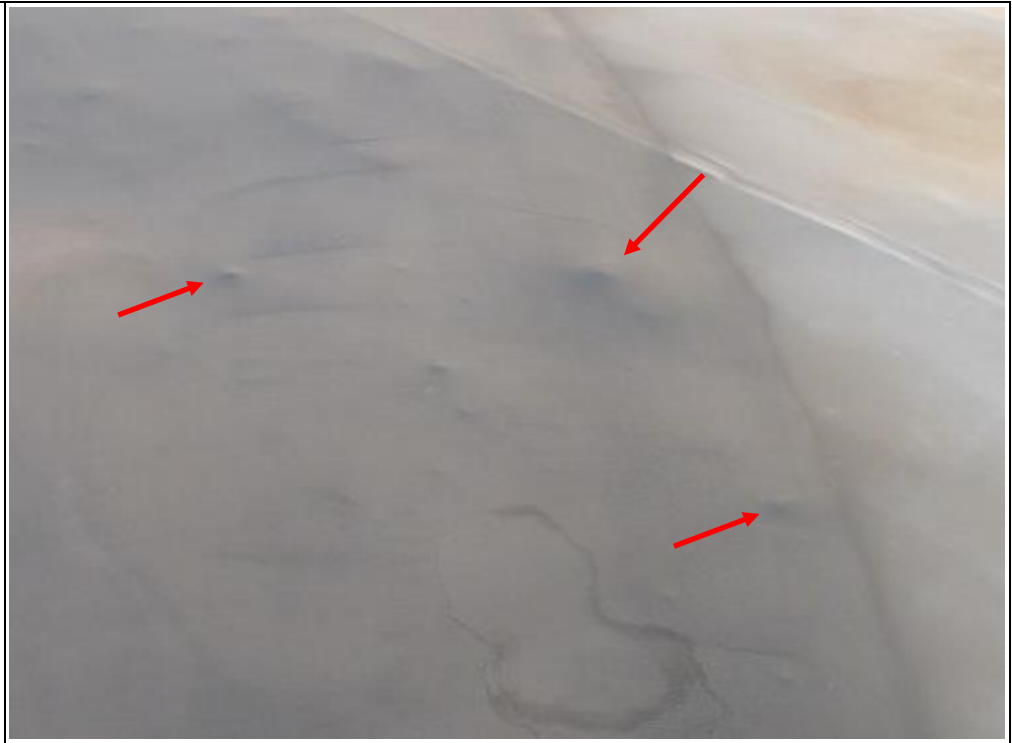
**Photograph: 25****Description:**

Building 959: View of apparently withdrawn fasteners in the black-colored area of the roof (red arrows).

Note the apparent mounding of the materials below the roof membrane.

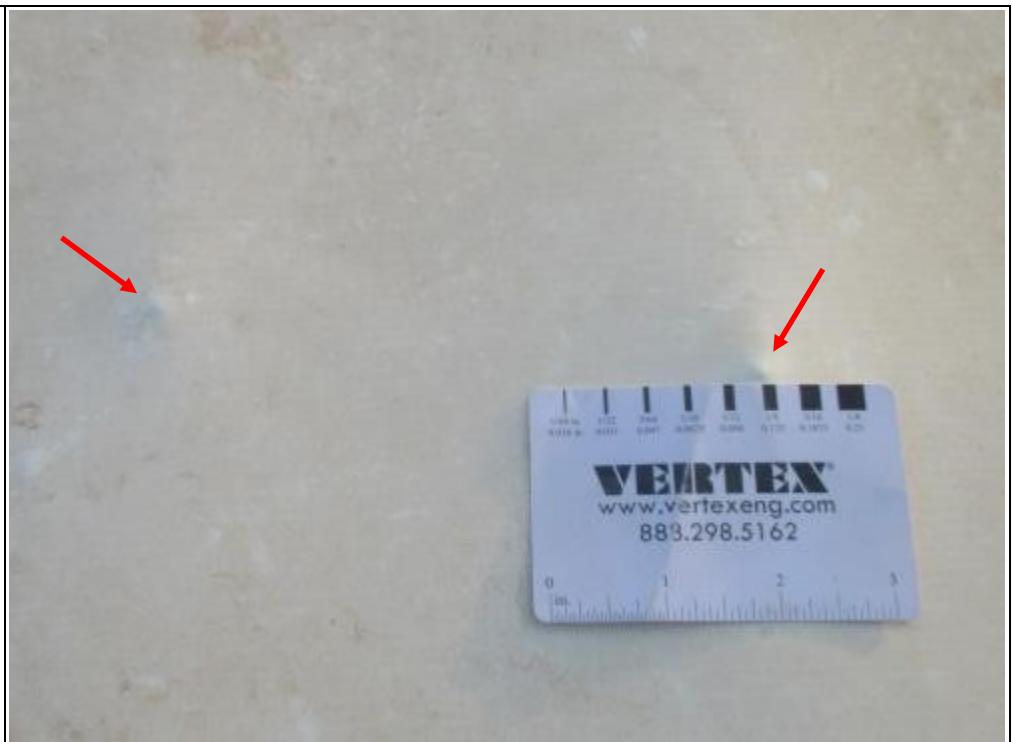
**Photograph: 26****Description:**

Building 959: Closeup view of apparently withdrawn fasteners (red arrows).

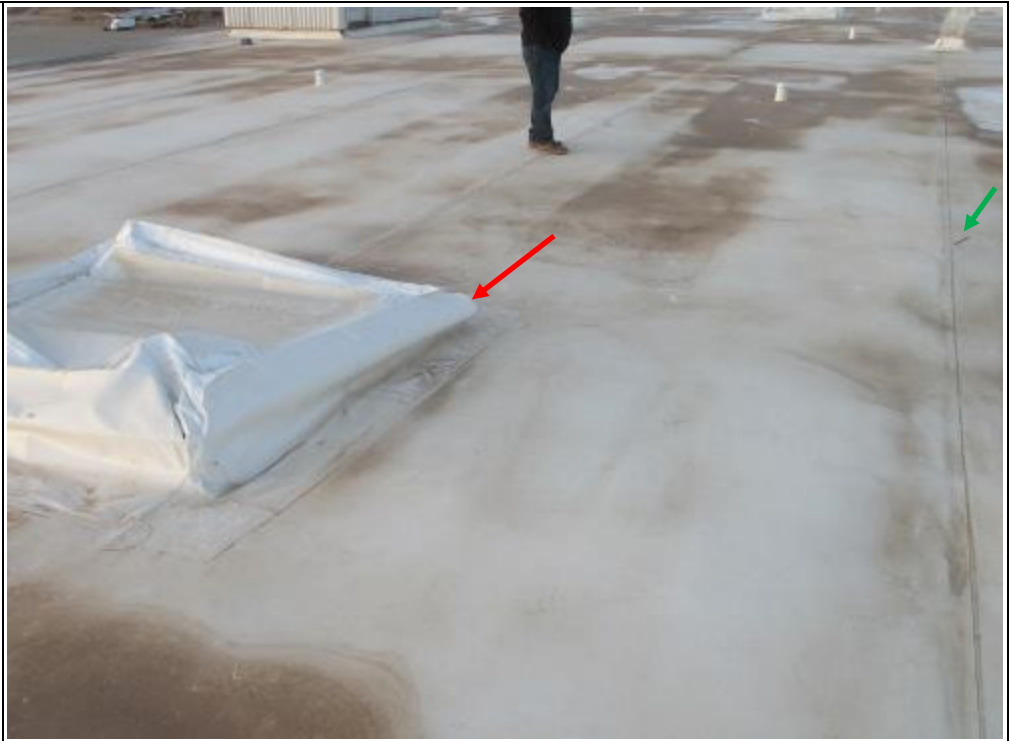
**Photograph: 27****Description:**

The southwest corner of the roof had a tear at a seam of an apparent roof curb. The material at the exposed edges at the roof seam were not discolored or faded. The roof membrane edges below the roof curb cover were mechanically anchored, and the fasteners were not withdrawn. The thermoplastic roof membrane appeared to have been installed over an older ballasted roofing system. The roof membrane at the lapped seam east of the roof curb had several punctures from fasteners. The edges at the punctures were not discolored, stained, or worn (see Photos 27 thru 30).

Building 959: View of the west side of the roof.

A corner of a apparently covered skylight had been torn (red arrow), and a fastener had penetrated the membrane (green arrow).

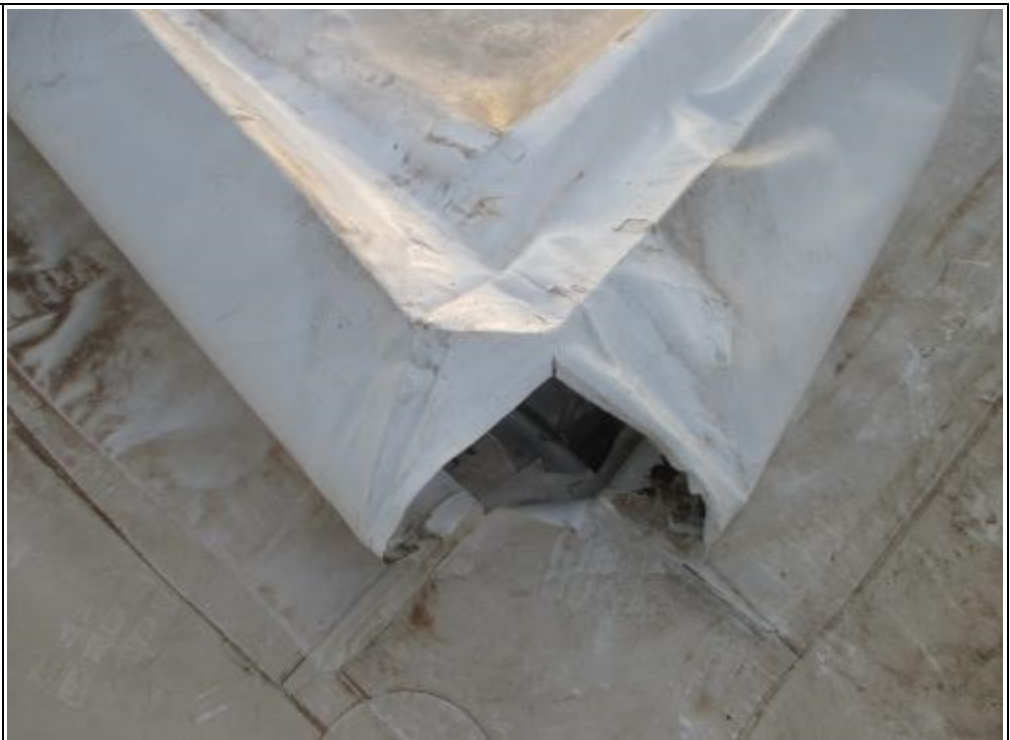
**Photograph: 28****Description:**

Building 959: Closeup of the torn corner of the roof membrane at an apparent skylight.

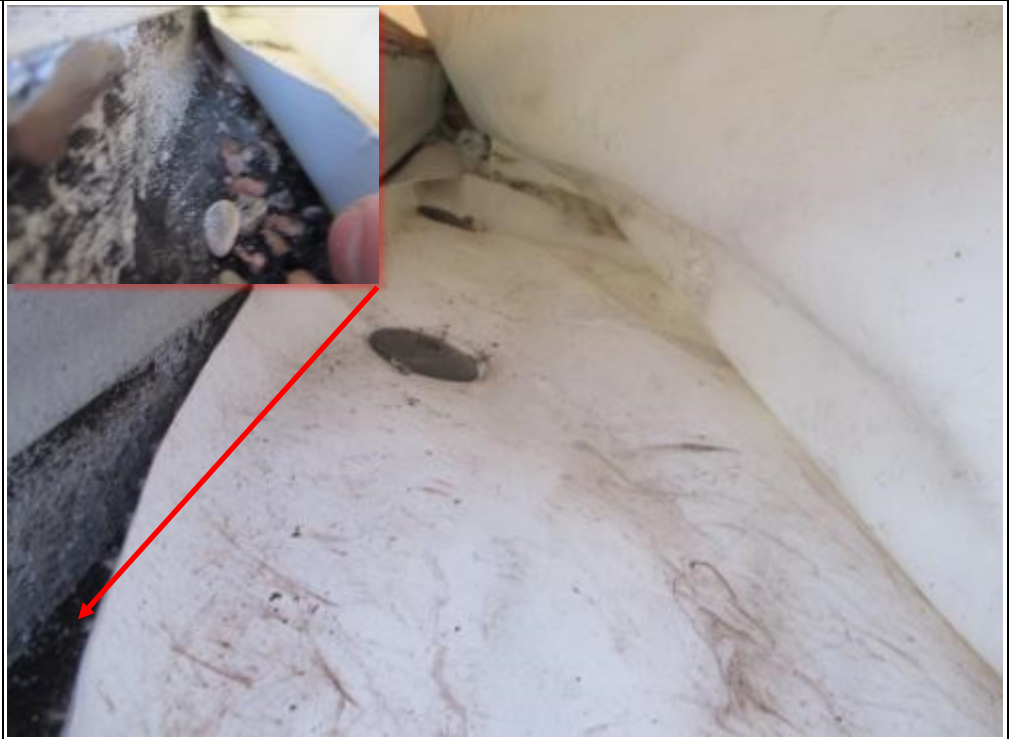
**Photograph: 29****Description:**

Building 959: View beneath the membrane at the torn skylight corner area.

The membrane appeared to have been placed over a ballasted roof (inset photo)

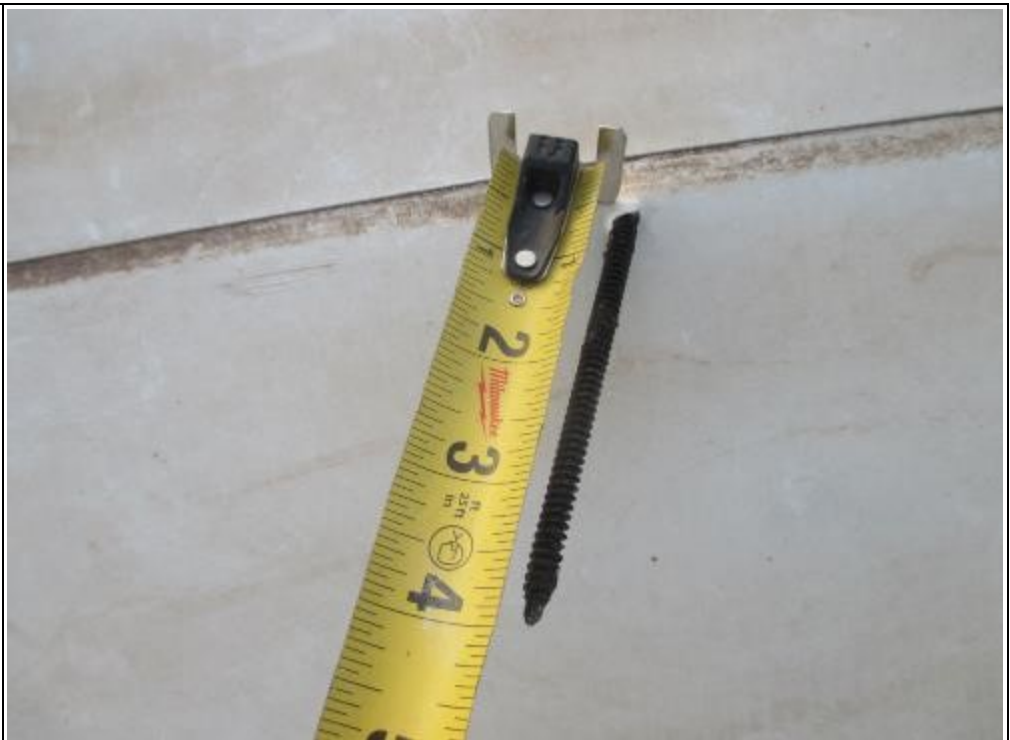
**Photograph: 30****Description:**

Building 959: View of a withdrawn fasteners that had penetrated the roof membrane.

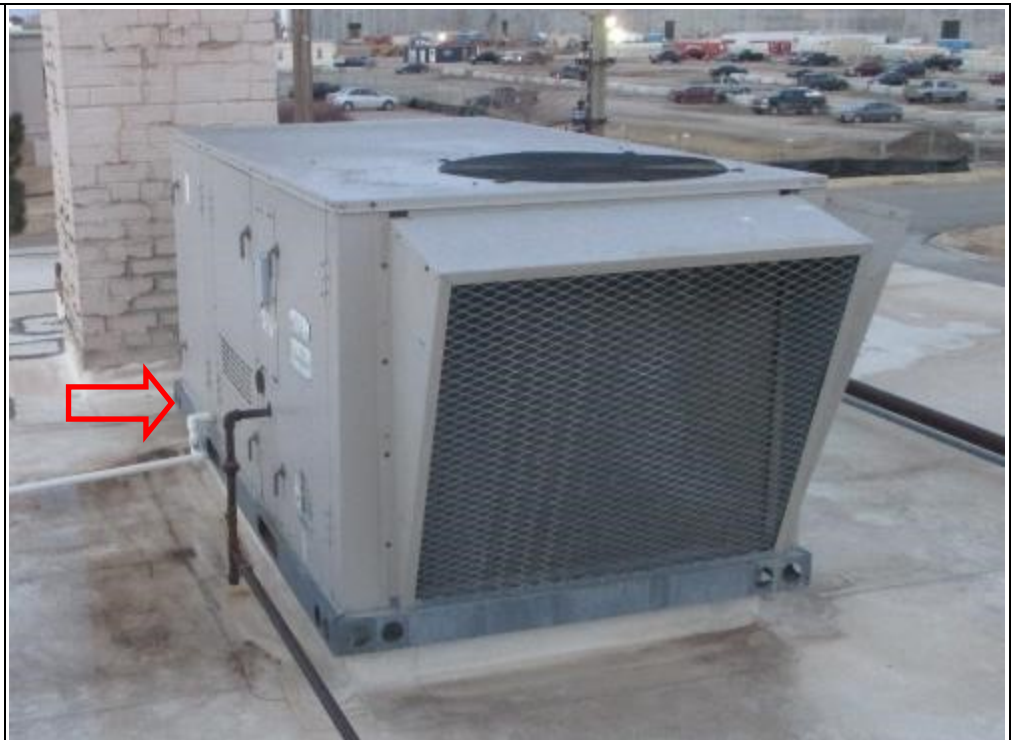
**Photograph: 32****Description:**

The specifically reported components for Rooftop Units (RTU's) 1 thru 3 and 6 on the roof of Building 120 were reportedly repaired prior to VERTEX's inspection and the cause of the reported damage to these components could not be determined. Moreover, although the User's Information Manual for Units 1 and 2 indicated that the RTU's should be fastened to the roof, the RTU's were not apparently attached to the roof curbs. Since the RTU's were not fastened, the RTU's appeared to have been laterally displaced approximately between 1/4 to 1/2 of one inch to the east. While the RTU's did rest evenly on the roof curbs, the RTU's could have been temporarily lifted during the elevated winds and displaced. This horizontal and vertical movement could have cracked the heat exchangers for Units 2 and 6. Also, the movement of Unit 3 could have caused the wires for the main disconnect box to be pulled when the unit moved and

caused the wires to either be loosened or be disconnected from the switch. Although lateral movement of the Unit 1 would not be expected to affect the controller card, an electronic disturbance could have occurred due to movement of the unit and affected the controller card operation.

Building 120: View of the northeast unit (Unit 1) on the lower roof.

Both Units 1 and 2 appeared to have been shifted to the east (red arrow indicating shifted direction).

- Building 120: Replace the controller card for Rooftop Unit 1.
- Building 120: Replace the heat exchangers for Rooftop Units 2 and 6.
- Building 120: Inspect and repair the main disconnect switch for Rooftop Unit 4.
- Building 120: Repair an area of approximately (60) square feet of thermoplastic membrane (5 feet long by 12 feet wide) at the (4) mechanical anchors of the lifted

The User's Information Manual for the Building 120 RTU's indicates that the unit roof frames should be securely fastened to the roof per local codes. Best engineering practice is to fasten the RTU's to the roof. VERTEX recommends that the RTU's be attached to the roof and that their

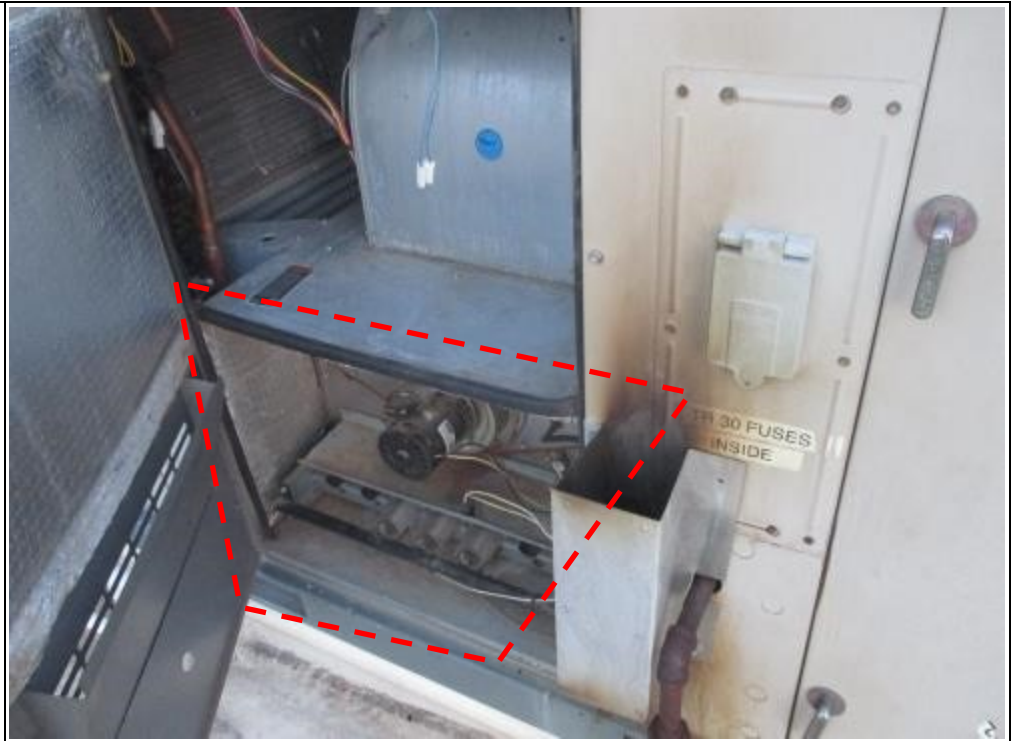
**Photograph: 33****Description:**

Building 120: Interior view of the heat exchanger assembly for Unit 2.

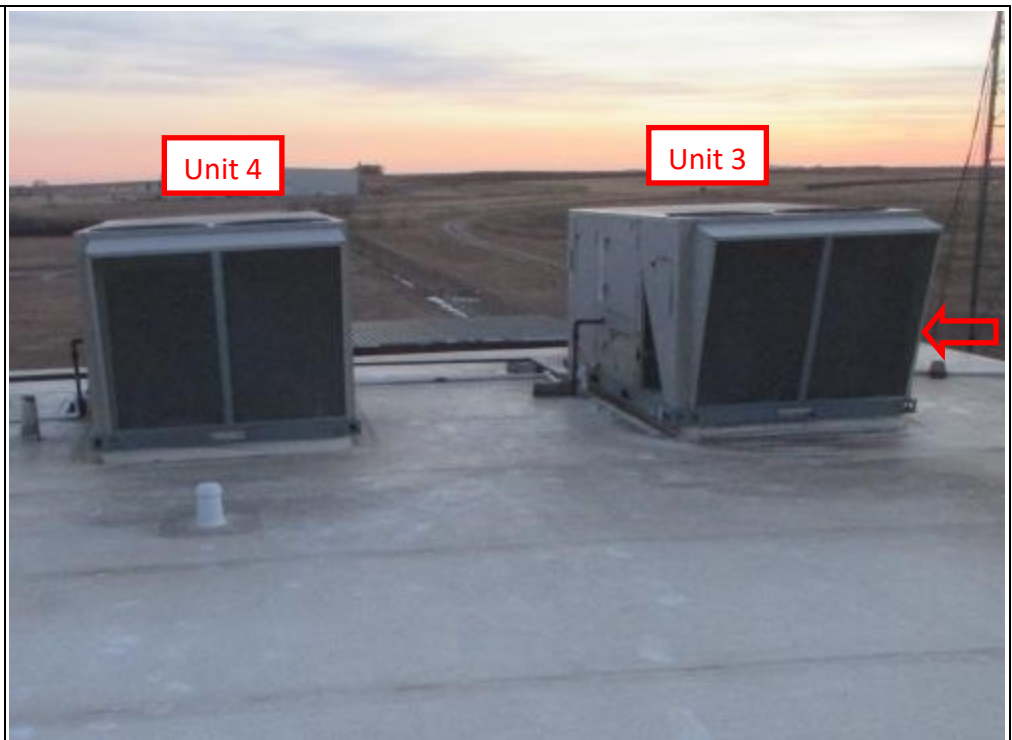
**Photograph: 34****Description:**

Building 120: View of Units 3 and 4 on the upper roof.

Unit 3 had been apparently shifted to the east (red arrow indicating shifted direction).

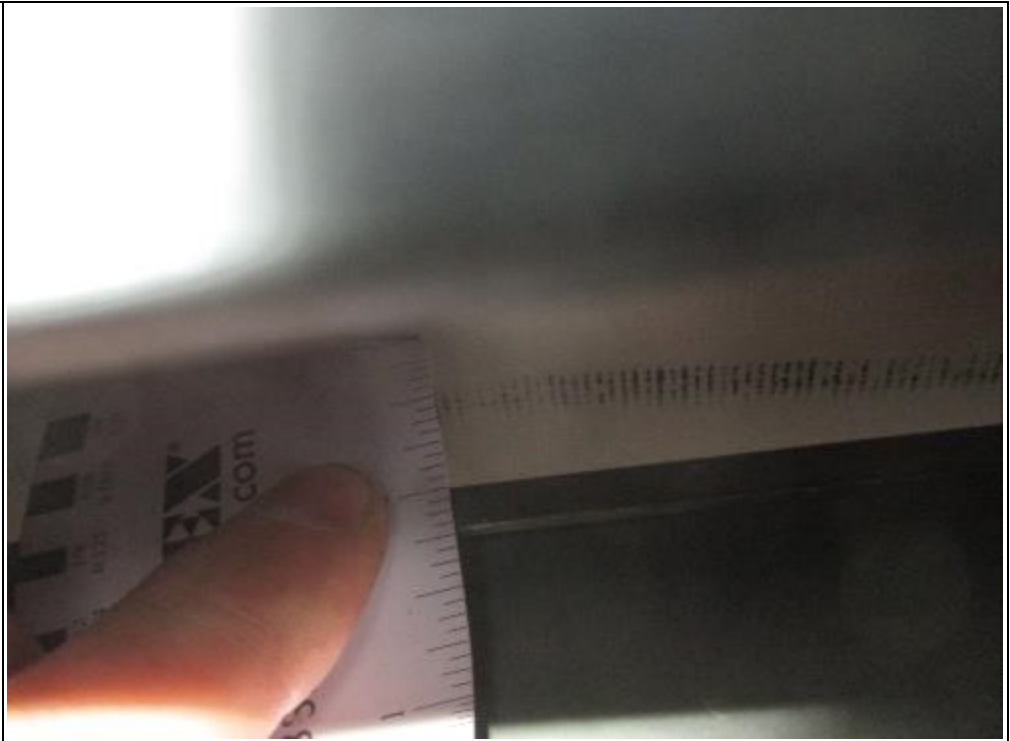
**PHOTOGRAPHIC DOCUMENTATION****Photograph: 35****Description:**

Building 120: View of the gap between the roof curb and unit support frame on the east side of Unit 3.

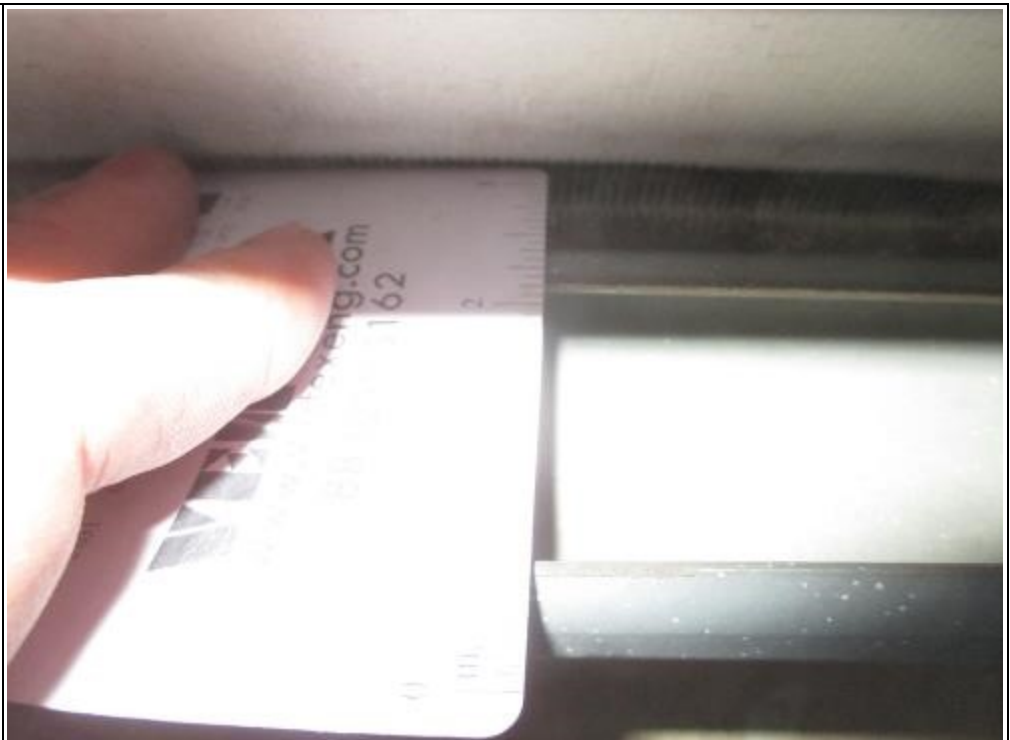
**Photograph: 36****Description:**

Building 120: View of the gap between the roof curb and unit support frame on the west side of Unit 3.

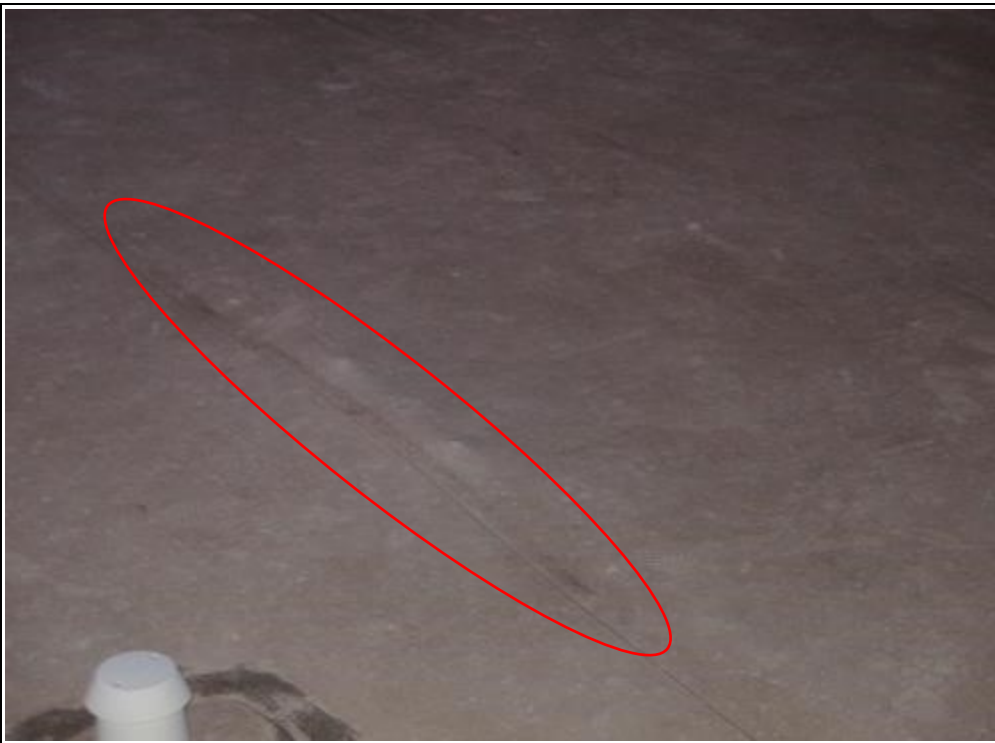
### Photograph: 37

The short length of lapped seam at the (4) withdrawn fasteners on west side of the south lower roof of Building 120 was similar with the withdrawn fasteners found on Buildings 412 and 959 and was also consistent with wind uplift. The withdrawal of roof fasteners and the uneven distribution of the insulation materials beneath indicated that the roof membrane had been lifted due to elevated winds. However, the lifting of the roof membrane appeared to be localized and not widespread across the entirety of the roof.

Building 120: View of approximately four fasteners withdrawn on the south side of the lower roof.

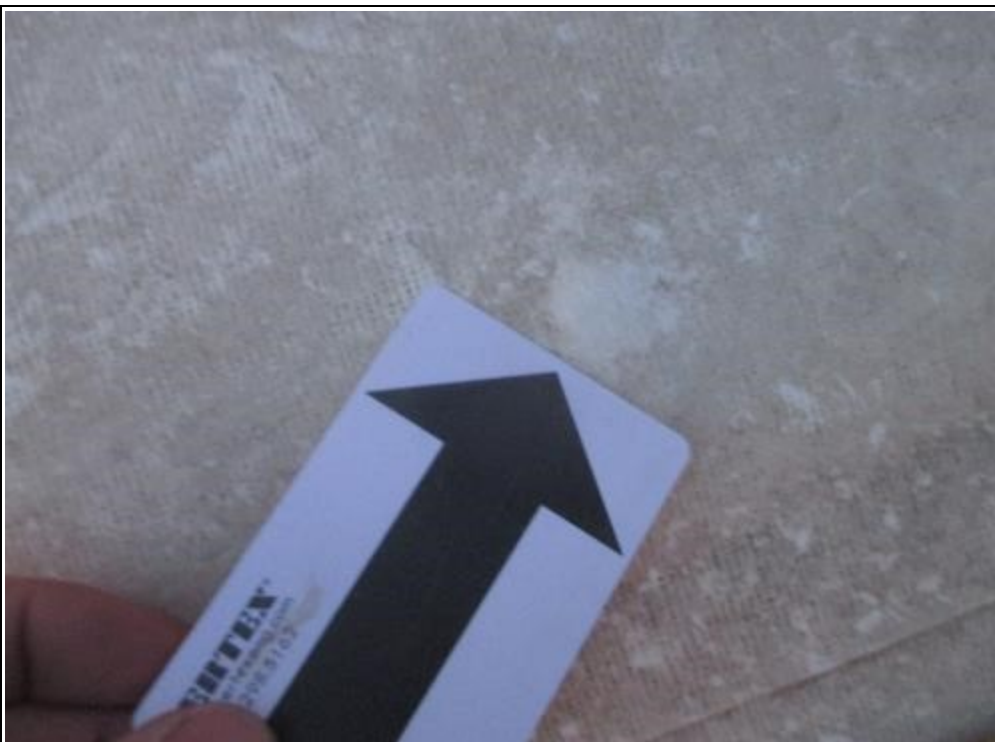
### Photograph: 38

Building 120: Closeup at an apparently withdrawn fastener.

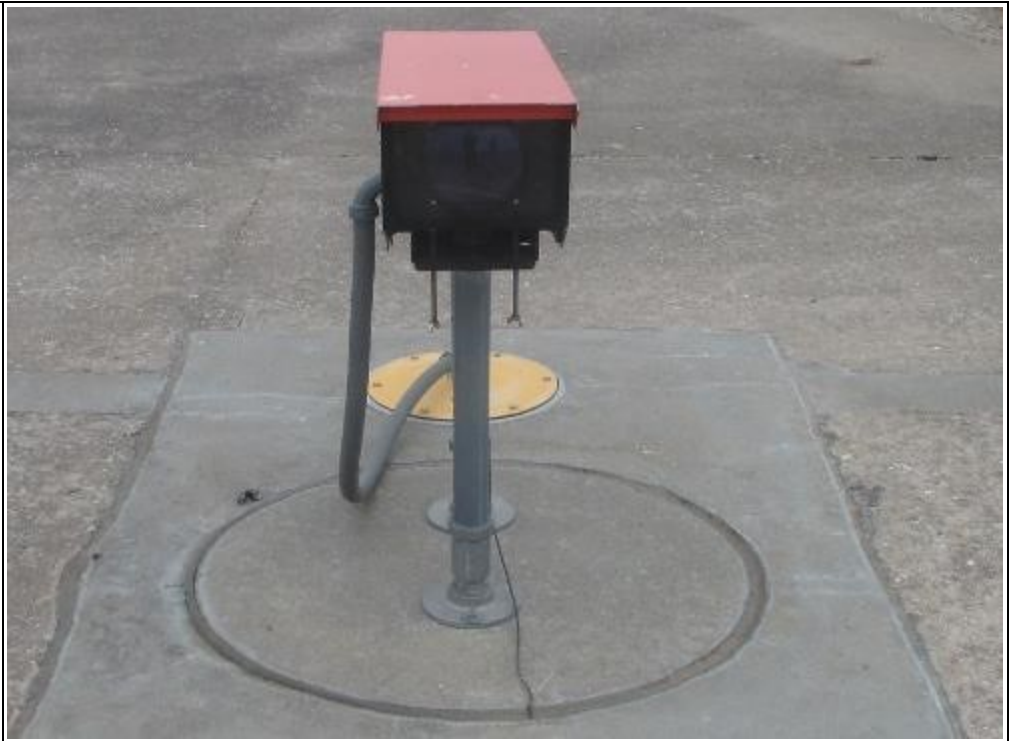
**Photograph: 41****Description:**

PAPI System: View of the east light box from the south.

The supports for the light box were not apparently aligned and appeared to have been rotated along the vertical axis of the light box.

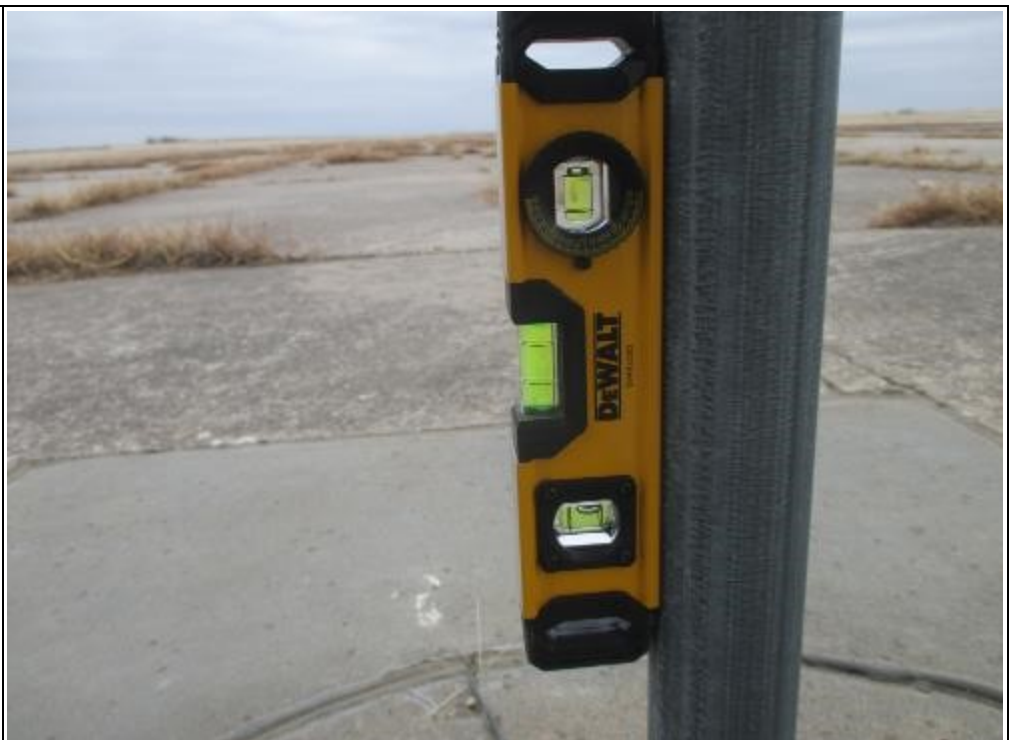
**Photograph: 42****Description:**

PAPI System: View of a plumb reading taken on the front support for the east light box.
