Salina Airport Authority
3237 Arnold Avenue
Salina, KS 67401

Report 3 – Structural Condition Assessment

Hangars A8 and D5 thru D8

FEBRUARY 25, 2022

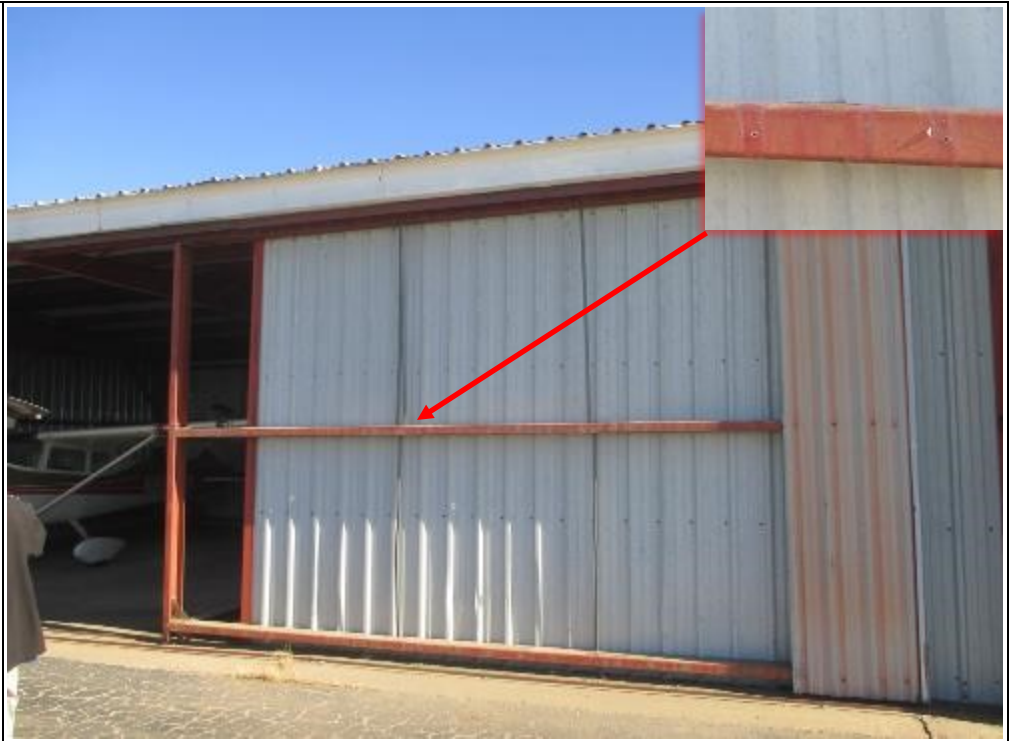
Photograph: 7**Description:**

The south rolling door required substantial force by hand to operate, and the bottom roller for the door did not appear to roll evenly. The south side rolling door was missing six metal wall panels, and each panel was approximately three feet wide. The south door frame was fabricated from cold-formed steel channel. The steel channel was approximately 16-gage and was approximately 6.75 inches wide by 3 inches deep. The door frame connections had several apparently replaced bolts that had a bright appearance. The door frame was missing screw fasteners where the metal panels had apparently been previously attached. The holes in the door frame for the missing fasteners were not visibly corroded, discolored, or stained (see Photo 7)

Hangar A8: View of the missing metal panels on the right side rolling door.

The holes in the door frame for the missing panels were not discolored or stained.

- Remove and replace the south rolling door that was approximately 20.5 feet wide by 12.5 feet high.
- Remove and replace approximately 30 feet of the top track channel C10x3x1/8.

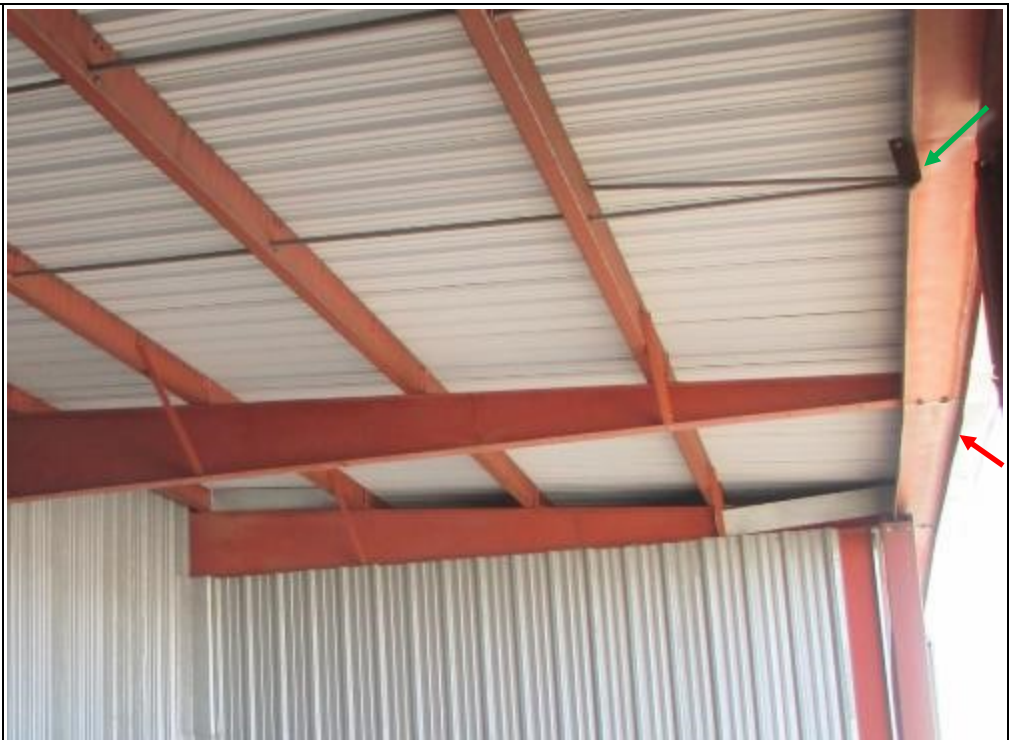
**Photograph: 8****Description:**

The top track was fabricated from cold-formed steel channel. The cold-framed channel was approximately 10 inches wide by 3 inches deep by 30 feet long. Two bolts that attached the track to the hangar steel frame were bright in appearance and had apparently been replaced. The outside flange of the top track was bent outwards. The right door bump stop was displaced inward, and the channel flange where it was attached was bent. The bent flange surfaces were not apparently corroded, discolored, or stained (see Photos 8 thru 10).

The elevated winds appeared to have generated wind forces on the south (right) side rolling door that bent its top track for Hangar A8 on or around December 15, 2021. Additionally, the wind forces appeared to have failed the fasteners for the metal panels and allowed the metal panels to become detached and these panels were missing. The top track was not discolored or corroded and was an indicator that the top track had been recently bent. The holes for the wall panels in the rolling door frame were bright in appearance and was also an indicator that the fasteners

Hangar A8: View of the top track for the right side rolling door.

The top track and rolling door bump stop (red arrow) were bent (green arrow).

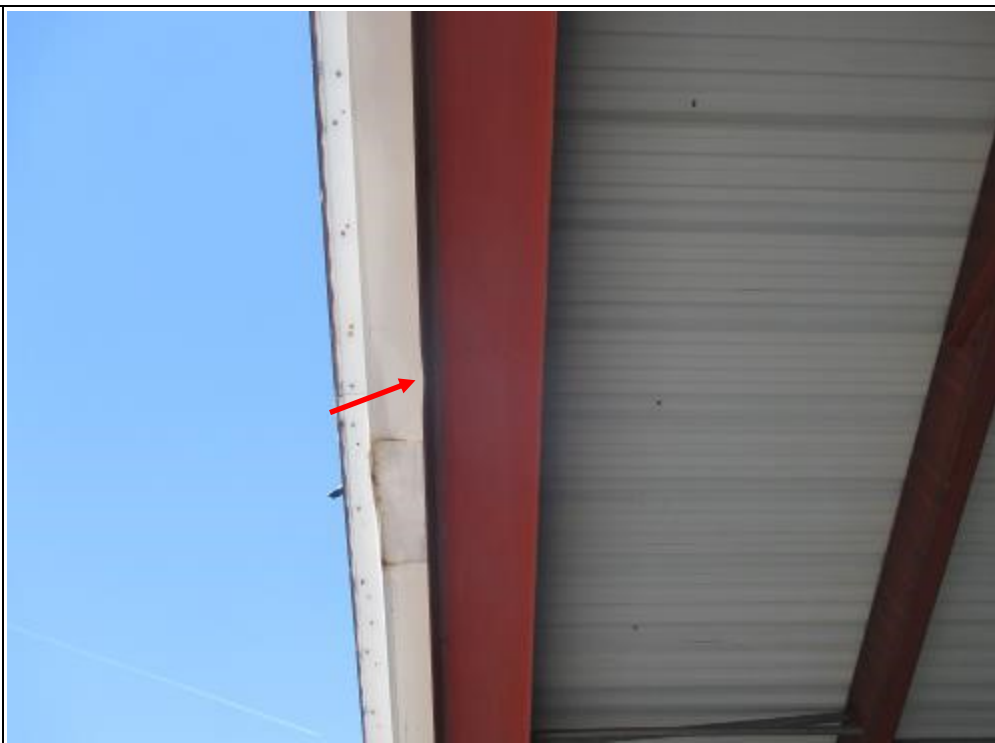
Photograph: 9**Description:**

Hangar A8: View of a bend in the top track.

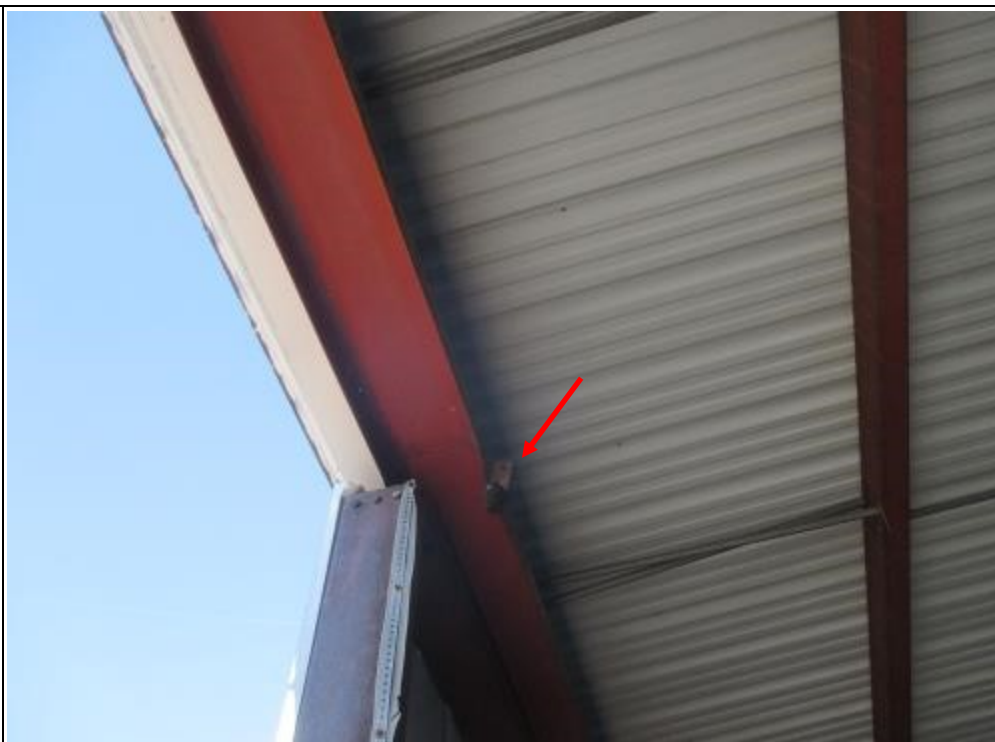
**Photograph: 10****Description:**

Hangar A8: View of a top track bent flange at an apparent butmp stop (red arrow).

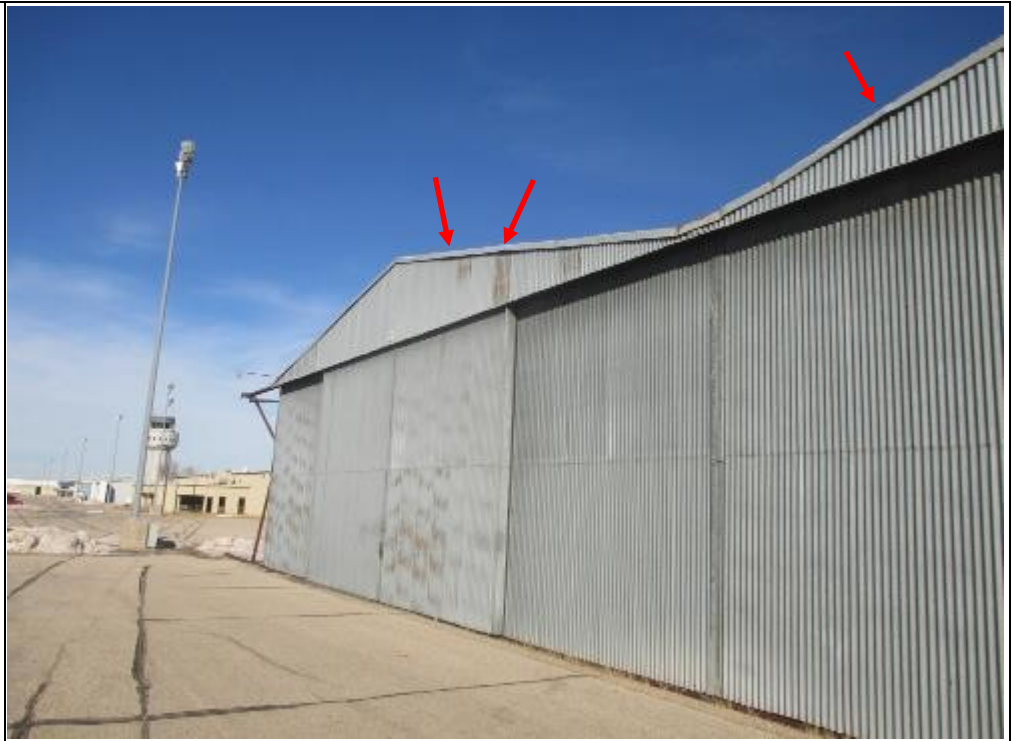
PHOTOGRAPHIC DOCUMENTATION**Photograph: 11****Description:**

The rake trim on the west sides of the roofs of the “D” Hangars were consistently bent upward between fasteners. The bent surfaces of the rake trim were not apparently corroded, discolored, or stained (see Photos 11 and 12).

Hangar D5: View of the west elevation.

The rake trim was bent at two places.

Note the bent rake trim for Hangar D6 to the south.

- Remove and replace the (2) rake trims on the west side of the roof which were each approximately 27.5 feet long.

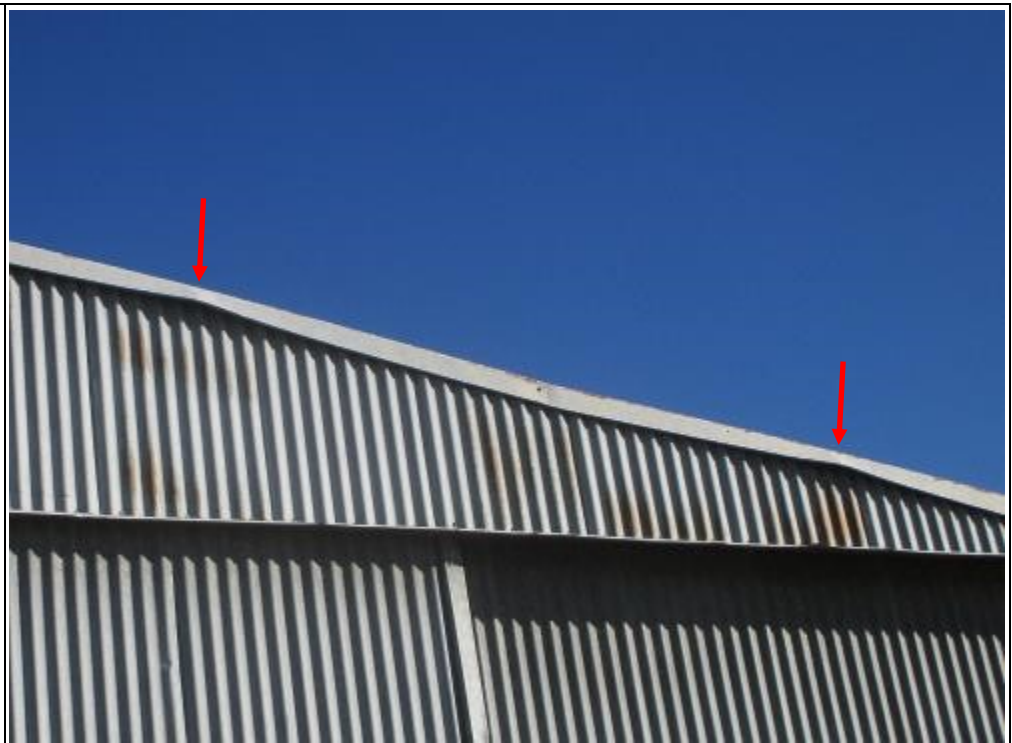
**Photograph: 12****Description:**

The “D” Hangars had also experienced sustained elevated winds that had affected building components on or around December 15, 2021. The exterior rake trim on the west roof bays of the “D” Hangars appeared to have been bent from wind uplift forces. The rake trim was bent upward between fasteners and was consistent with wind uplift. The rake trim was not discolored or stained where it was bent and was an indicator that the rake trim had been recently bent. The west bays of the roof deck and purlins for Hangars D6 thru D8 were bent upward and was consistent with a structure that had been subjected to wind uplift.

Hangar D6: Closeup of the rake trim on the west elevation.

- Remove and replace the (2) rake trims on the west side of the roof which each approximately 27.5 feet long.
- Remove and replace (16) roof purlins of the west roof bay which were each approximately L3.5x3.5x1/8 by 13.5 feet long.
- Remove and replace approximately 745 square feet of corrugated metal roof deck.

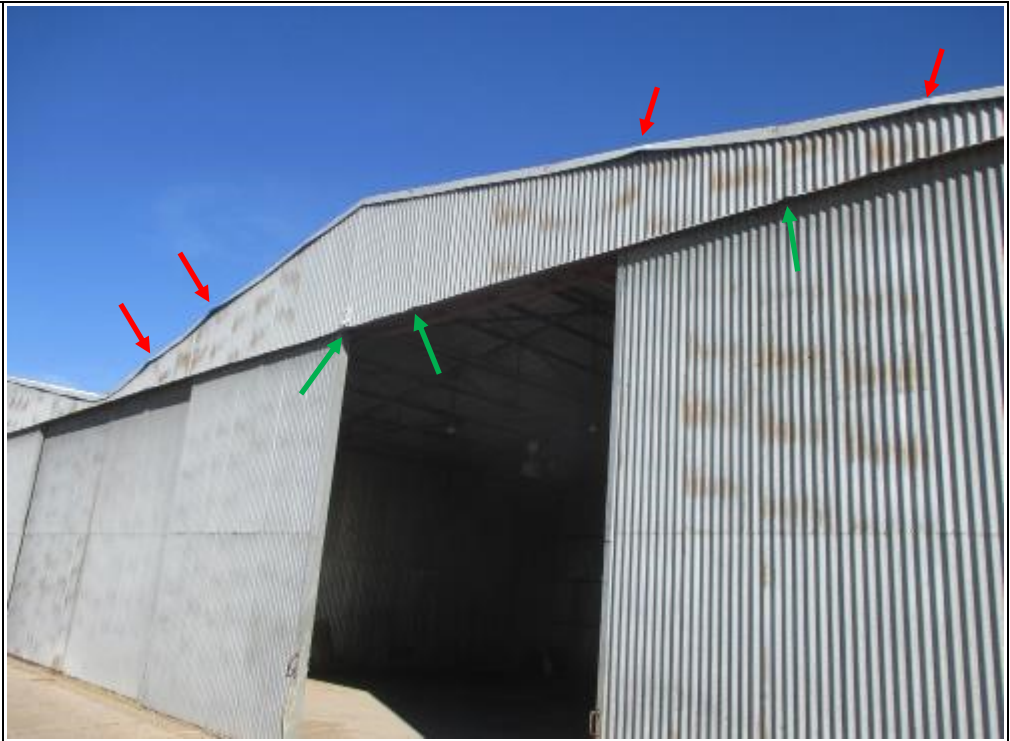
Photograph: 13**Description:**

Hangar D7: View of the bent rake trim on the west elevation (red arrows).

The bottom edges of the metal wall panels were bent at several places (green arrows).

- Remove and replace the (2) rake trims on the west side of the roof which were each approximately 27.5 feet long.
- Remove and replace (16) roof purlins of the west roof bay which were each approximately L3.5x3.5x1/8 by 13.5 feet long.

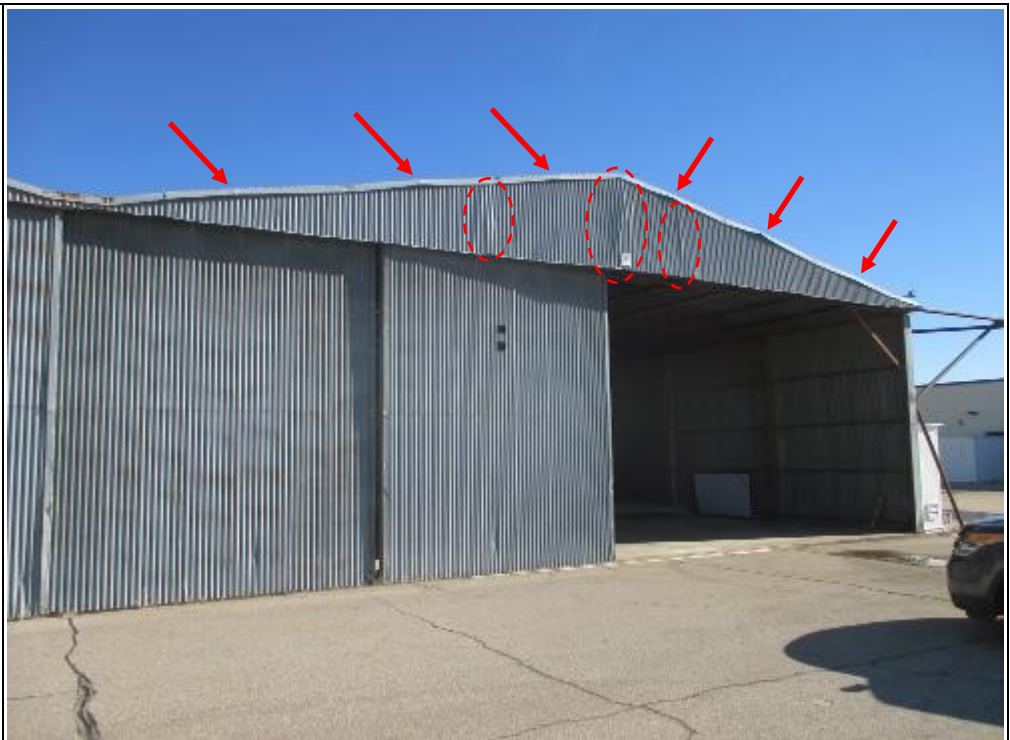
**Photograph: 14****Description:**

Hangar D8. The metal panels for the south rolling doors were torn and fractured at several places. The torn edges of the metal panels were jagged and bright in appearance. The rollers for the doors were bent and chipped, and the rollers were sharp and bright in appearance. The bottom track for the south rolling doors was bent outward. The bent metal panels attached to End Truss 3 were bent and protruded outward at three places. The bottoms of the metal wall panels were displaced outward. The metal panels at the bent locations were not discolored or stained (see Photos 14 thru 18).

Hangar D8: View of the west elevation.

The rake trim was bent at (3) places along the roof slope approximately equally spaced between fasteners (red arrows).

The wall panels above the rolling door protruded outward at (3) places (red ovals).

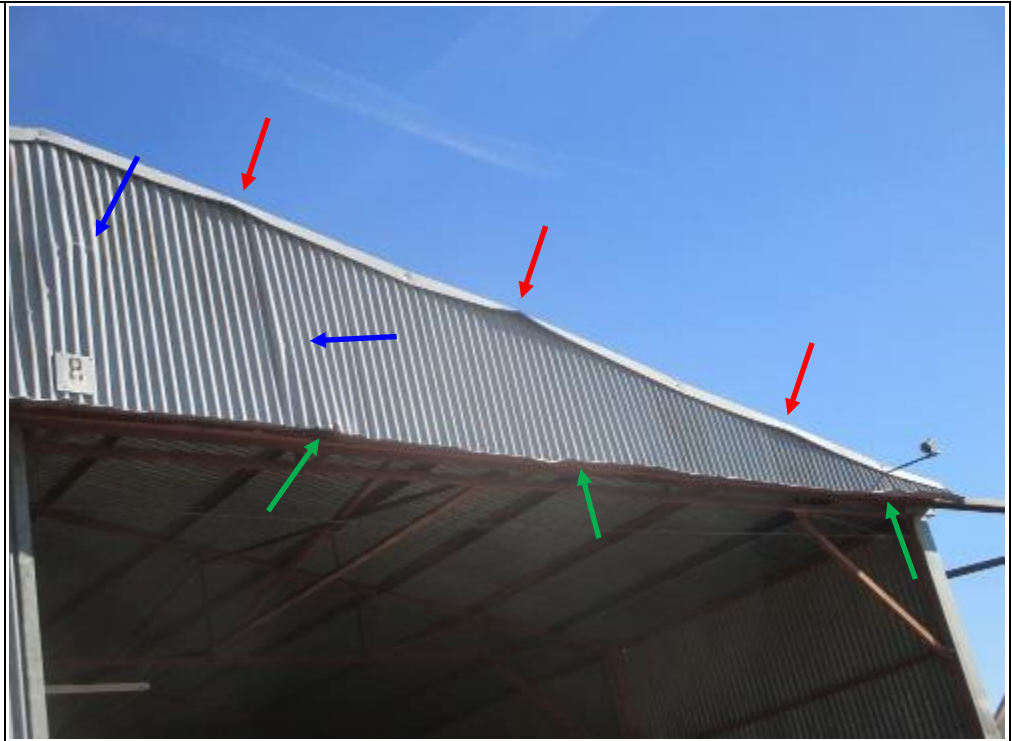
Photograph: 15**Description:**

Hangar D8: Closeup of the bent rake trim (red arrows) and the outward protrusions (blue arrows) of the metal panels.

The bottoms of the metal panels were bent and displaced outward (green arrows).

- Remove and replace approximately 135 square feet of corrugated metal wall panels.
- Remove and replace approximately 54 feet of the top track channel C10x3x1/8 which were each approximately 27 feet long.

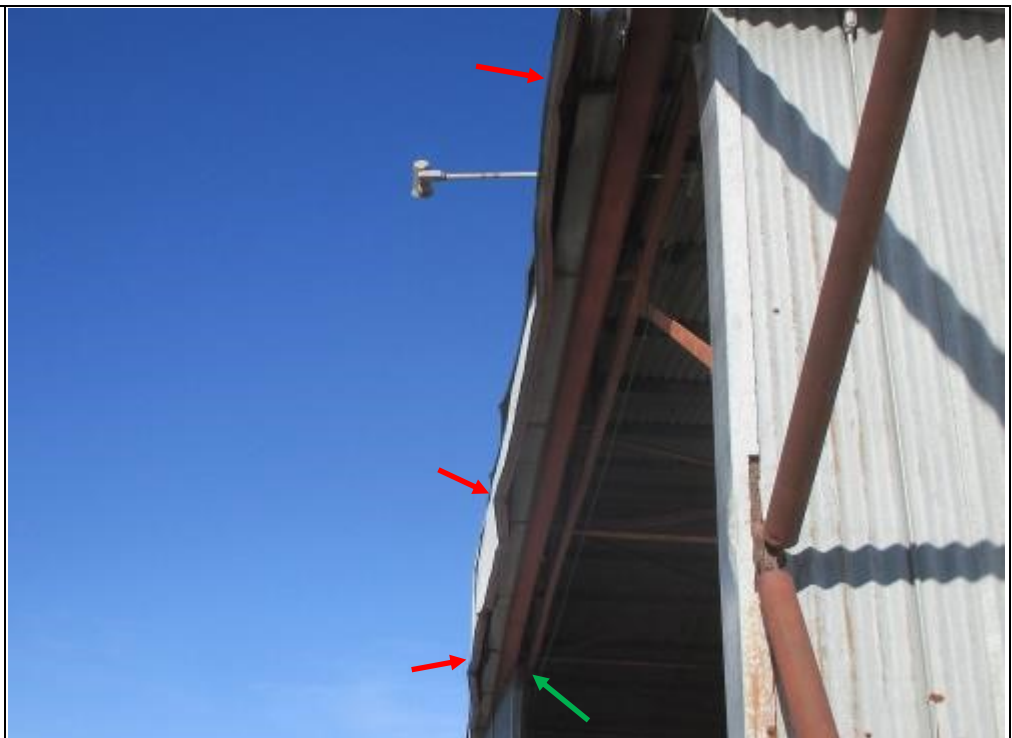
**Photograph: 16****Description:**

Hangar D8: View of the bottom of the metal panels on the west wall.

The metal panels were bent in several places (red arrows).

The top of the side rolling door was out of the top track (green arrow).

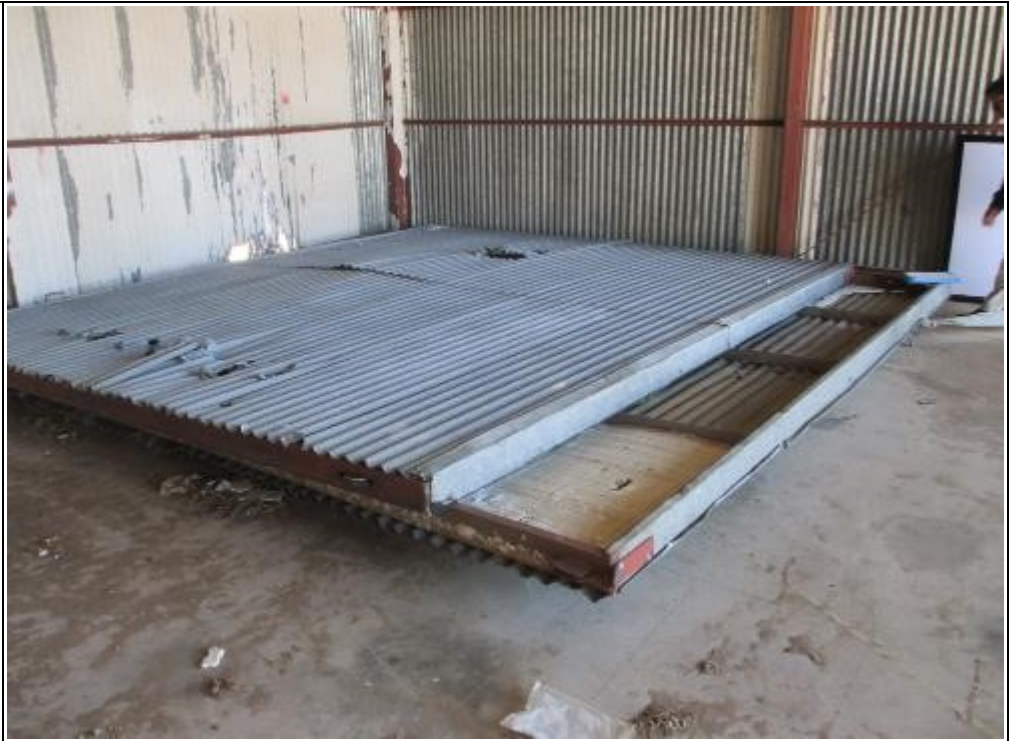
Photograph: 17

The west walls of Hangars D7 and D8 appeared to have experienced the greatest wind forces and exhibited the greatest deformation. The elevated winds appeared to have caused the “D” Hangar west rolling doors to move in and out from the sustained winds. The movement of the rolling doors appeared to have caused the top tracks to locally bend at their roller locations and subsequently bent the truss bottom chords for the west end trusses. The wind forces appeared to have been greatest at the south end of the Hangar D8 west side where the bending caused the end truss bottom chords to bend and failed a truss joint for End Truss 2. The bending and displacement of the bottom chords for the Hangar D8 west end joists appeared to have allowed the two south hangar doors to fall.

Hangar D8: View of the two south rolling doors on the hangar floor.

- Remove and replace (2) side rolling doors approximately 13.5 feet wide by 16 feet high.
- Remove and replace (2) side rolling doors approximately 8 feet wide by 16 feet high.

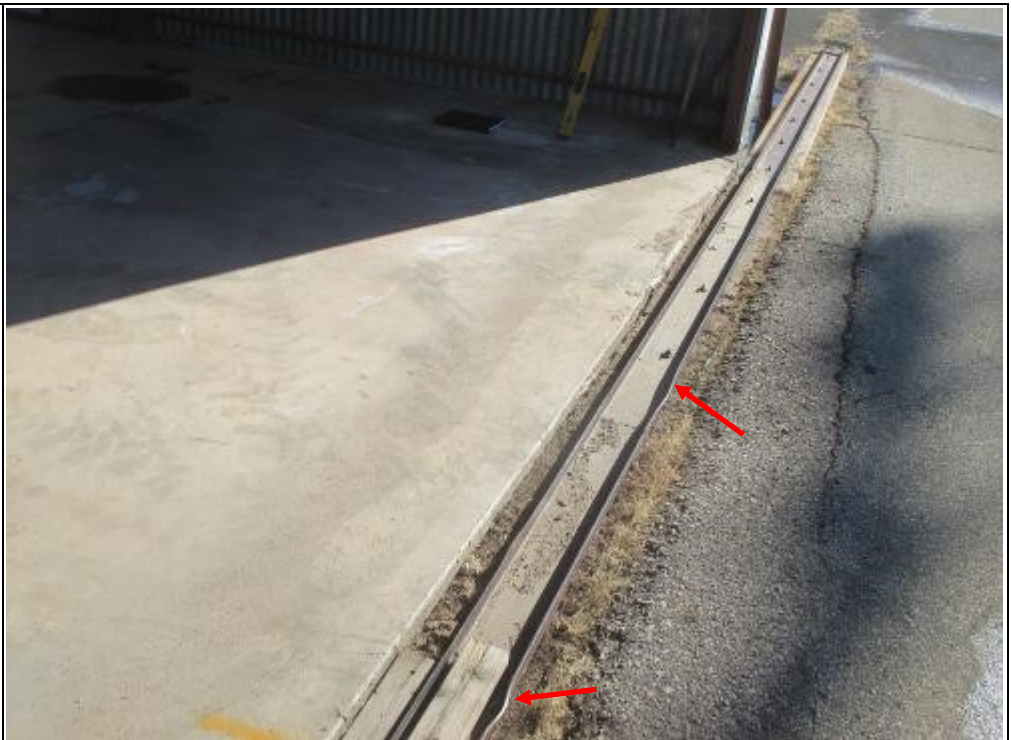
Photograph: 18

Hangar D8: View of the bottom track for the east sliding doors.

The bottom track was bent in two places (red arrows).

- Remove and replace approximately 54 feet of bottom track channel C10x3x1/8 which were each approximately 27 feet long.
- Remove and replace the (2) diagonal braces in the center bay of the south wall. The diagonal braces were approximately 1/2-inch diameter by 21 feet long.

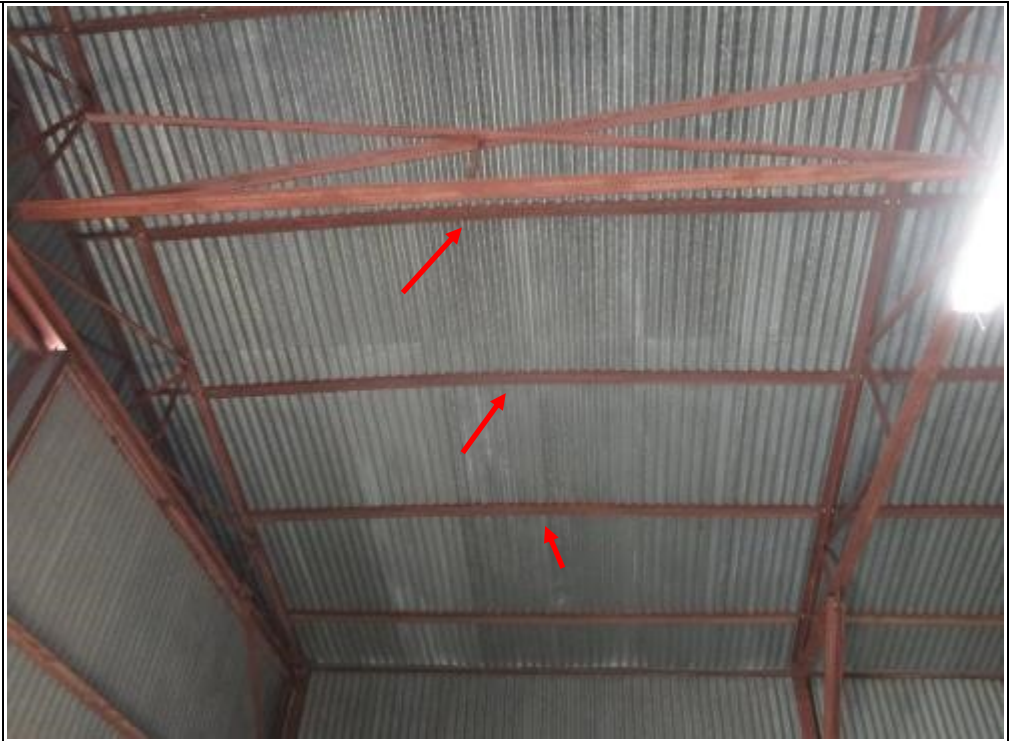
Photograph: 19**Description:**

The roof deck and purlins were consistently bent upward for the west bays of Hangars D6 thru D8. The End Truss 2 bottom chord was bent for both Hangars D7 and D8. The End Truss 2 bottom chord for Hangar D7 was bent in two places. The End Truss 2 bottom chord of the Hangar D8 was bent in three places. The End Truss 3 bottom of chord for Hangar D8 was bent and displaced outward at two places. The bent locations of the bottom chords were not discolored or stained. A truss joint for End Truss 2 had failed. The End Truss 2 bottom chord at the failed joint was detached from the vertical chord member, and the adjacent truss diagonal was bowed inward. The end of the detached vertical chord member was jagged and bright in appearance (see Photos 19 thru 22).

The roof deck and purlins were bent upward (red arrows).

Hangars D7 and D8 were similar.

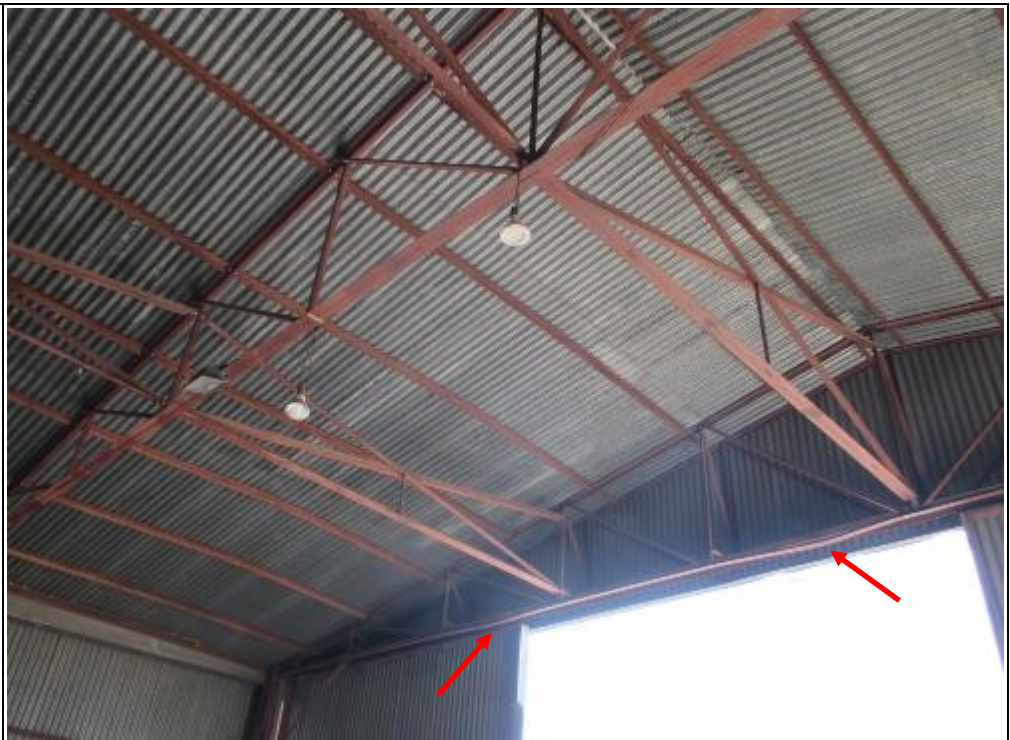
**Photograph: 20****Description:**

Hangar D7: View of the south side of the west bay.

The bottom chord of End Truss 2 was bent in two places (red arrows).

- Remove and replace approximately 745 square feet of corrugated metal roof deck.
- Remove and replace End Trusses 2 and 3. Replace each truss with an equal truss or open web steel bar joist approximately 5 feet deep by 54 feet long.

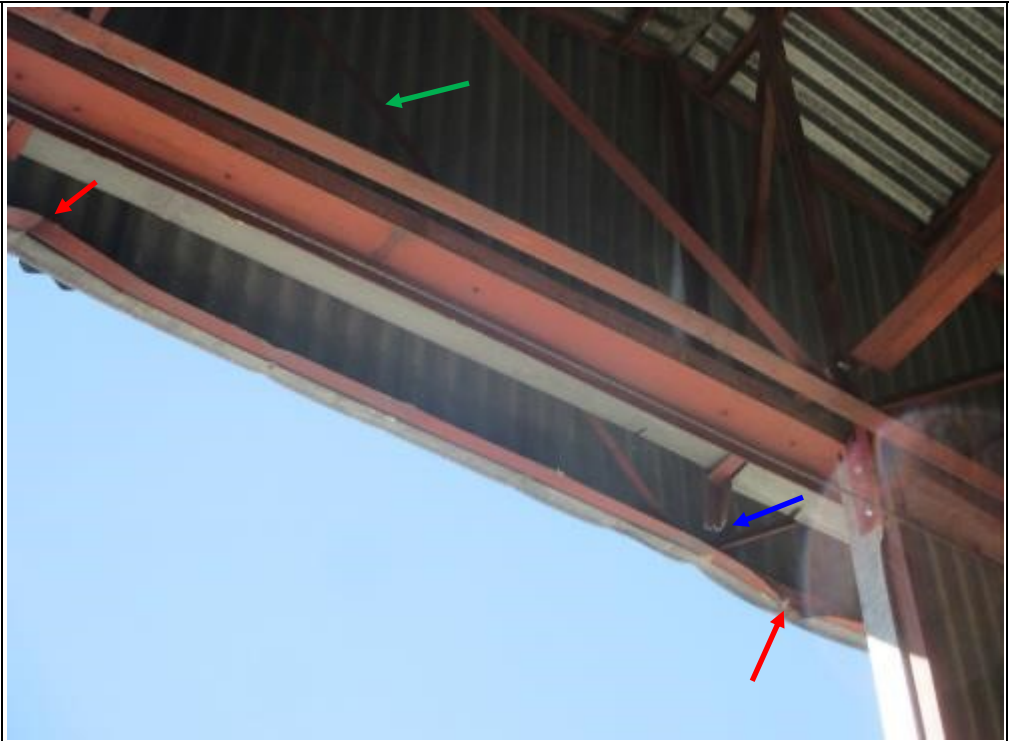
Photograph: 21**Description:**

The bottom of chord of the truss was bent in two places (red arrows) and displaced outward.

The bottom chord was detached from the vertical chord member (blue arrow), and a truss diagonal was bowed (green arrow).

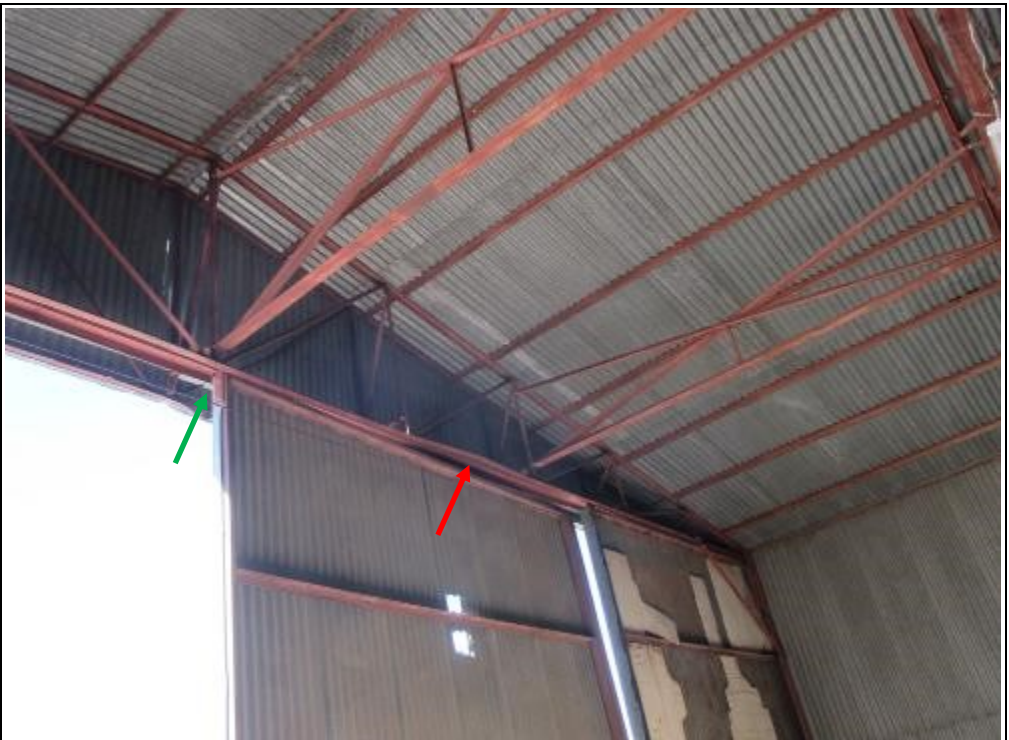
**Photograph: 22****Description:**

Hangar D8: The bottom chord of End Truss 2 was bent (red arrow).

The side rolling door was out of the top track (green arrow).

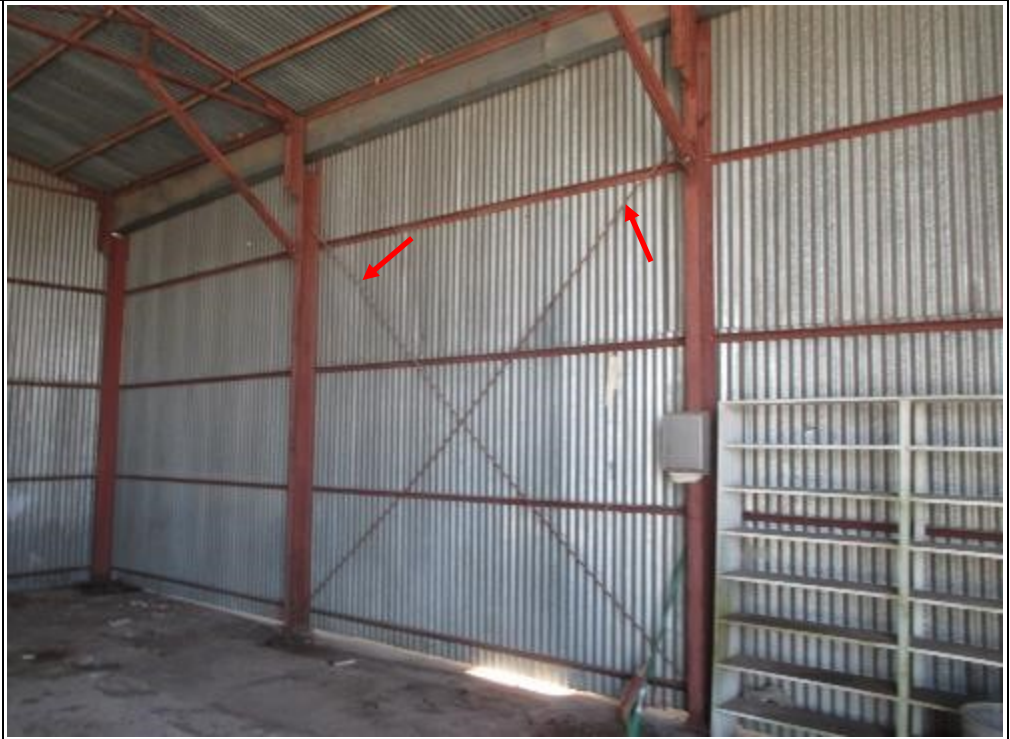
Photograph: 23**Description:**

The diagonal braces for North-South Walls 3 and 4 for Hangars D7 and D8 were bent. The diagonal braces were bent near the top connections at the columns. The diagonal braces were discolored and dulled in appearance where the bracing rods were bent. The columns for the North-Wall 3 braced-bay were displaced upward, and their column baseplates were bent. Both of the columns for the braced-bay had a missing anchor bolt and a partially withdrawn anchor bolt. The withdrawn anchor bolts were discolored and corroded by apparent surface rust. Debris and sediment were between the bottoms of the column baseplate and the concrete floor. The concrete below the east column for Hangar D7 was cracked. The concrete at the southwest

Moreover, the hangar braced-bays in the east-west direction did not appear to have been affected by the elevated winds on or around December 15, 2021. While the diagonal bracing was bent for the North-South Walls 4 and 5 braced-bays of Hangars D7 and D8, the appearance of the bent rods was consistent with corrosion and weathering that had occurred over an extended period. Similarly, the missing and partially withdrawn anchors bolts for the column bases for the North-South Wall 4 braced-bay of Hangar D7 had corrosion and weathering that had occurred over an extended period. Additionally, the concrete cracks for the west column for the North-

Hangar D7: View of the steel framing and braced frame on the south wall.

The diagonal bracing was bent in two places (red arrows).

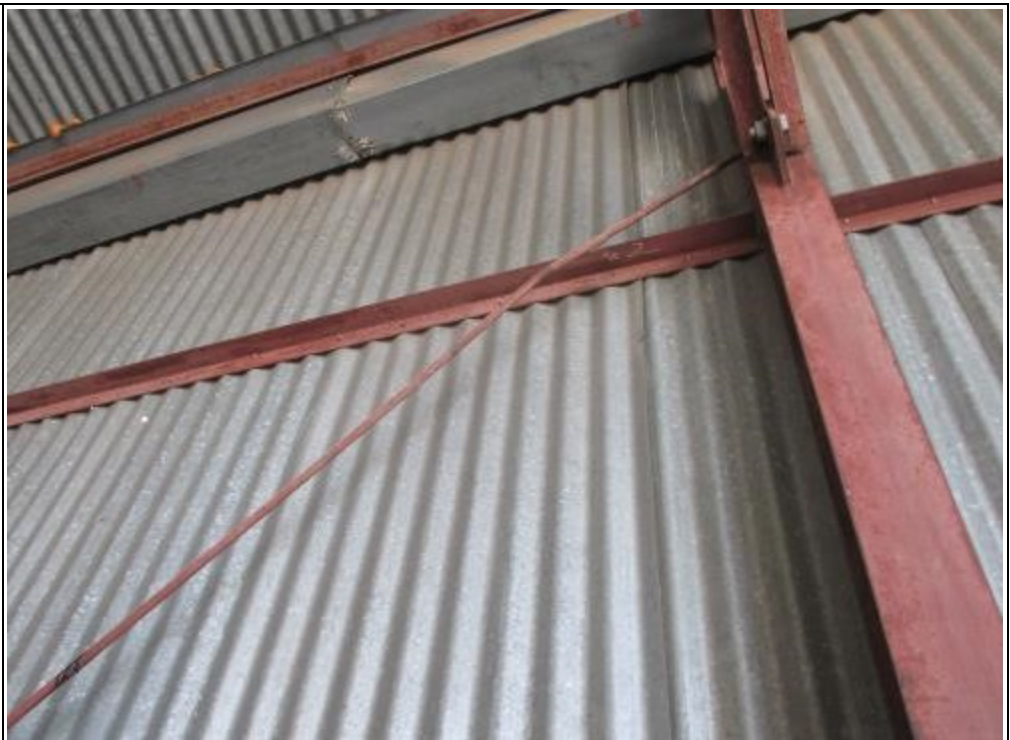
**Photograph: 24****Description:**

Hangar D7: Closeup of one of the bent diagonal braces on the south wall.

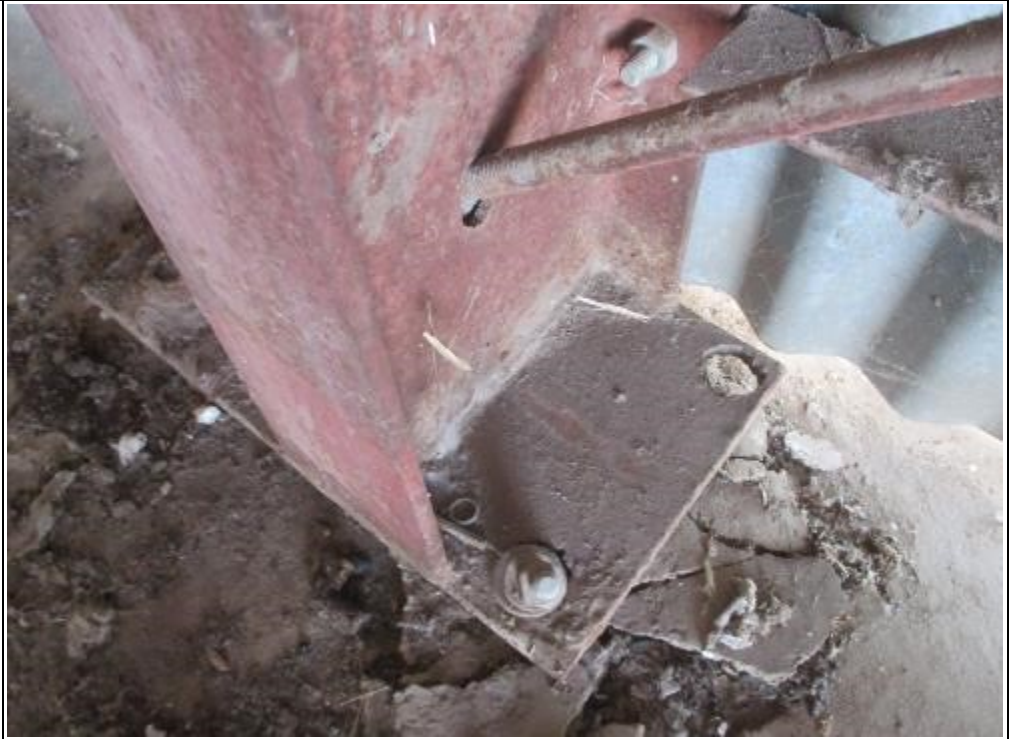
Photograph: 25**Description:**

Hangar D7: View of the baseplate for the east interior column on the south wall.

- Remove and replace the baseplates including the anchors for the two columns for North-South Walls 4 and 5.
- Repair the concrete crack at the east braced column for North-South Wall 4.
- Repair the concrete crack at the Hangar D8 southwest corner.

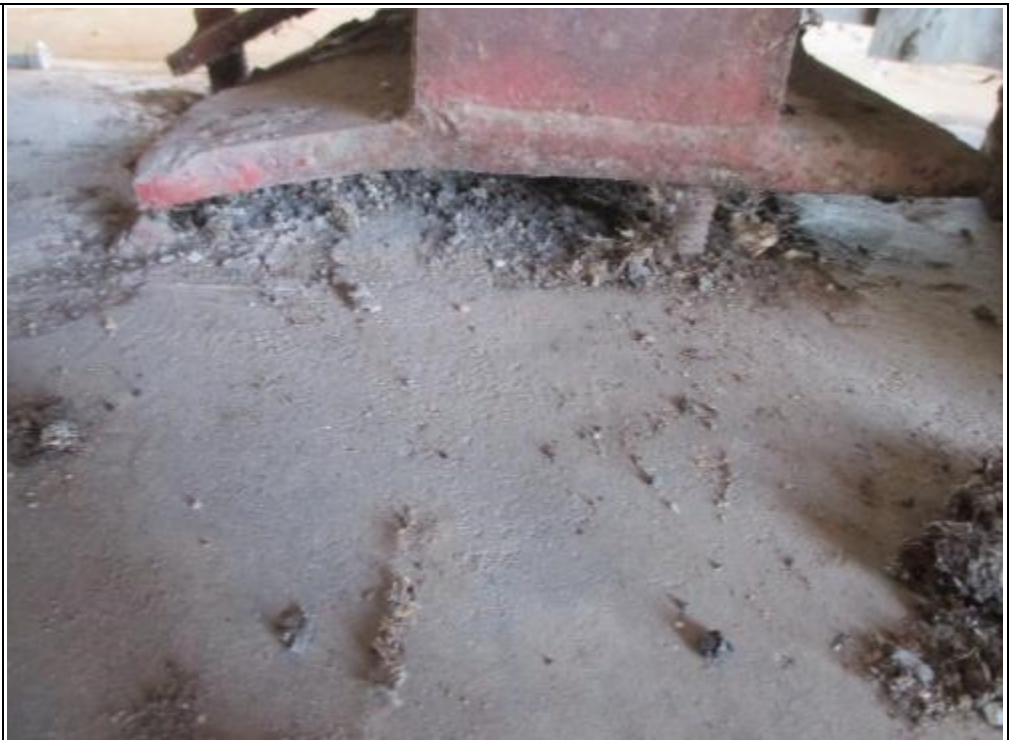
**Photograph: 26****Description:**

South Wall 4 braced-bay and the Hangar D8 southwest column were consistent with damage that had occurred years prior to the VERTEX inspection. The concrete crack edges were rounded and worn, and debris was observed within the cracks. These were indicators that the uplifted braced columns, buckled diagonal bracing, and the cracked concrete had occurred years prior to the elevated winds on or around December 15, 2021.

Hangar D7: View of the baseplate for the west interior column on the south wall.

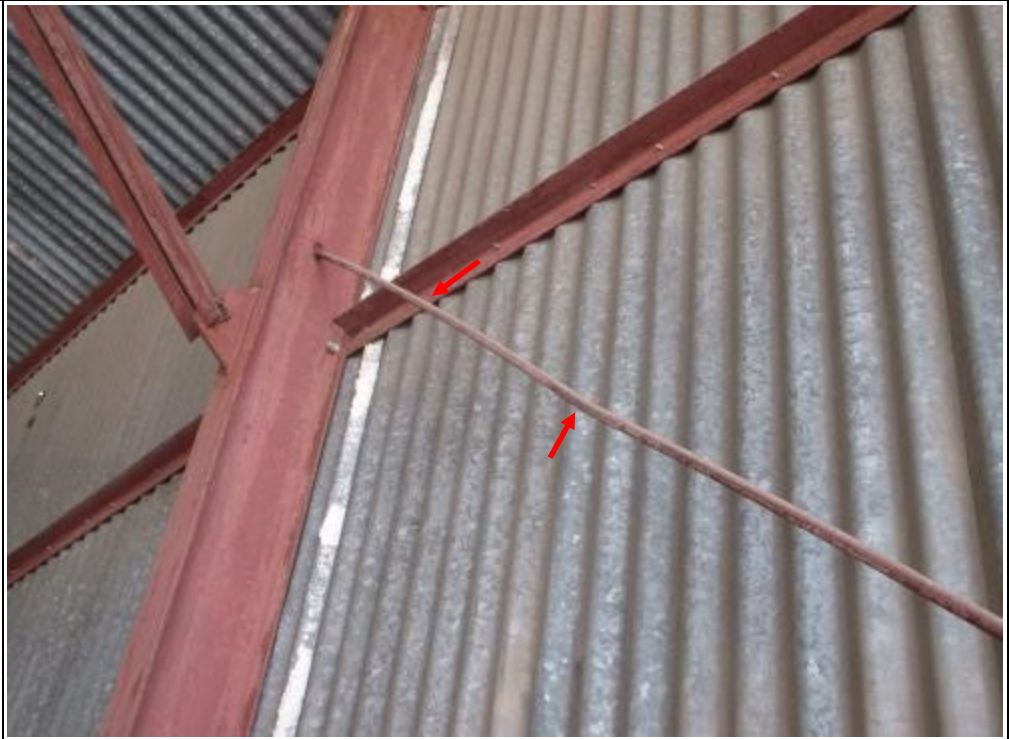
Photograph: 27**Description:**

Hangar D8: View of a diagonal brace on the south wall of the hangar.

The diagonal brace was bent in two places (red arrows).

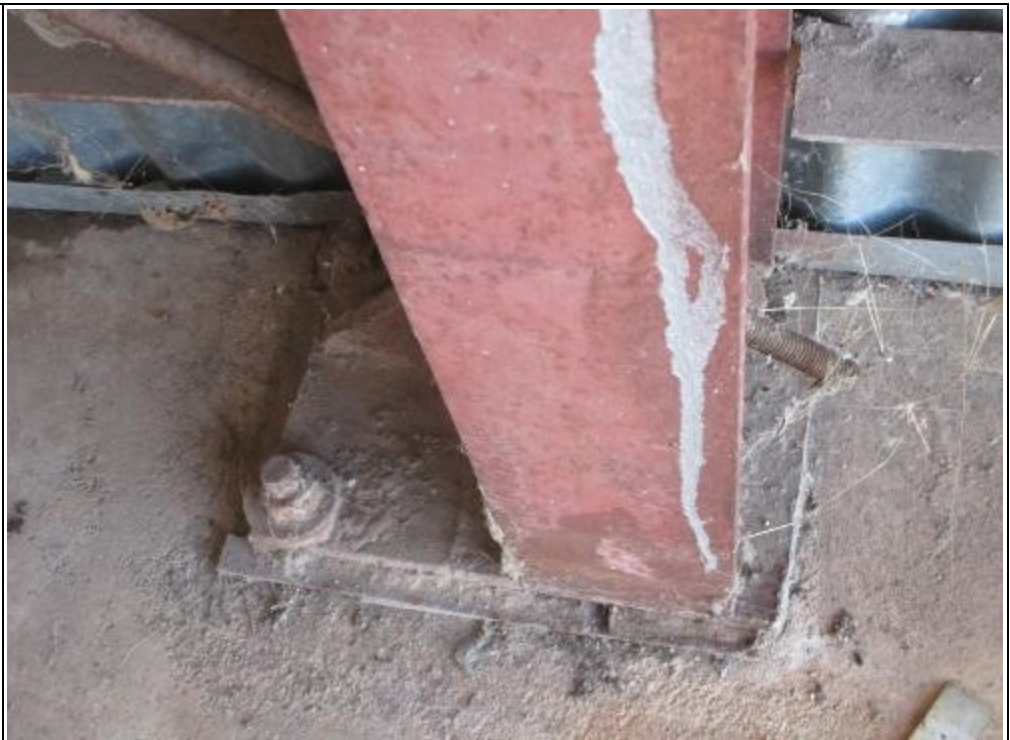
**Photograph: 28****Description:**

Hangar D8: View of the baseplate for the west interior column on the south wall.

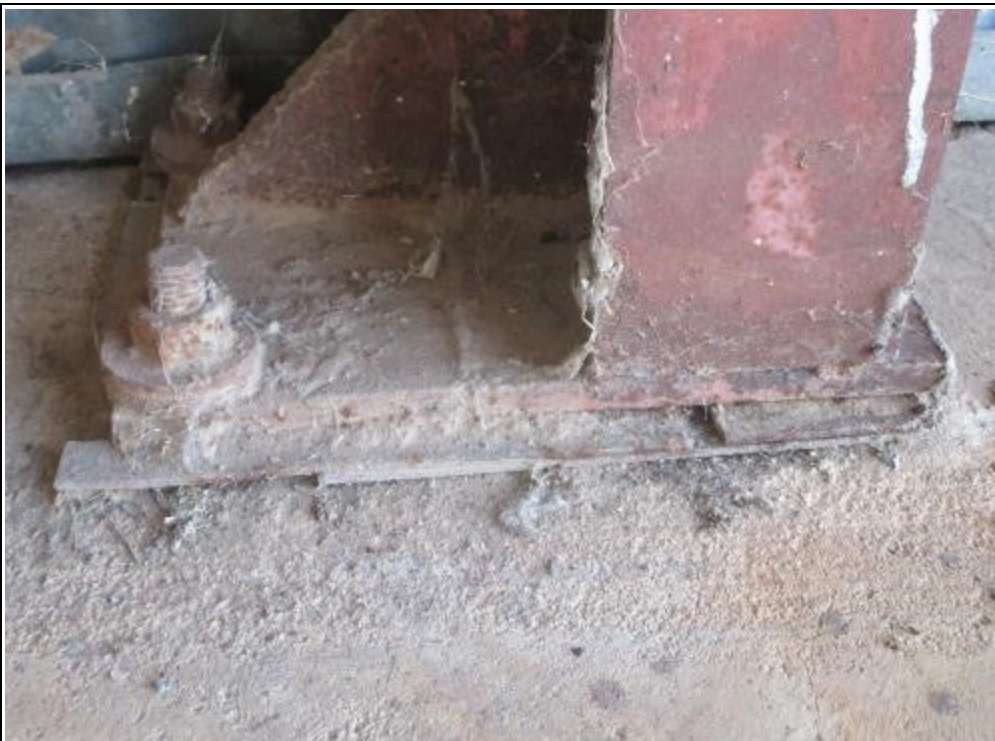
Photograph: 29**Description:**

Hangar D8: Additional view of the baseplate for the west interior column on the south wall.

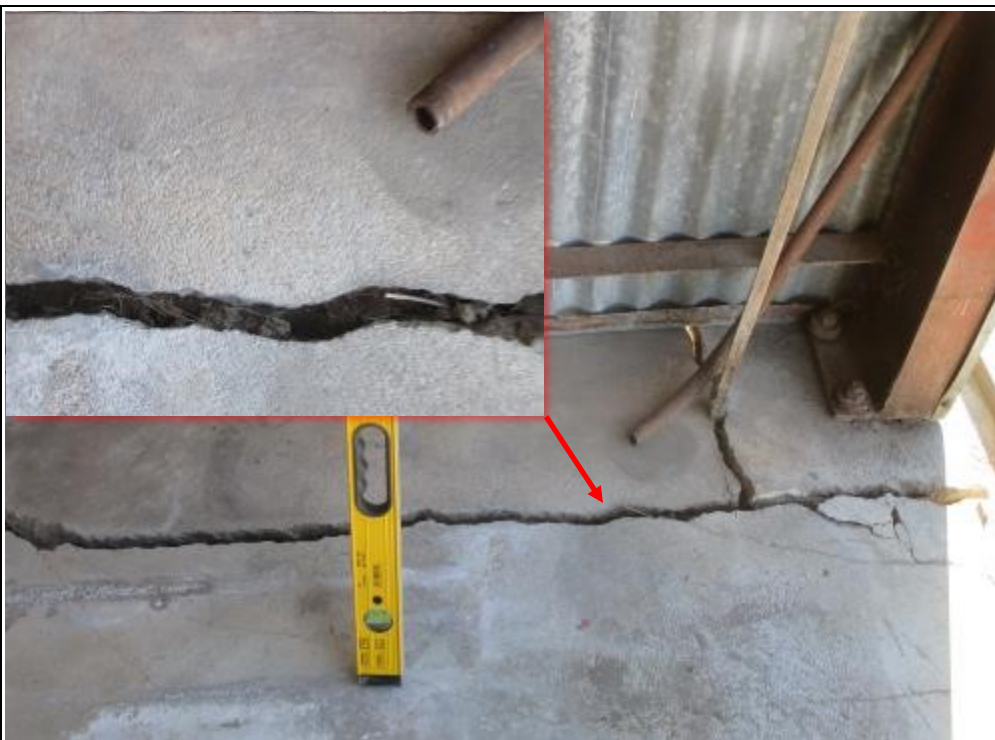
**Photograph: 30****Description:**

corner for Hangar D8 was also cracked. The concrete cracks were rounded and were filled with debris (see Photos 23 thru 30).

Hangar D8: View of a crack in the southwest corner concrete slab.
