Report 4 – Structural Condition Assessment Hangars 504 and 606 and Building 655

MARCH 1, 2022

Claim: 5630075143

VERTEX Project: 76253

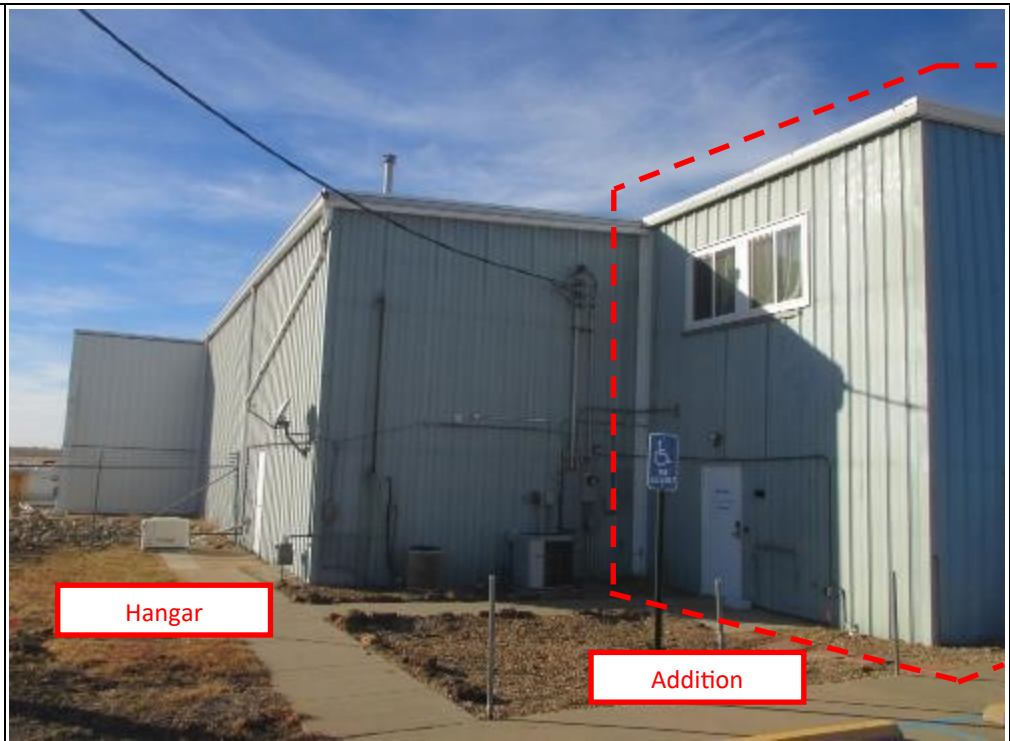
Hangar 504:
View of the south elevation of the building addition (red dashed outline).

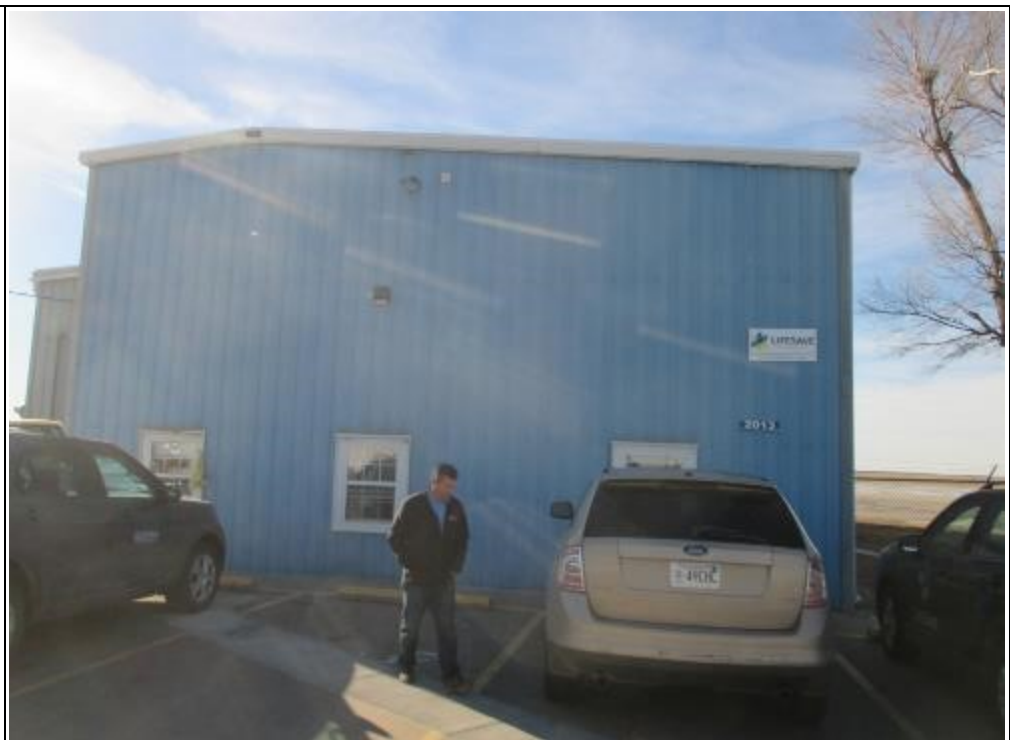
Photograph: 2

Hangar 504:
View of the east elevation of the building addition

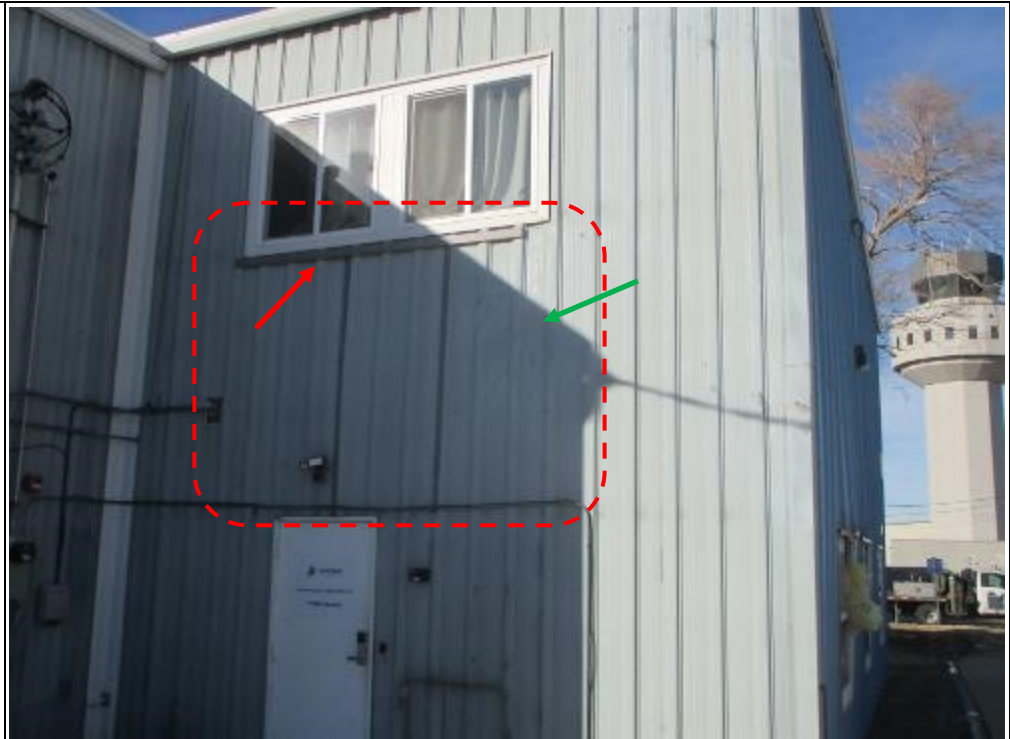
Photograph: 9

The metal panels on the south elevation were faded. The metal wall panels below the window were reported to have been loose and bent from elevated winds, and a board was reported to have been installed along the bottom of the upper story window to temporarily reattach the panels. The metal panels above and adjacent to the upper window were not apparently bent, and the flashing and seals were not loose. The fasteners above the window had a dulled appearance. A repair material appeared to have been installed above the right side of the window. The wall panel lapped joints were reversed below the window. A vertical strip of the metal panels at the lapped joints was not apparently discolored or faded. The fasteners at the lapped joints and the installed board had a bright appearance. The metal panels had jagged, sharp holes next to the installed fasteners. The hole edges had a bright appearance that was not discolored or faded (see Photos 9 thru 12).

The panels below the upper window were reported to have been loose and bent due to elevated winds. A board was reported to have been installed below the window (red arrow).

The bottom right metal panel had been bent (green arrow).

- Remove and replace the metal panels for the east and south elevations of the building addition. Remove and replace the flashings and trims around the south door and east and south windows as required.
- Inspect the girt and frame connection bolts. Replace the bolts as required and install washers at short-slotted and oversized holes.
- Patch and paint the nail pops to the drywall for the east wall for the first and second floors.
- Replace the (4) acoustic ceiling tiles in the living room.

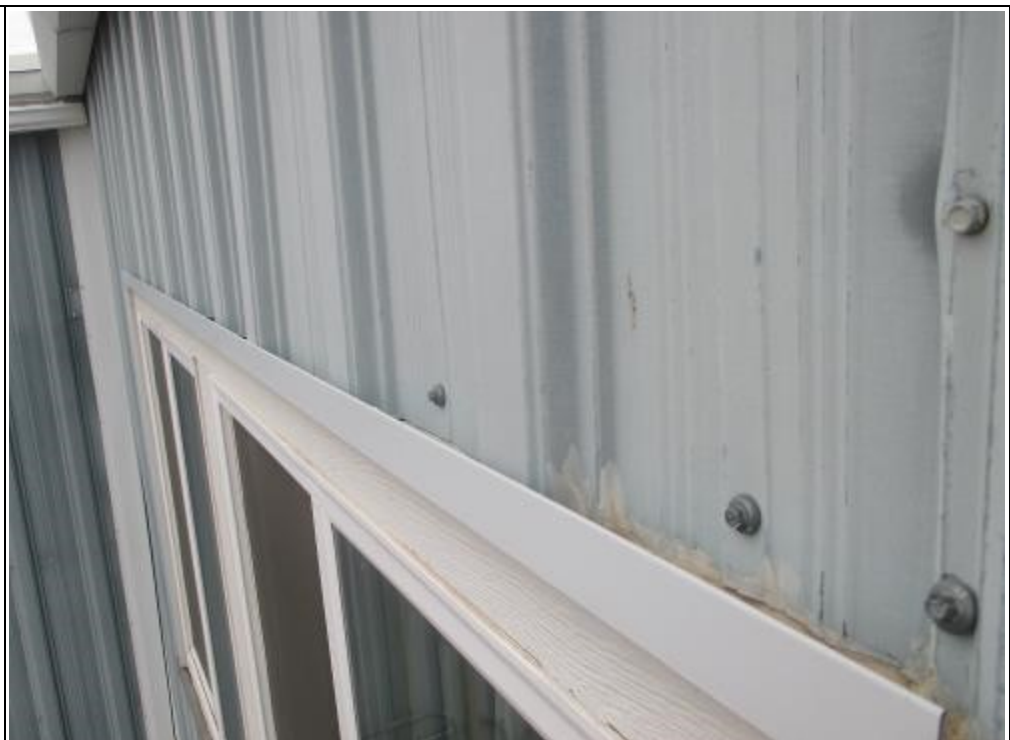
Photograph: 10

Hangar 504: View of the flashing and metal panels upon the upper window.

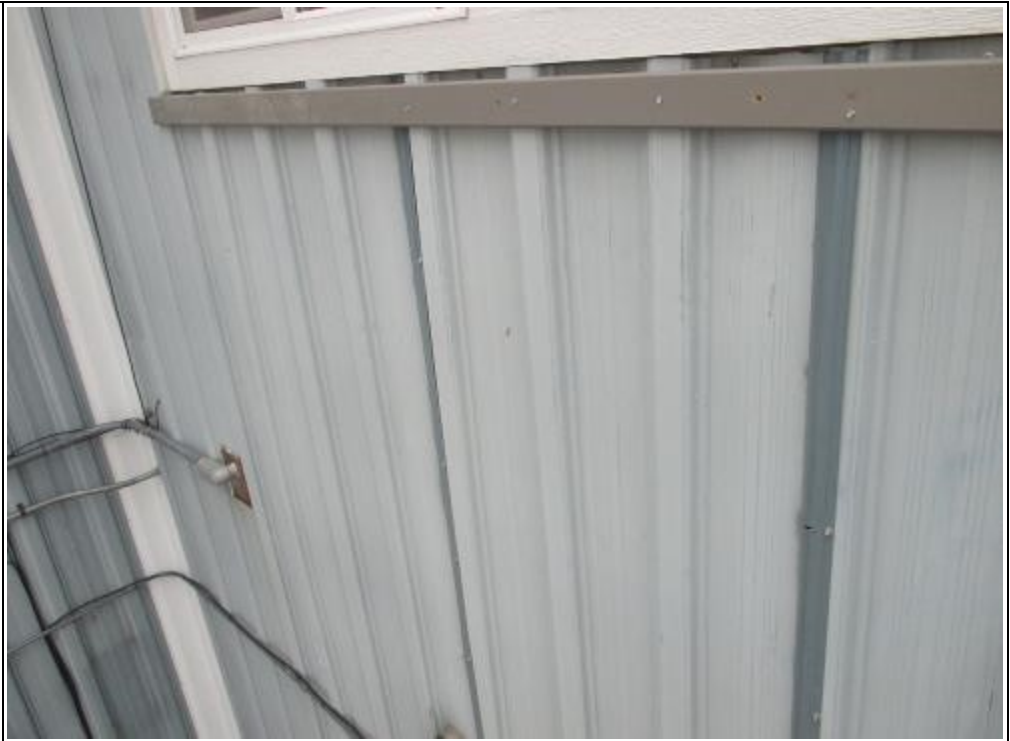
Photograph: 11

Hangar 504: View of the bottom of the upper story window.

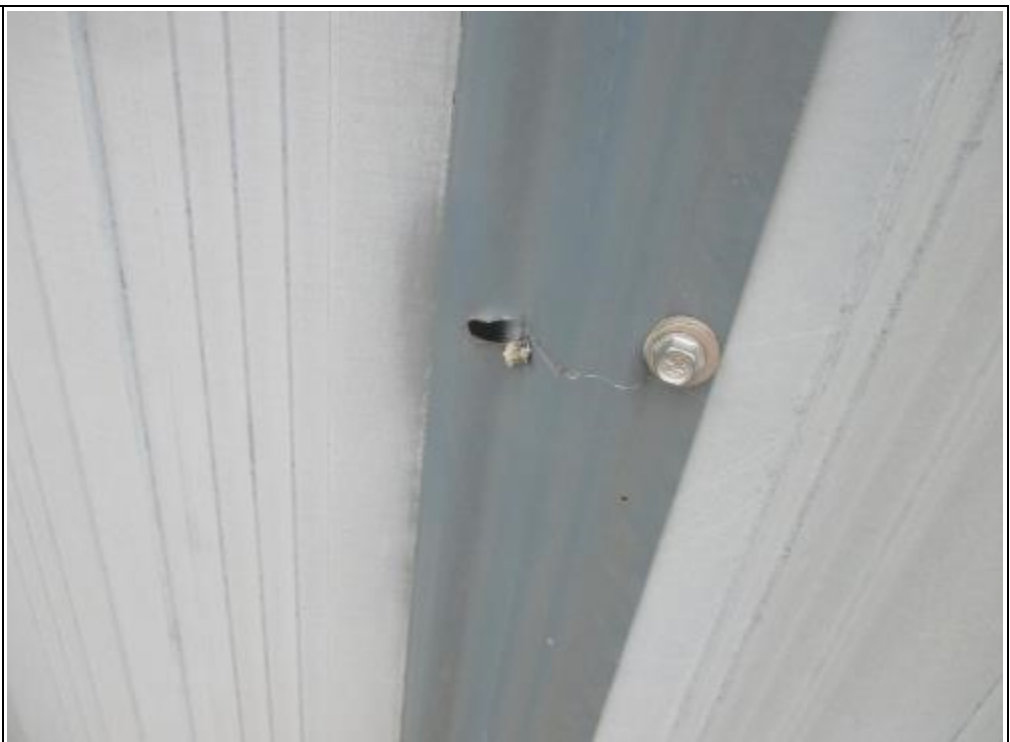
Photograph: 12

Hangar 504: View of a fasteners installed on a metal panel seam.

Note the hole in the metal panel adjacent to the fastener.

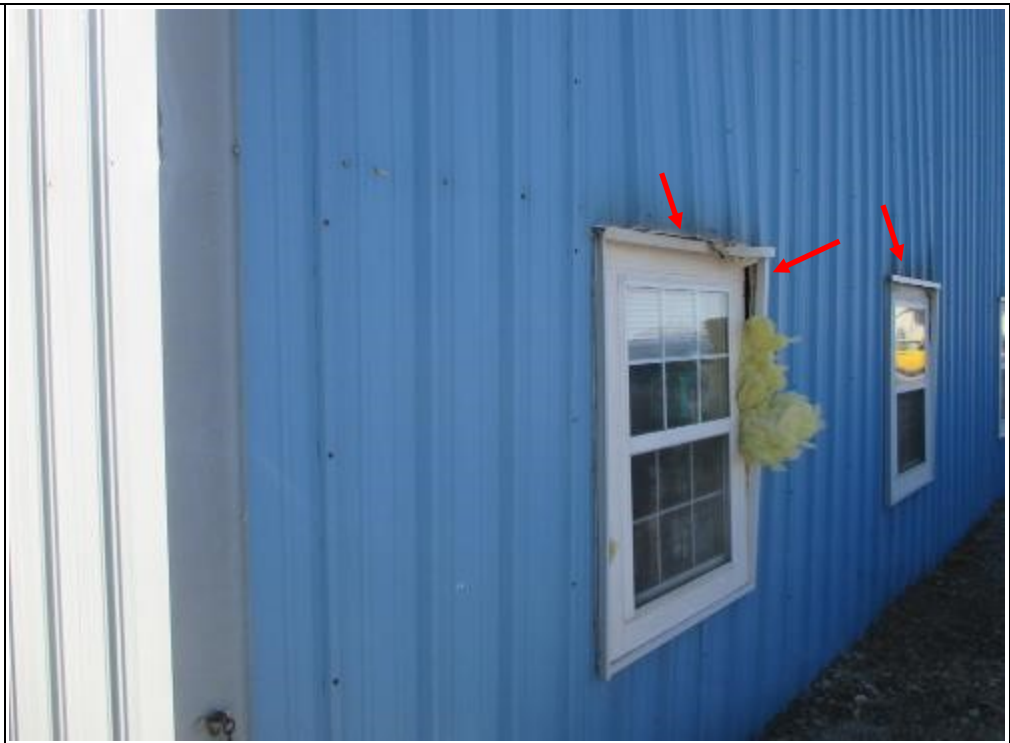
Photograph: 13

were locally bent and/or torn at both the intact and the missing fastener locations. The metal panels on the lower south end of the east elevation could be moved inward when pushed by hand along the horizontal row of fasteners above the windows. The metal panels above the two south windows were displaced outward and had missing and partially withdrawn fasteners. The hole edges at the missing fasteners above the window had a bright and jagged appearance. The bottom edges of the metal panels above the southmost window were exposed, and the metal panels at the upper right corner protruded past the window approximately 3.25 inches, exposing the underlying fiberglass batt insulation. The metal panel was bent and torn at the upper left window corner. The exposed and torn edges of the metal panels had a bright appearance without apparent surface corrosion (see Photos 13 thru 16).

The joints around the windows were not even and uniform.

The metal panels above and adjacent to the windows protruded outward (red arrows).

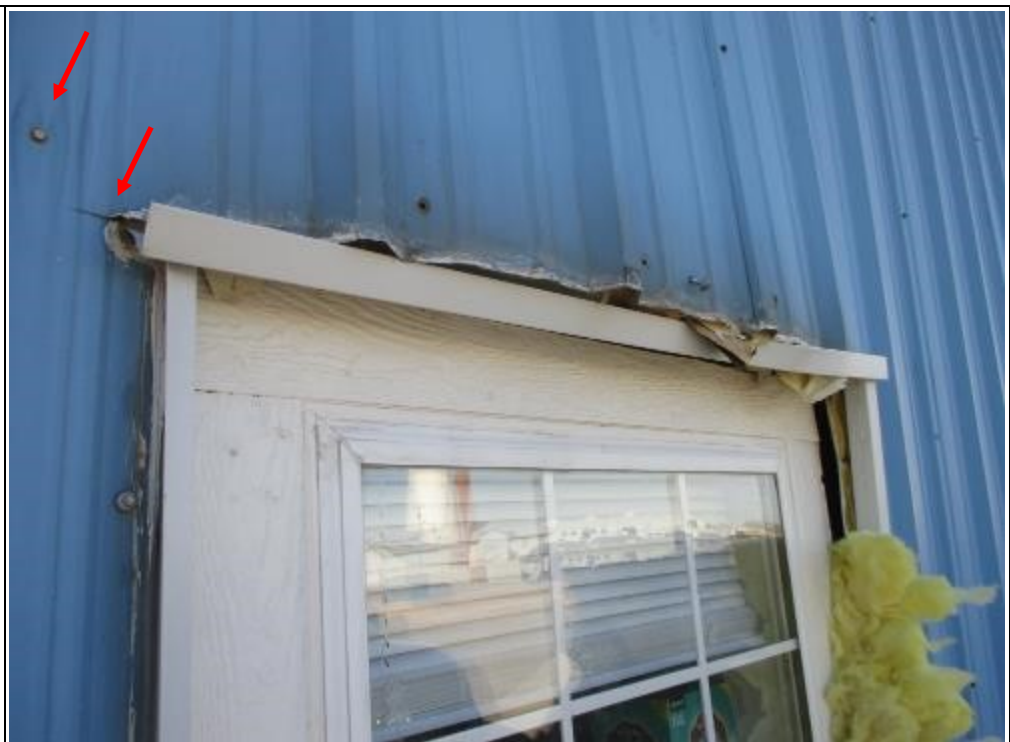
Photograph: 14

Hangar 504: View of the top of the southmost window on the east elevation.

The metal panel was bent and torn at the upper left window corner (red arrows).

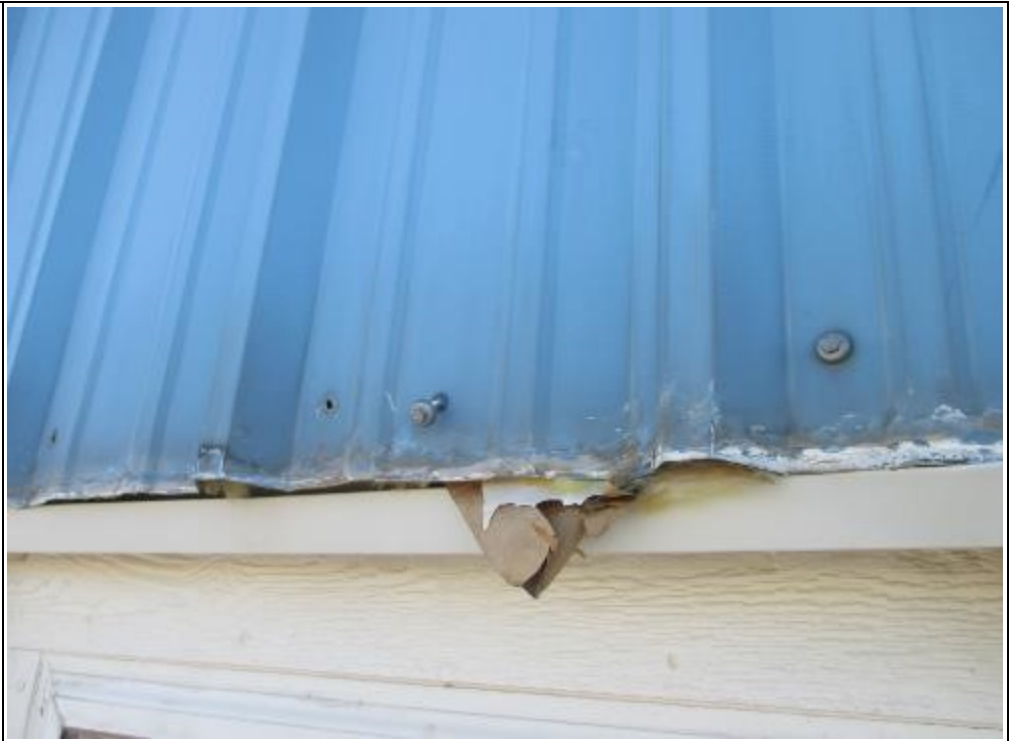
Photograph: 15

Hangar 504: Closeup of the metal panels above the south window on the east elevation.

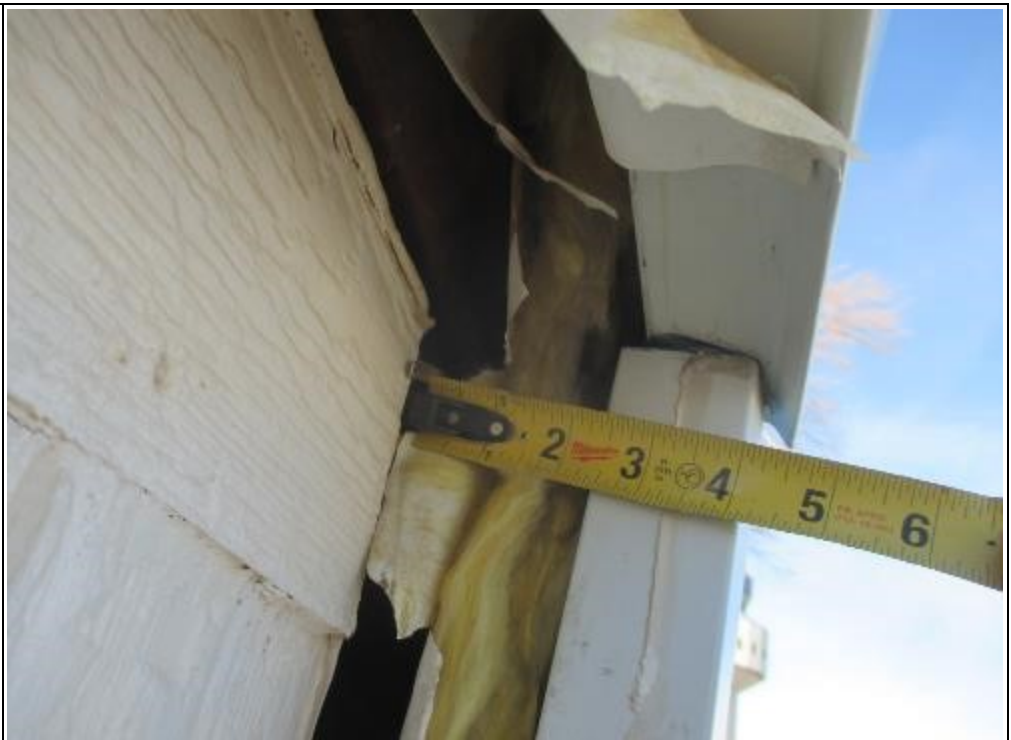
Photograph: 16

Hangar 504: Closeup of the upper right corner of the south window on the east elevation.

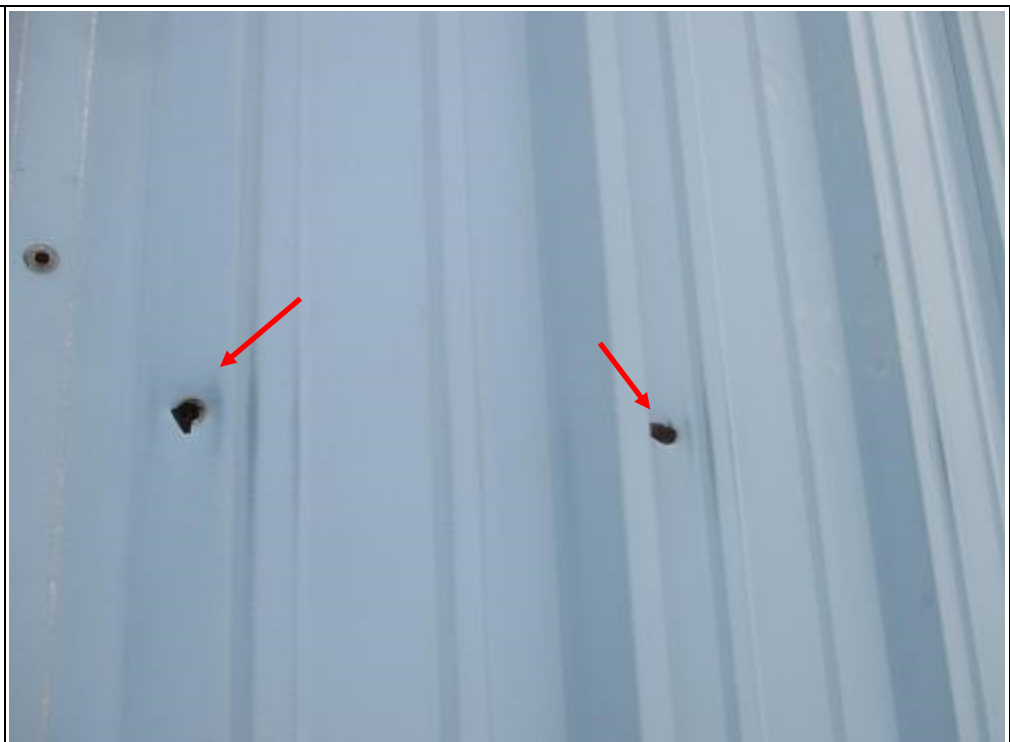
Photograph: 18

Hangar 504: Closeup of the holes at two missing fasteners for a wall panel (red arrows).

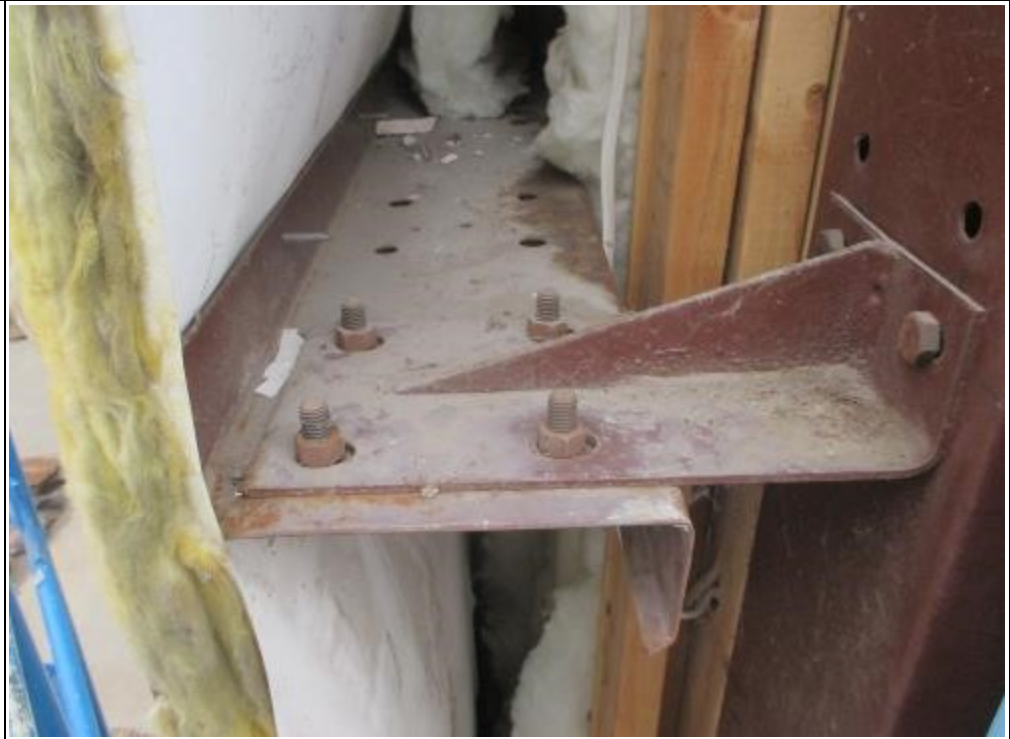
Photograph: 19

The south wall girts were cold-formed bypass girts that were attached to stiffened cold-formed angles that were bolted to the outside south column face. The bypass girt bolted connections were tight, and the bolts had been installed with the threads upward. The nuts had been installed without washers into the short-slotted holes of the stiffened angles. The bolts and girt metal edges had corrosion from apparent surface rust. The beam-column and beam-beam frame connections were bolted without washers. The bolted connections were tight. The frame connection bolts had a dulled appearance (see Photos 19 and 20).

Hangar 504: View of an upper girt connection for the south wall.

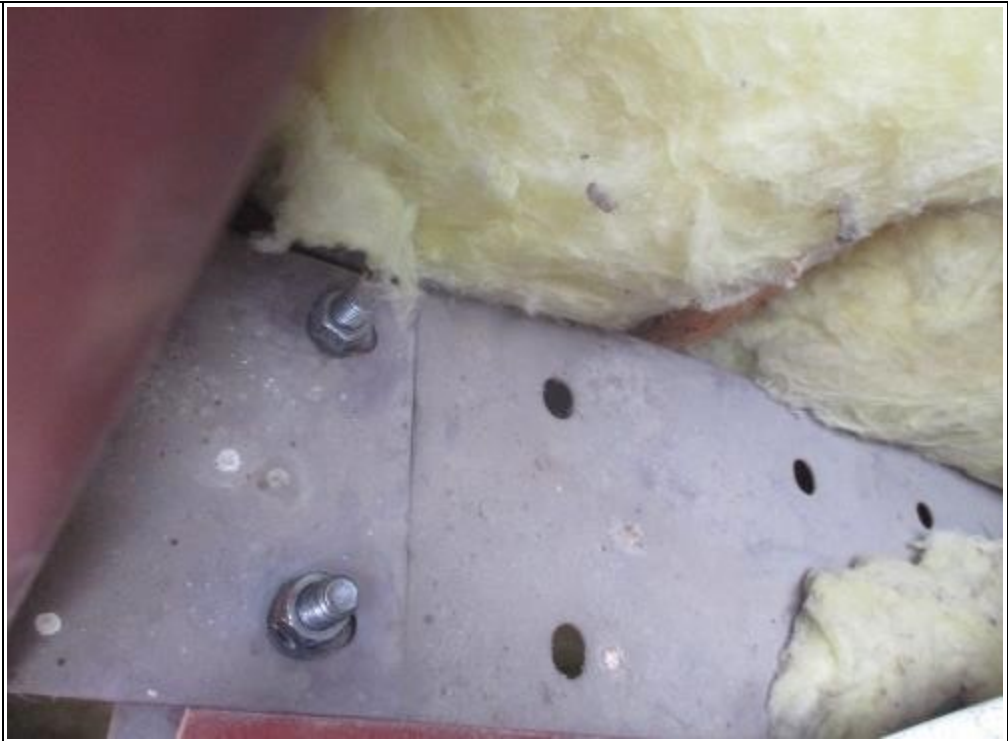
Photograph: 21

The east girts were flush mounted girts bolted to clips that were attached to the column webs. The girt bolted connections were tight, and the bolts had been installed with the threads upward. The nuts had been installed without washers into the short-slotted holes of the stiffened angles. The top surface of the clips at the short-slotted holes had darkened rings. The bottom girt south end connection was reported by the contractor to have had its bolts replaced (see Photo 21).

Hangar 504: View of the girt-column connection for the girt above the window on the east elevation.

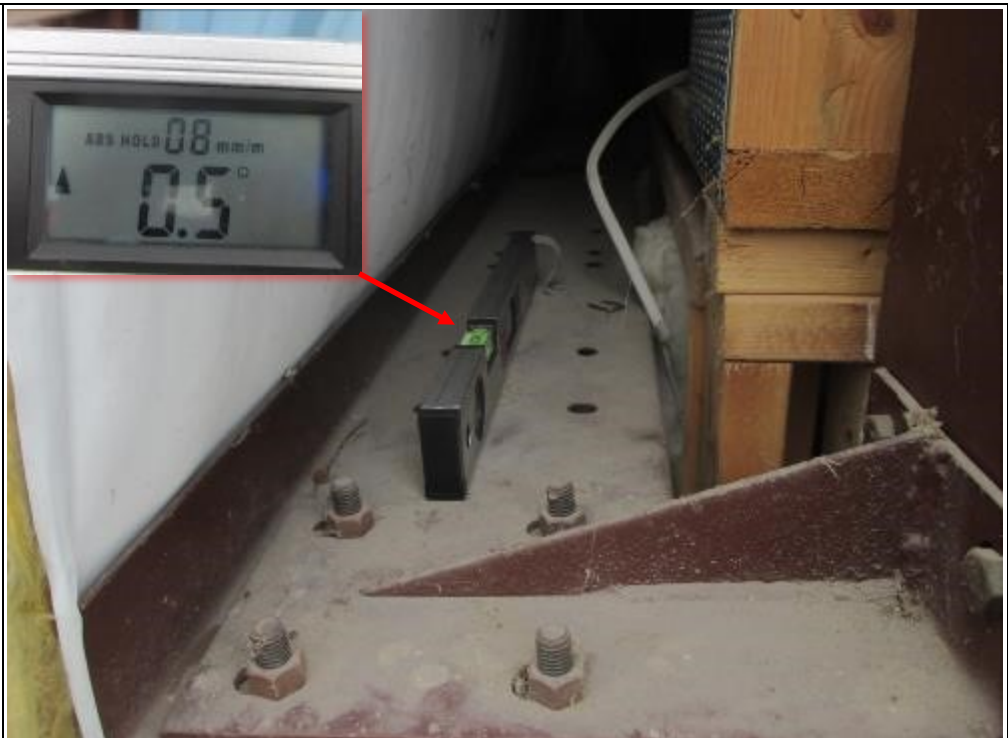
Photograph: 22

Hangar 504: View of a level reading taken on a south wall girt.

Note the truss was not apparently fastened or strapped to the wall framing.

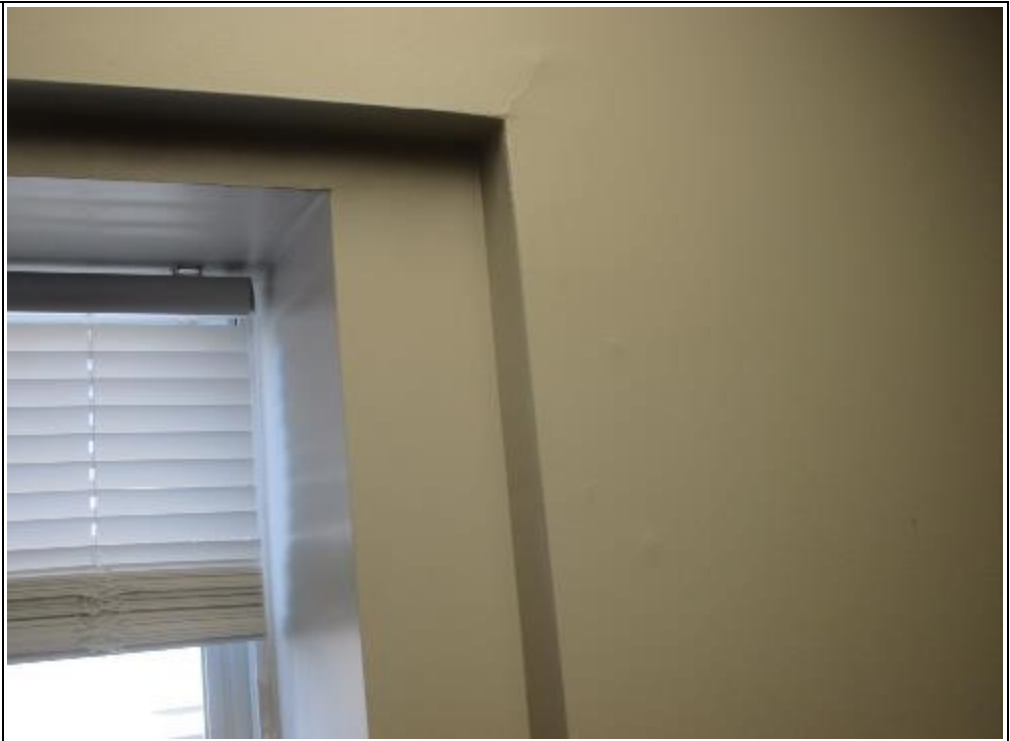
Photograph: 23

Hangar 504: View of nail pops to the drywall adjacent to the south side of the south kitchen window.

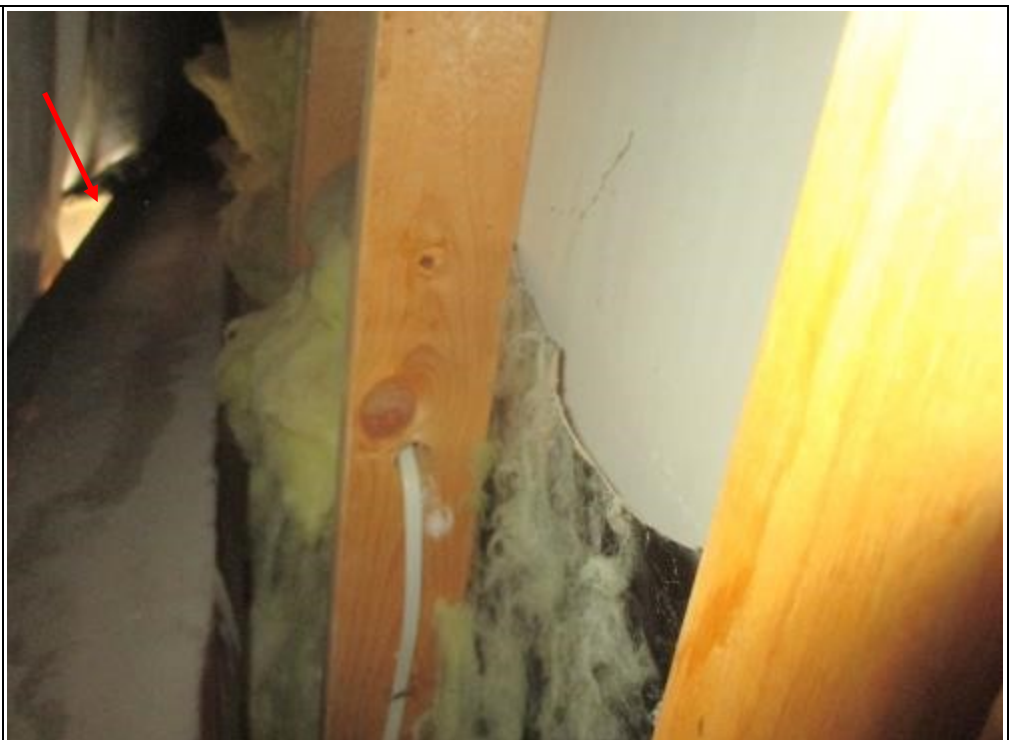
Photograph: 26

Hangar 504: View of the wall cavity for the east kitchen wall.

The metal building girt was rotated (red arrow).

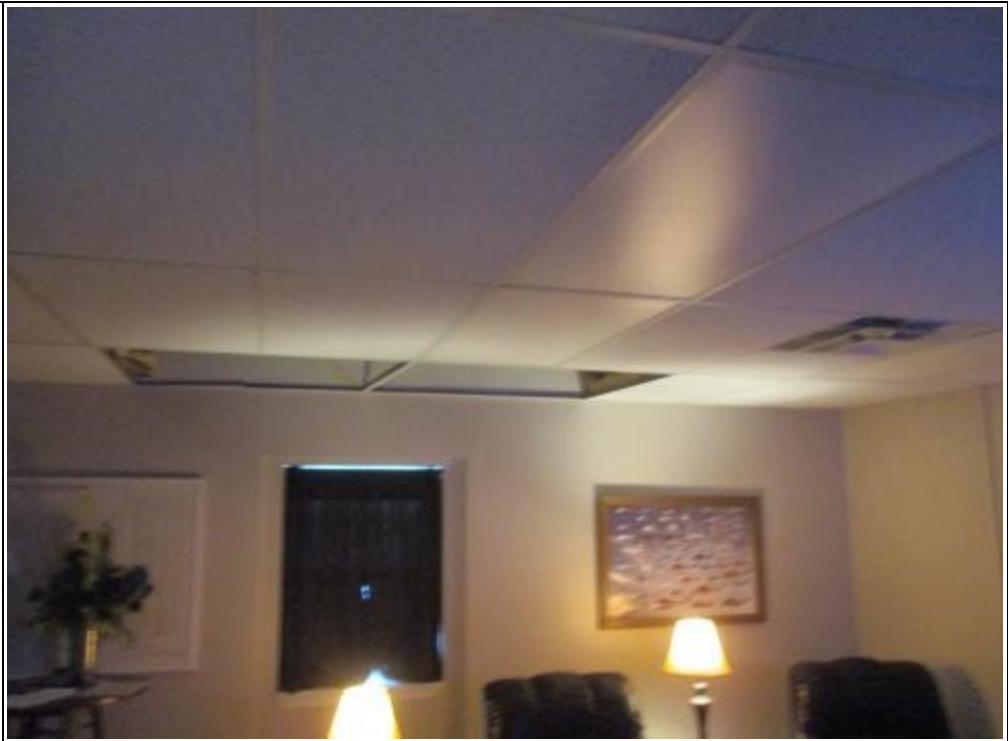
Photograph: 27

The west end of the living room was missing four acoustic ceiling tiles. The second-floor framing members above the ceiling tiles had full bearing and were not apparently displaced or deformed. The second-floor office and sleeping quarters had multiple nail pops on the east wall surface (see Photos 27 thru 29).

Hangar 504: View of missing acoustic ceiling tiles at the west end of the first-floor living room.

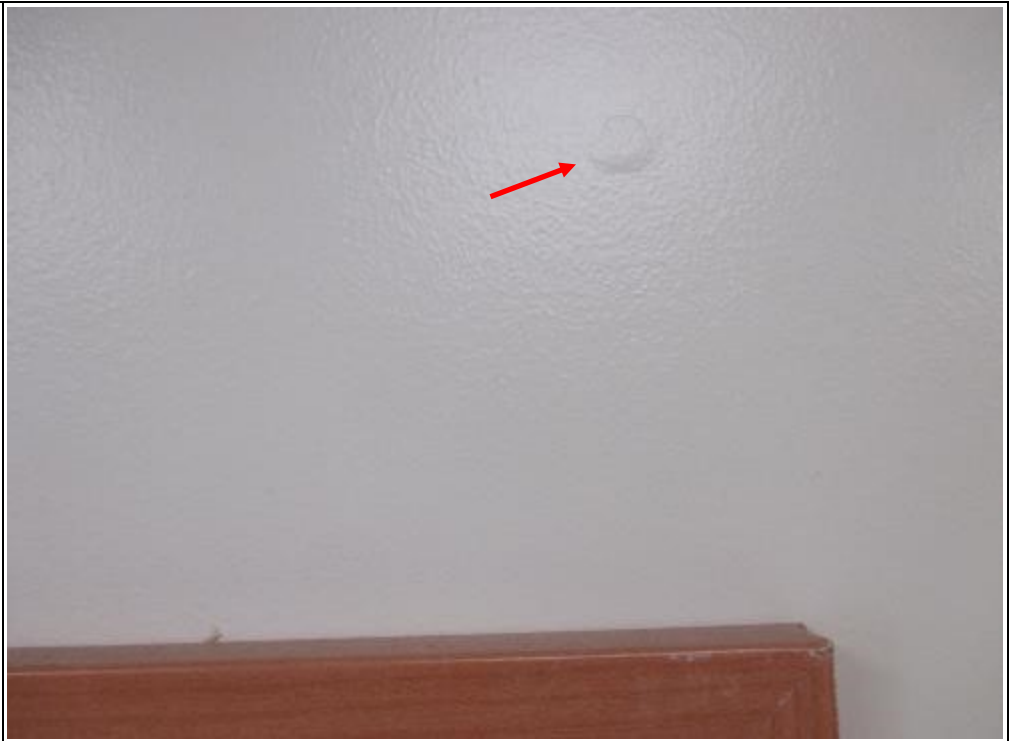
Photograph: 29

Hangar 504: View of a nail pop (red arrow) on the east wall of the second-floor office.

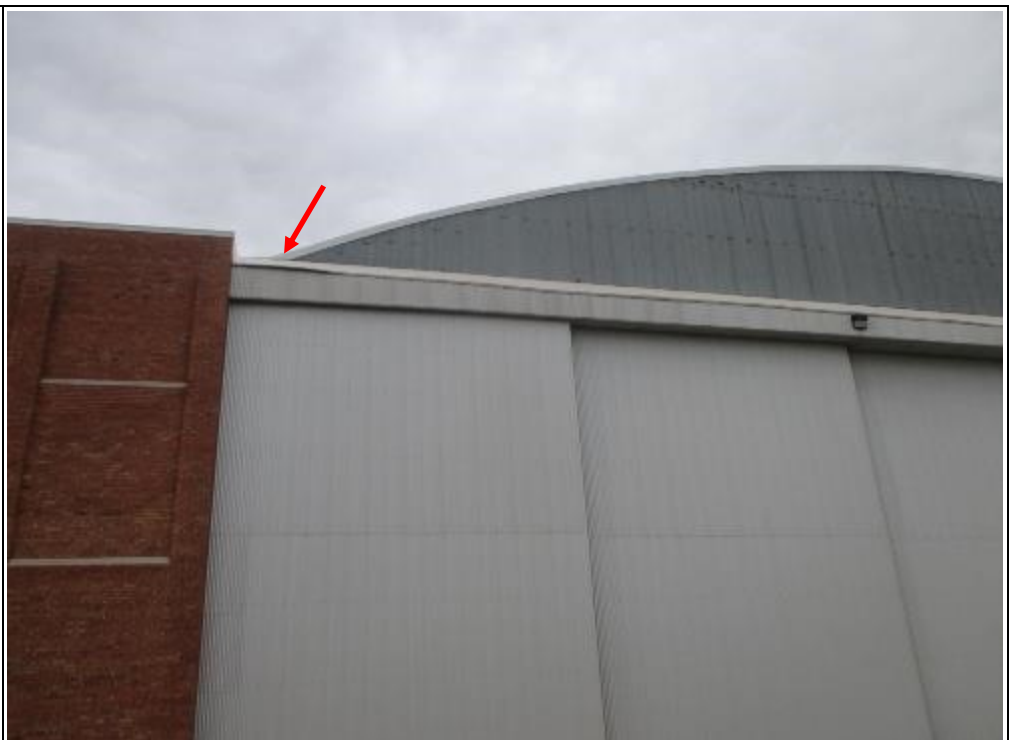
Photograph: 30

The elevated winds had affected Hangar 606. The elevated winds appeared to have produced wind uplift that caused the localized detachment of the thermoplastic roof at two places on the south lower hangar door roof. Additionally, the elevated winds appeared to have entered the wall cavities on the west hangar wall. While there were no detached or missing wall panels on the exterior of the west hangar wall, the winds could have entered between the bottoms of the corrugated metal panels and the concrete wall. Moreover, the greatest displacement of the west hangar wall appeared to be at the center bay where the wall panels were offset from the concrete frame. The winds appeared to have entered the into the wall cavities at these locations and caused the bottoms of the interior wall panels to become displaced. The lack of discoloration and staining to the interior wall panels and their base angle was an indicator that the wall movement had occurred recently, consistent with on or around December 15, 2021, in the weeks prior to the VERTEX inspection. The interior wall panels were not part of the lateral force-resisting system and did not appear to have affected the lateral force-resisting system for Hangar 606.

Hangar 606: View of the thermoplastic membrane detachment (red arrow) at the west side of the south lower hangar door roof.

- Remove and reattach approximately (16) feet of the thermoplastic membrane edge at two places for the south lower hangar door roof. VERTEX recommends that the full roof be inspected by a qualified contractor.

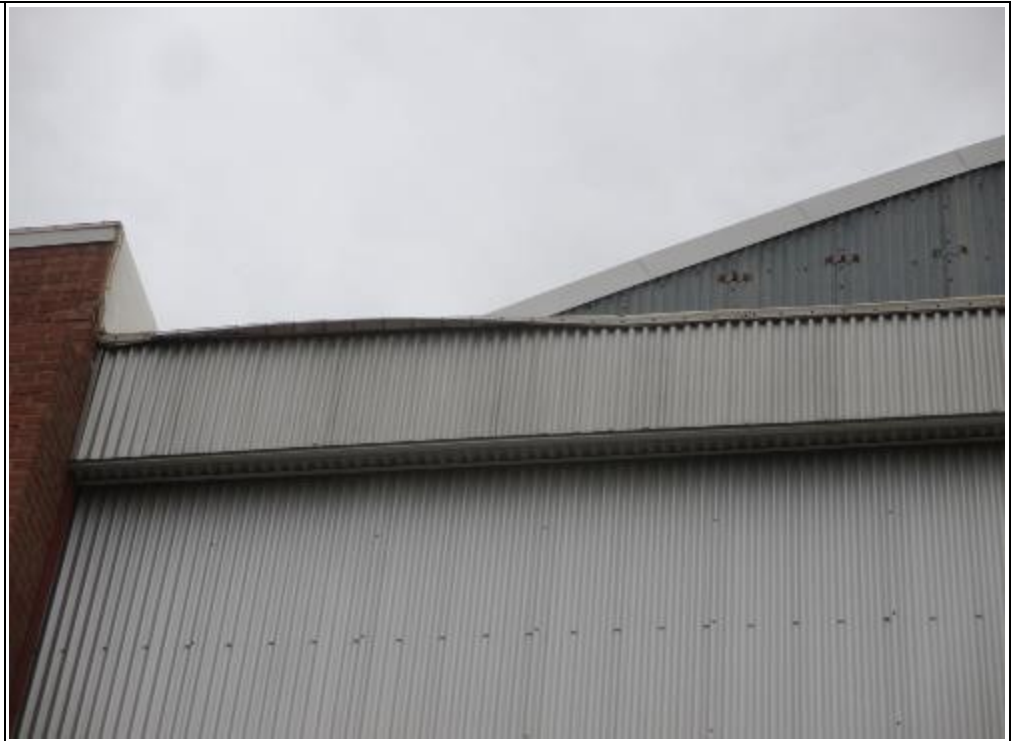
Photograph: 31

Hangar 606: Closeup of the detached thermo-plastic membrane.

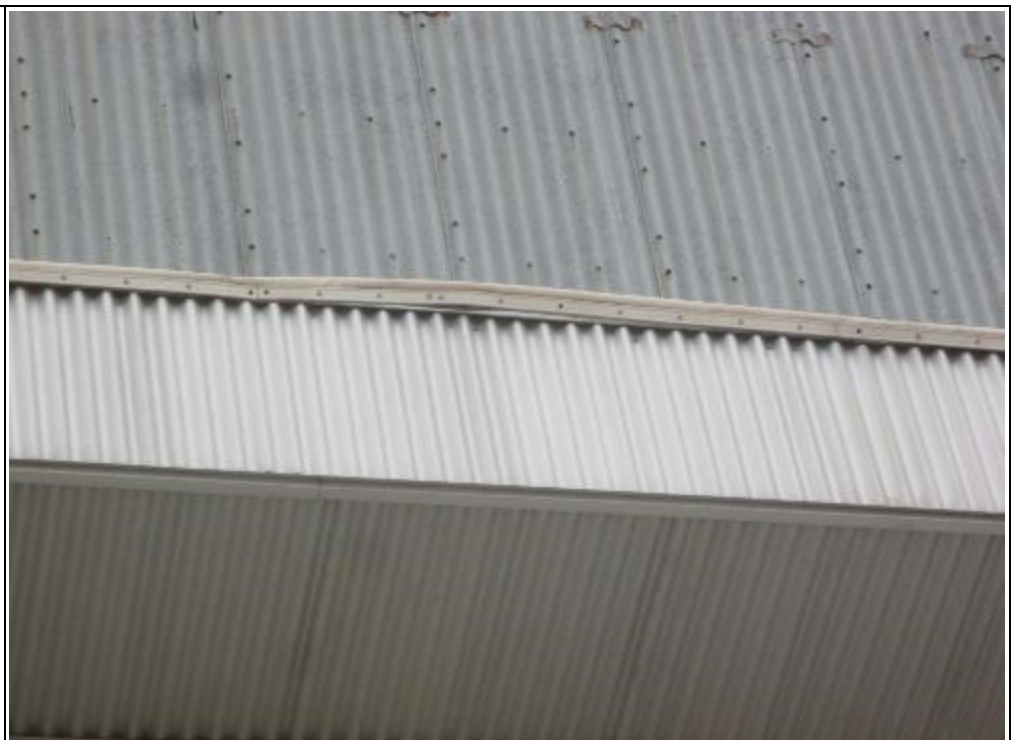
Photograph: 32

Hangar 606: View of the vertical displacement of the thermoplastic membrane along the south edge of the lower south hangar door roof.

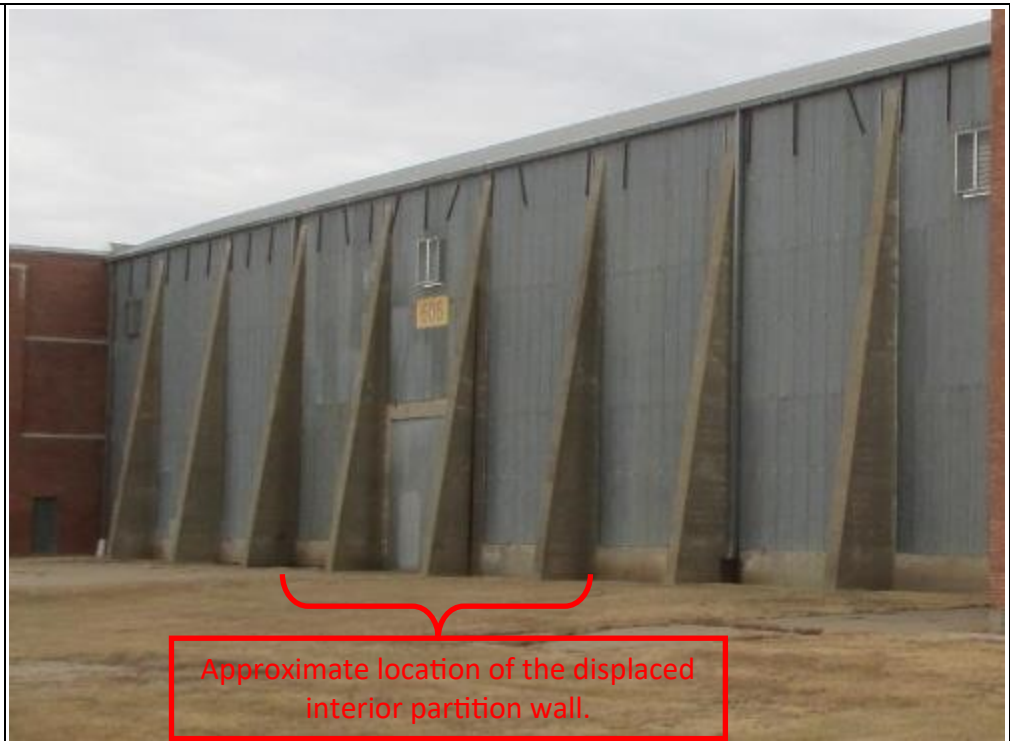
Photograph: 33

The hangar roof and the walls between the concrete buttresses were covered corrugated metal panels. The wall had a partial height concrete wall approximately (3) feet tall the length of the west elevation except for the center bay. The roof and wall panels were attached and were not missing. The bottoms of the metal panels were not detached or laterally displaced. The gaps between the metal panel corrugations and concrete walls were not apparently sealed. The metal panels were bent at their joints but had no apparent gaps in the joints. No missing fasteners were observed at the metal panels. The metal panels had a repair sealant installed at several places, and the repair sealant was not apparently torn (see Photos 33 and 34).

Hangar 606: View of the west hangar wall.

The middle three bays of the interior partition wall on the hangar west side had been laterally displaced inward (red rectangle).

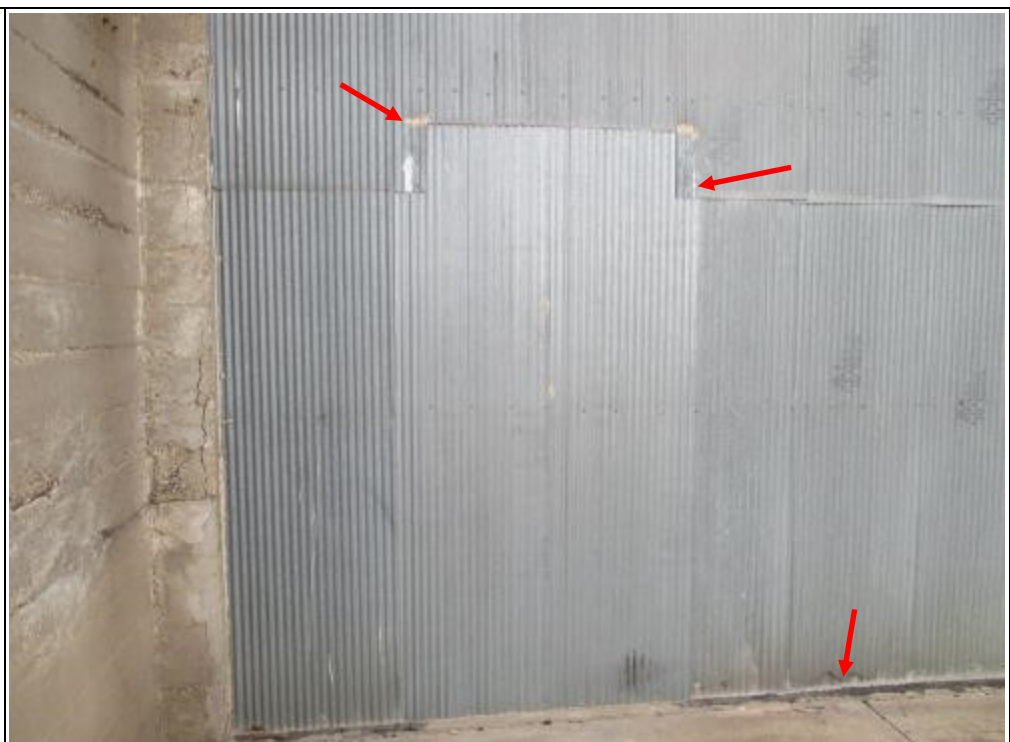
Photograph: 34

Hangar 606: Partial view of the metal wall panels at the center bay on the hangar west side.

Not the repair sealant at several places (red arrows).

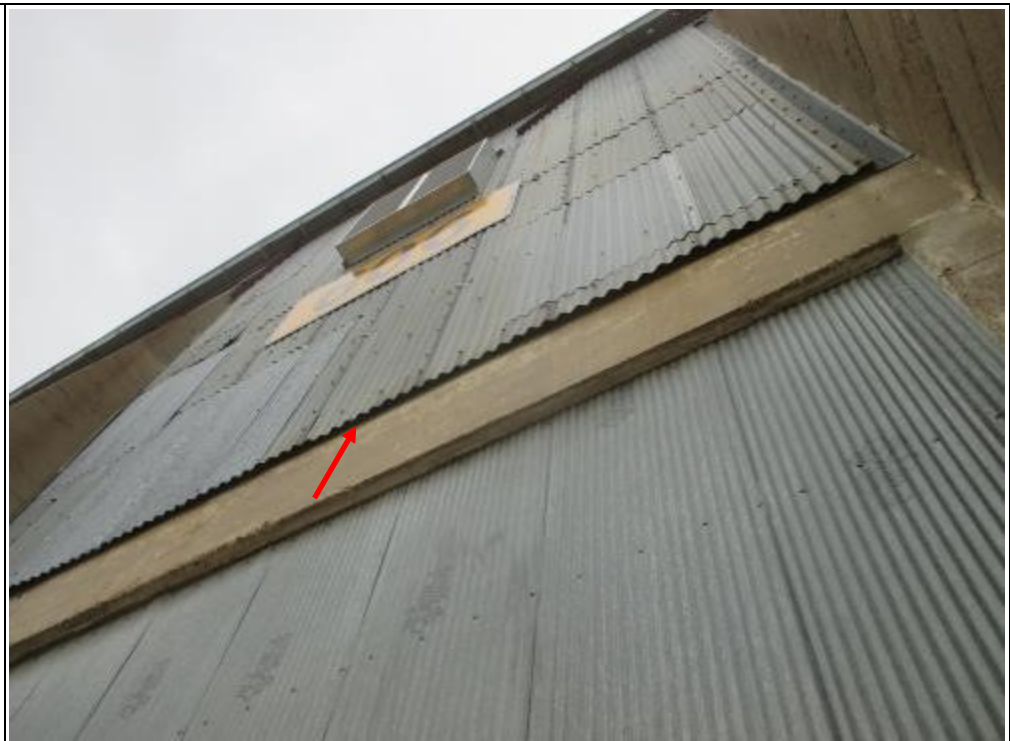
Photograph: 35

The center bay was approximately opposite of the middle of the length of the displaced partition wall. The center bay had a louver at approximately 3/4 of the wall height. The upper half of the wall had multiple metal panels that apparently had been replaced. The metal panels for the upper half of the wall were offset from the face of the concrete frame by approximately (2) inches. The concrete buttresses and the partial height wall had numerous cracks. The crack edges and interior surfaces were rounded and weathered (see Photos 35 and 36).

The upper half of the wall had multiple panels that had been apparently been replaced.

The metal panels were offset from the face of the concrete frame approximately (2) inches (red arrow).

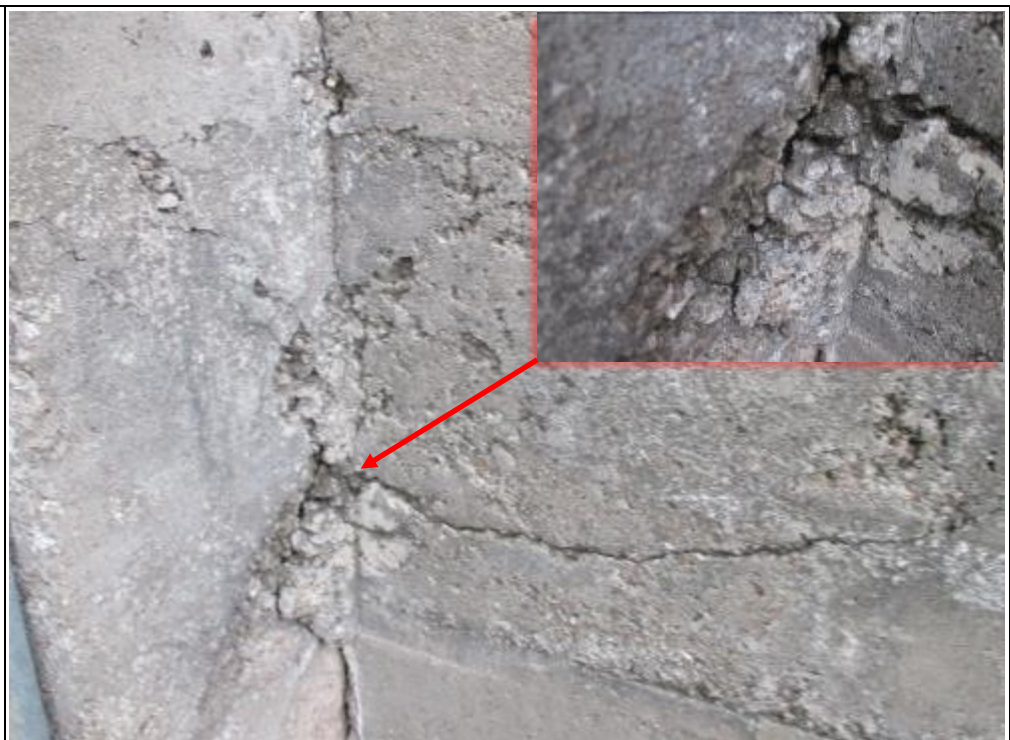
Photograph: 36

Hangar 606: View of a crack in a concrete buttress.

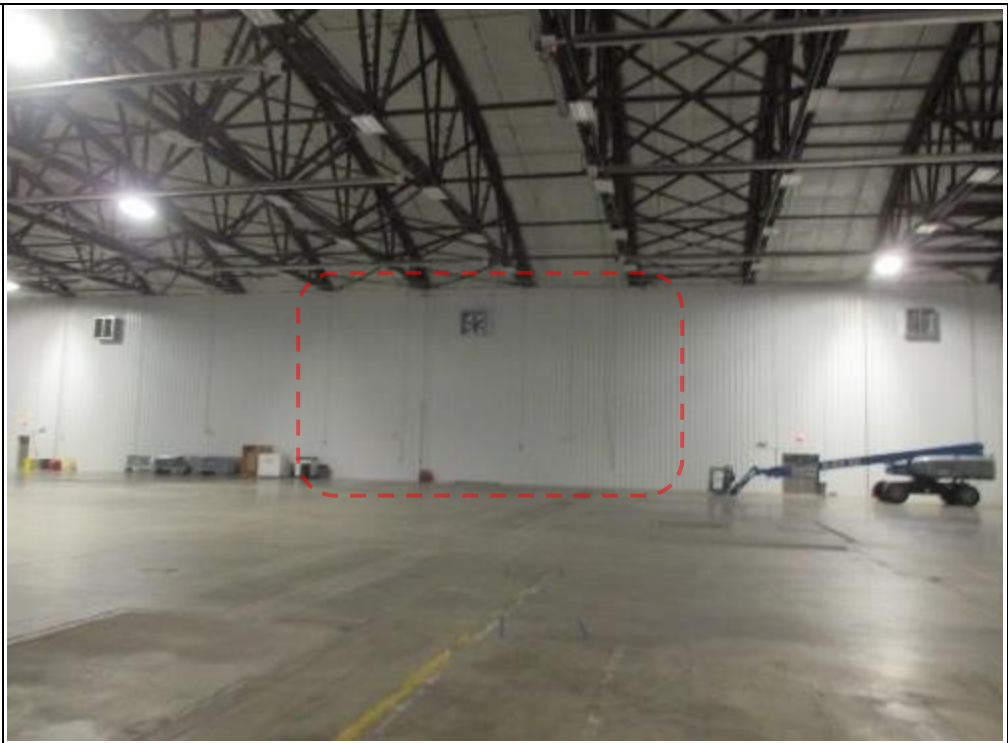
Photograph: 37

walls. Approximately the center (60) feet of the bottom west hangar wall had been displaced inward. The metal panels where the wall had been displaced was 1.8 degrees from vertical plumb. Measurements taken at a joint in concrete slab along the length of the wall indicated that the bottom of the wall had been displaced inward approximately (7) inches. The bottom angle for the interior wall was not locally bent or crippled. The wall panels and the bottom angle were not discolored or stained. The metal wall panels did not have missing fasteners, and the metal panels were not locally buckled or bent at the fasteners (see Photos 37 thru 40).

Hangar 606: View of the hangar west wall.

The bottom of the interior wall was displaced approximately (7) inches.
