Report 4 – Structural Condition Assessment Hangars 504 and 606 and Building 655

MARCH 1, 2022

Claim: 5630075143

VERTEX Project: 76253

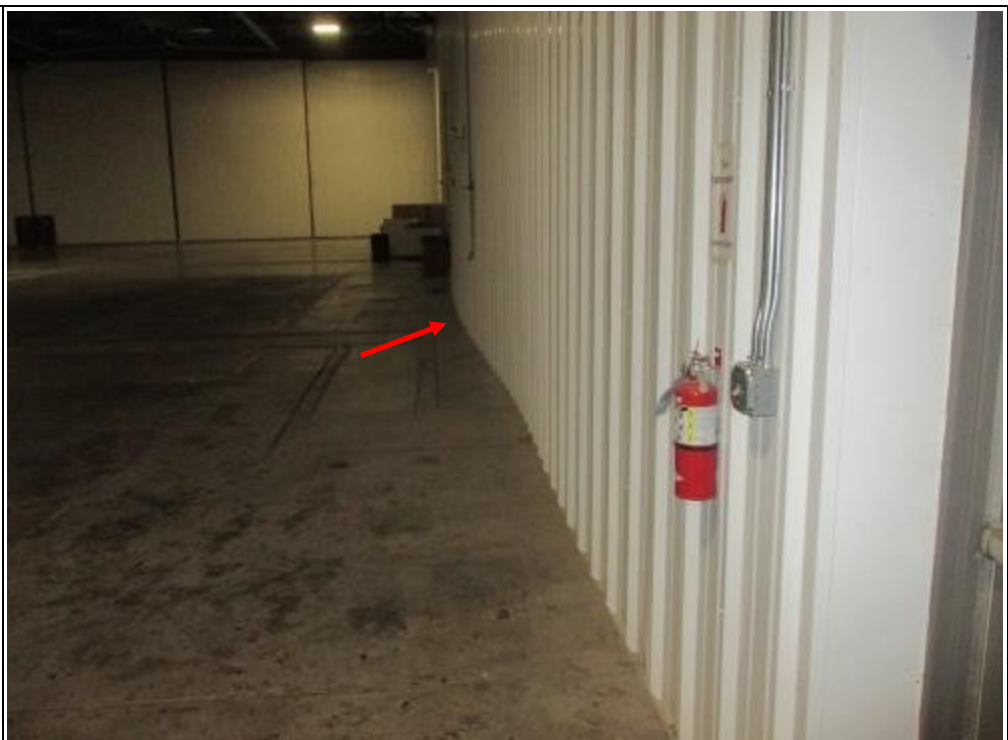
Photograph: 38

Hangar 606: Additional view of the hangar west wall that had been laterally displaced (red arrow).

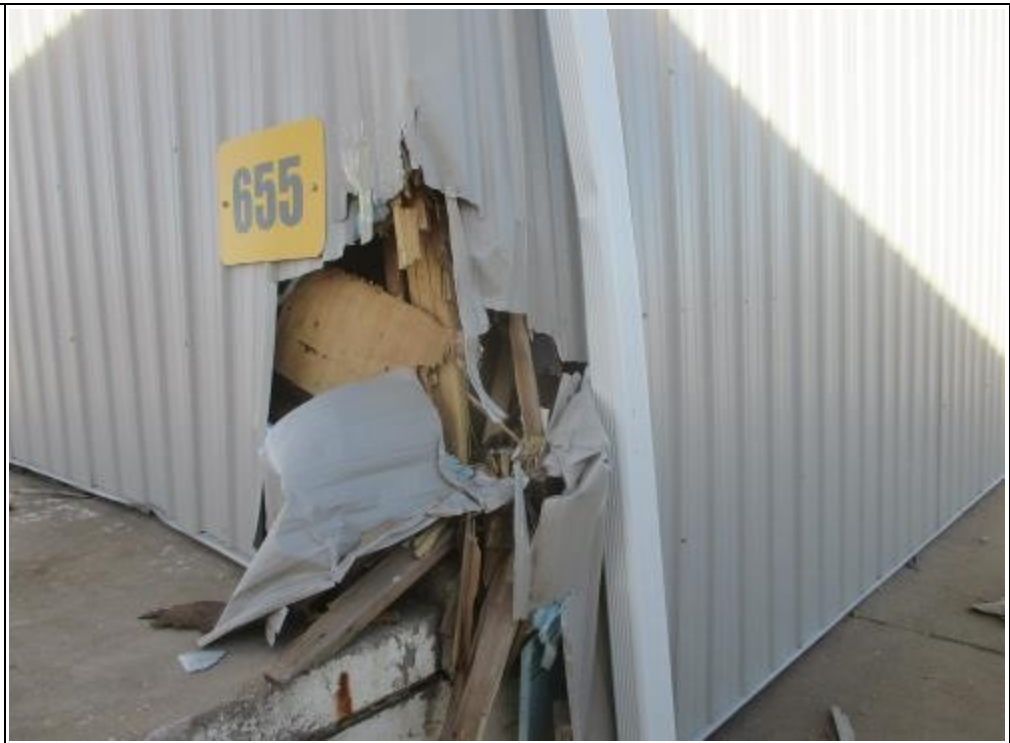
Photograph: 41

The southwest wall corner had reportedly been impacted by a semitrailer. The semitrailer had been reportedly righted and placed in its position prior to the VERTEX inspection. The metal panels had been bent and torn approximately (4) feet north and (3.5) feet east of the building corner. The base angle to which the metal panels were attached was bent approximately (4.3) feet north of the building corner. The metal panels were bent and torn approximately (4) feet above the top of the loading dock concrete slab. The metal panel torn edges were jagged and had a bright appearance. The fractured wood framing and sheathing surfaces were rough and were not discolored or stained (see Photos 41 thru 43).

Lastly, the southwest building corner of building 655 appeared to have been impacted by the reported semitrailer by the elevated winds on or around December 15, 2021. The semitrailer was not anchored, and the elevated winds appeared to have caused the trailer to overturn and impact

Building 655: View of the southwest corner of the warehouse at the loading dock that had been reportedly been impacted.

The metal panels had been bent and torn north and east of the building corner. The wood framing and sheathing had been fractured.

- Replace approximately (8) lineal feet of exterior wall panels and base angle.
- Remove and replace approximately (4) 2x8 studs including their bottom and top plates as required.
- Remove and replace approximately (8) lineal feet of exterior wood sheathing and insulation the height of the 2x8 studs and as required for the replacement of the metal wall panels.

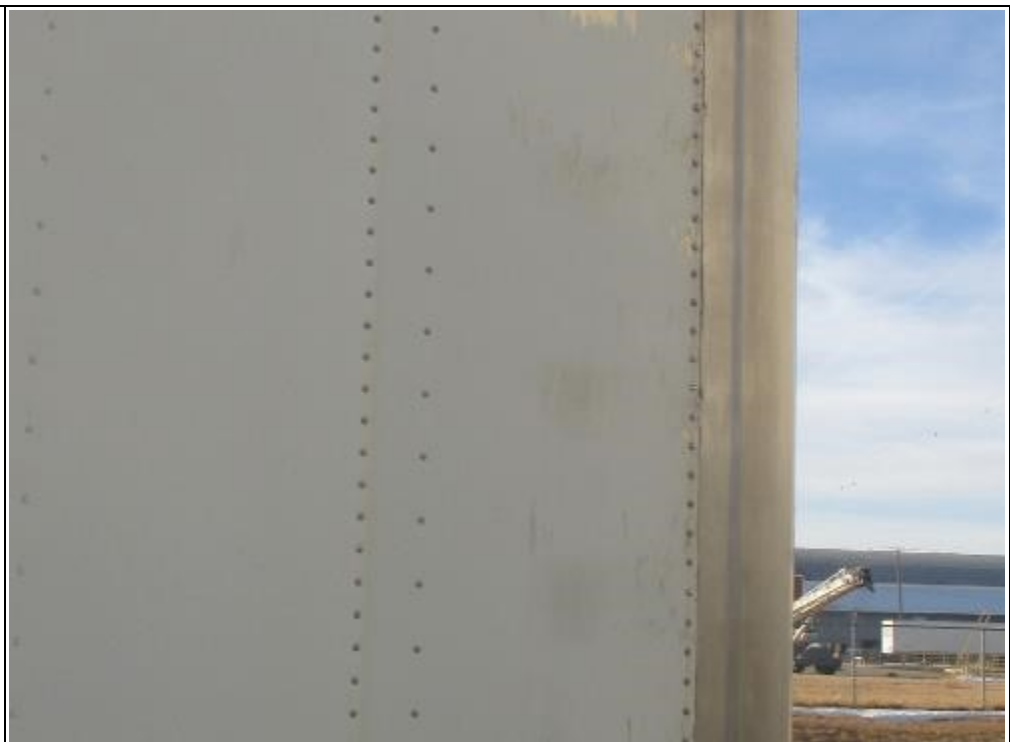
Photograph: 42

Building 655: View of scuffs to the side of the trailer that reportedly struck the building corner.

The trailer was reported to have been righted prior to the VERTEX inspection.

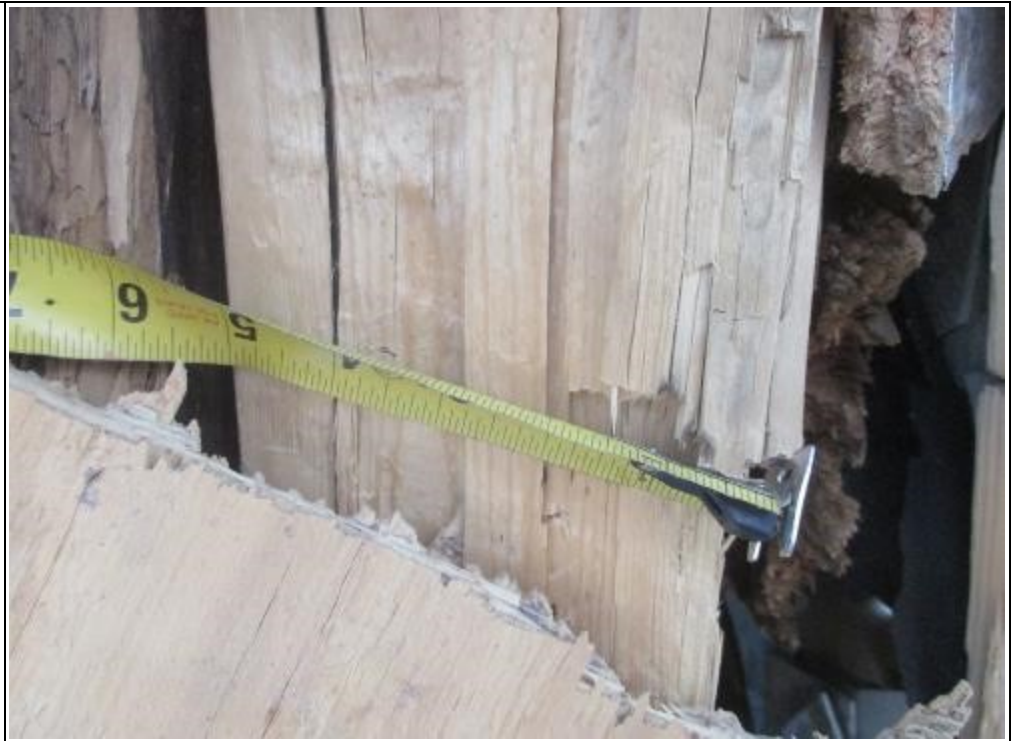
Photograph: 43

The metal panel torn edges were jagged and bright.

The fractured wood surfaces were rough and were not discolored or stained.
