BUCHER, WILLIS & RATLIFF
ENGINEERS ▮ PLANNERS ▮ ARCHITECTS

June 13, 1994

Re: Pump House No. 305 Summary Report

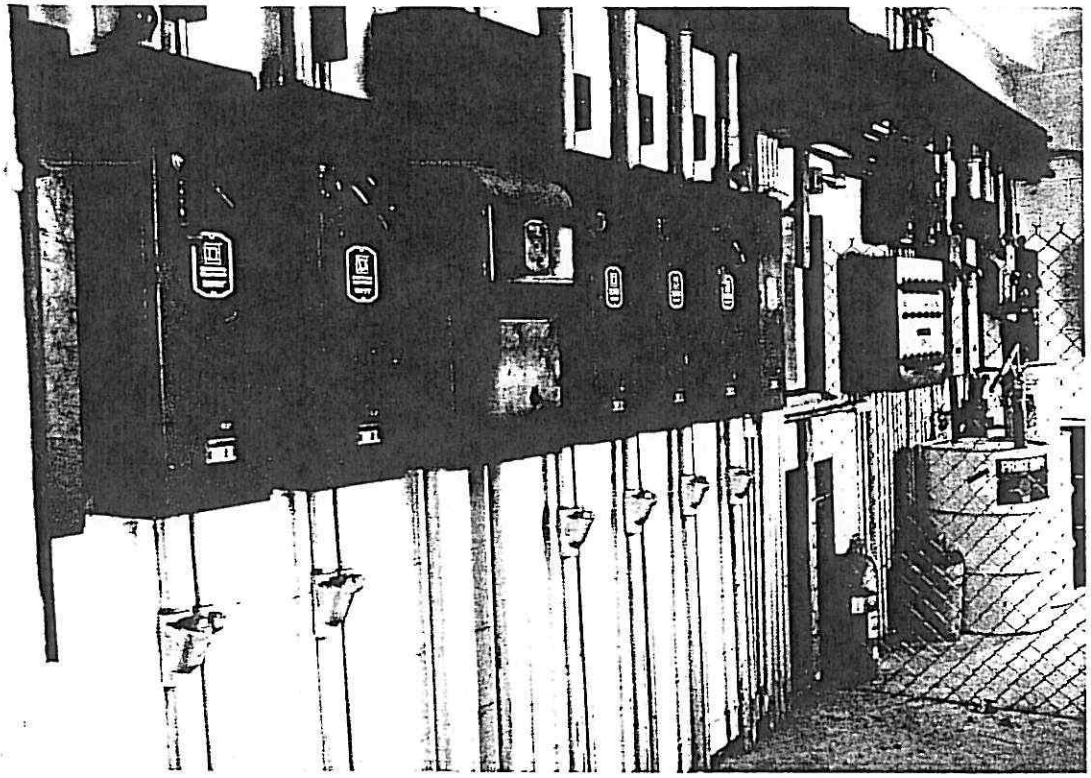
PUMP HOUSE NO. 305
INTERIOR, LOOKING WEST

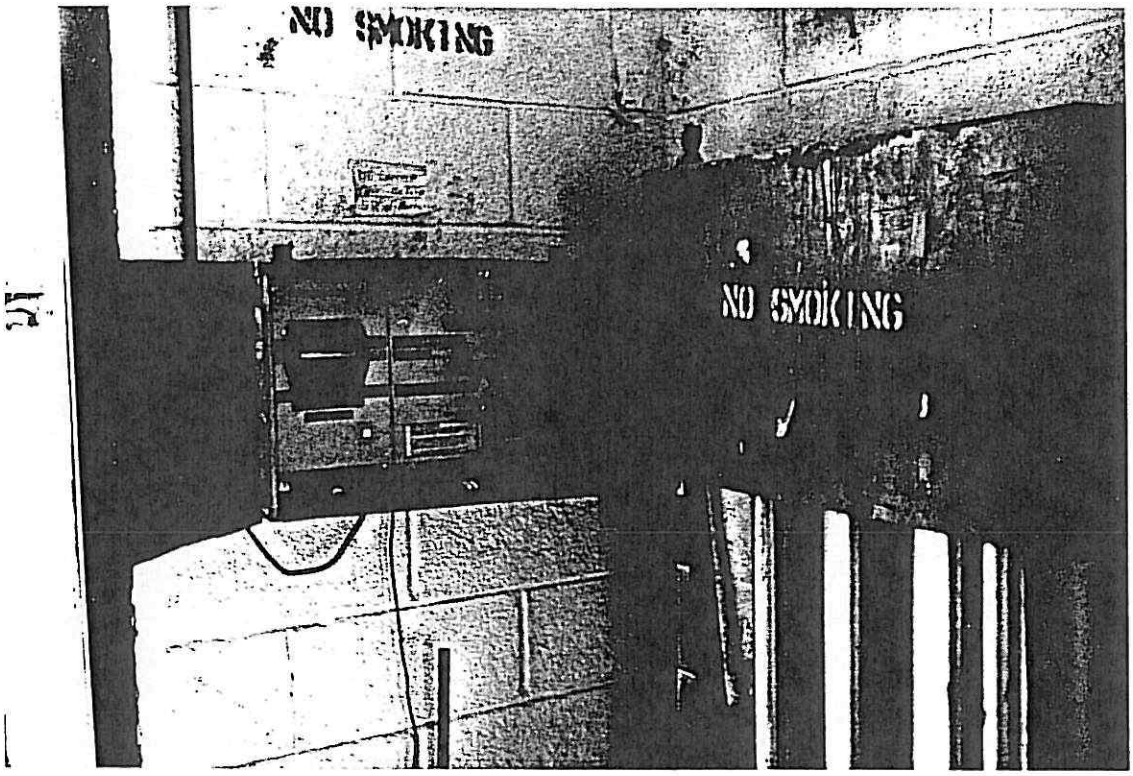
PUMP HOUSE NO. 305
INTERIOR, ELECTRICAL ROOM, LOOKING S/E
